Fire-resistance test on fire collars protecting a concrete slab penetrated by services

Test Report

Author: Mario Lara-Ledermann
Report number: FSP 1648
Date: 1 September 2014

Sponsored Investigation No. FSP 1648

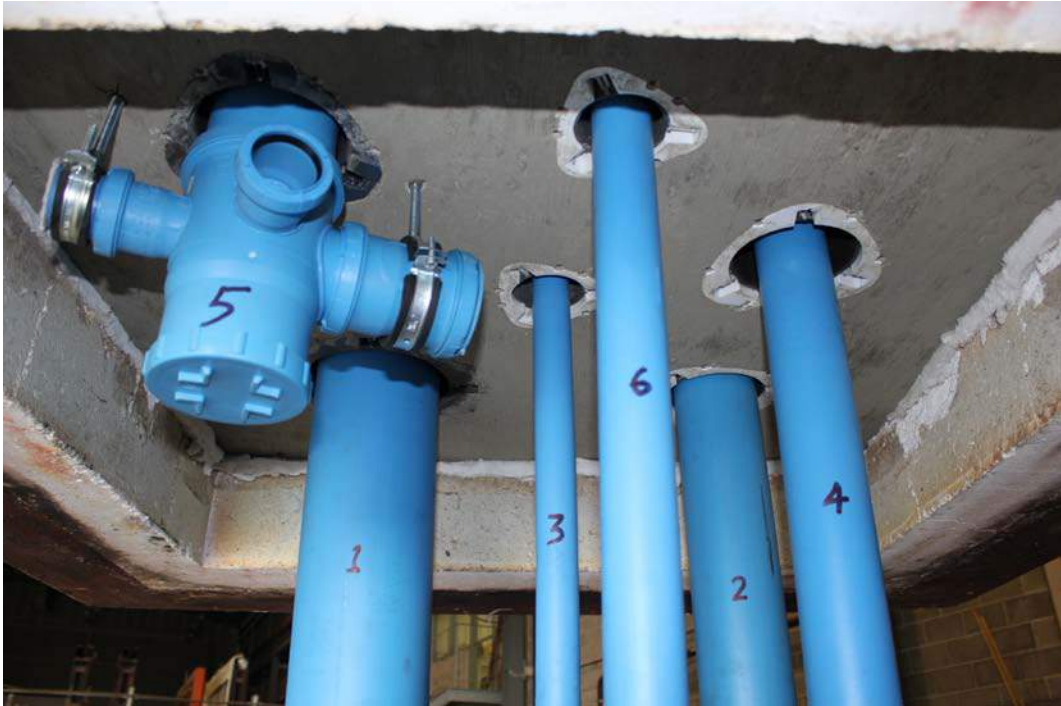
PHOTOGRAPH 1 – EXPOSED FACE OF SPECIMENS PRIOR TO TESTING

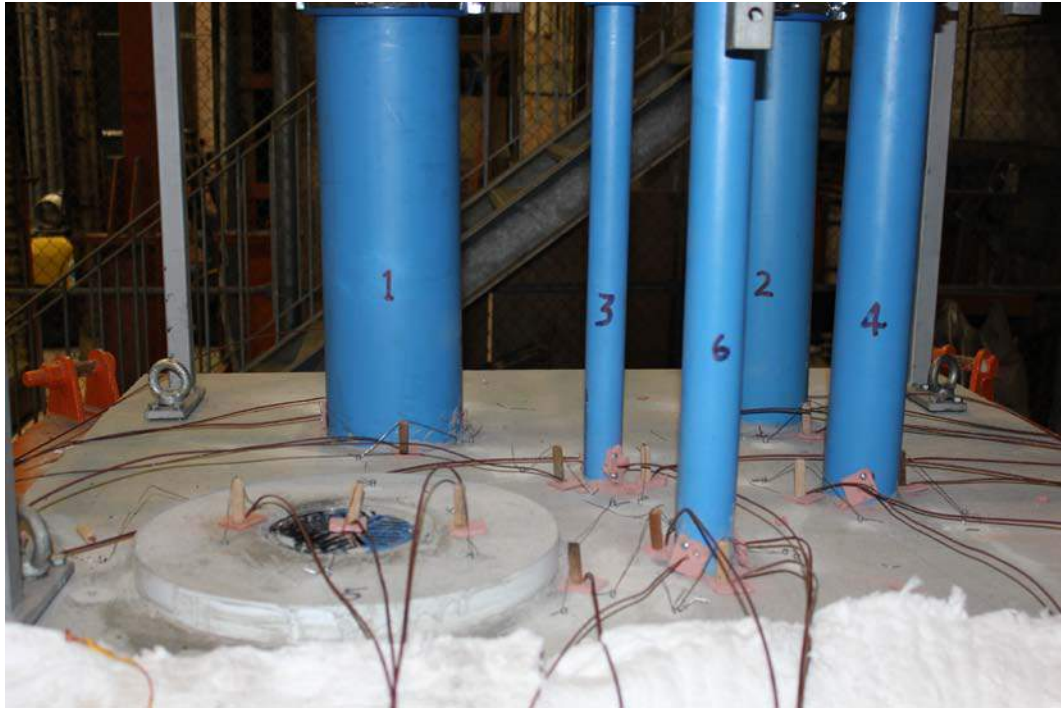
PHOTOGRAPH 2 – UNEXPOSED FACE OF SPECIMENS PRIOR TO TESTING

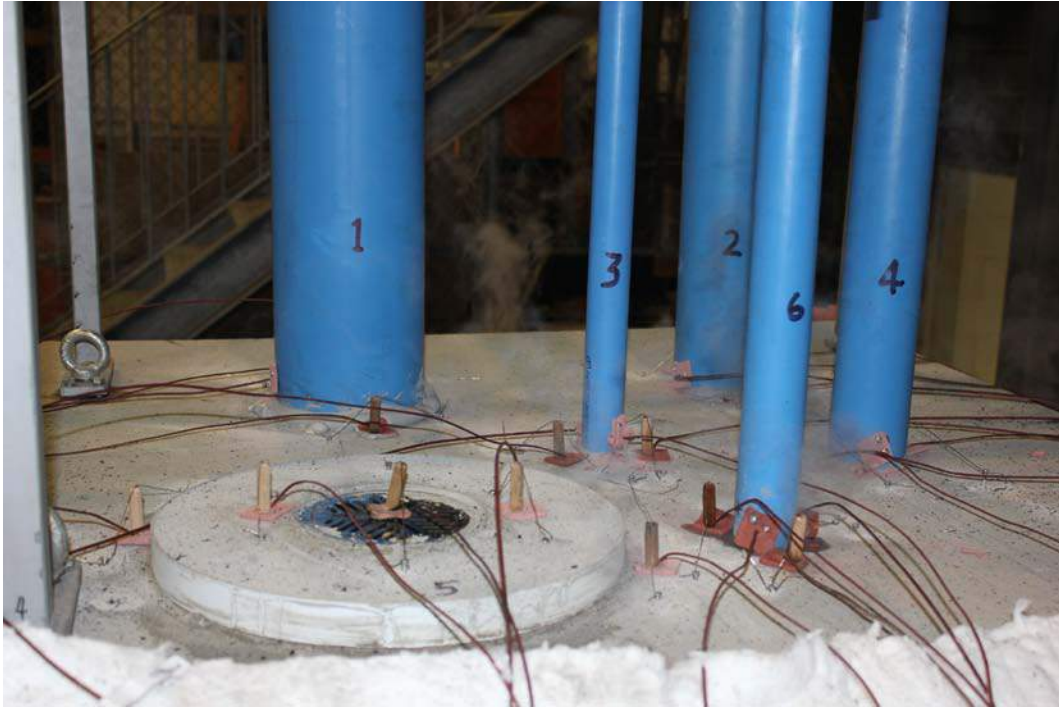
PHOTOGRAPH 3 – SPECIMENS AFTER 60 MINUTES OF TESTING

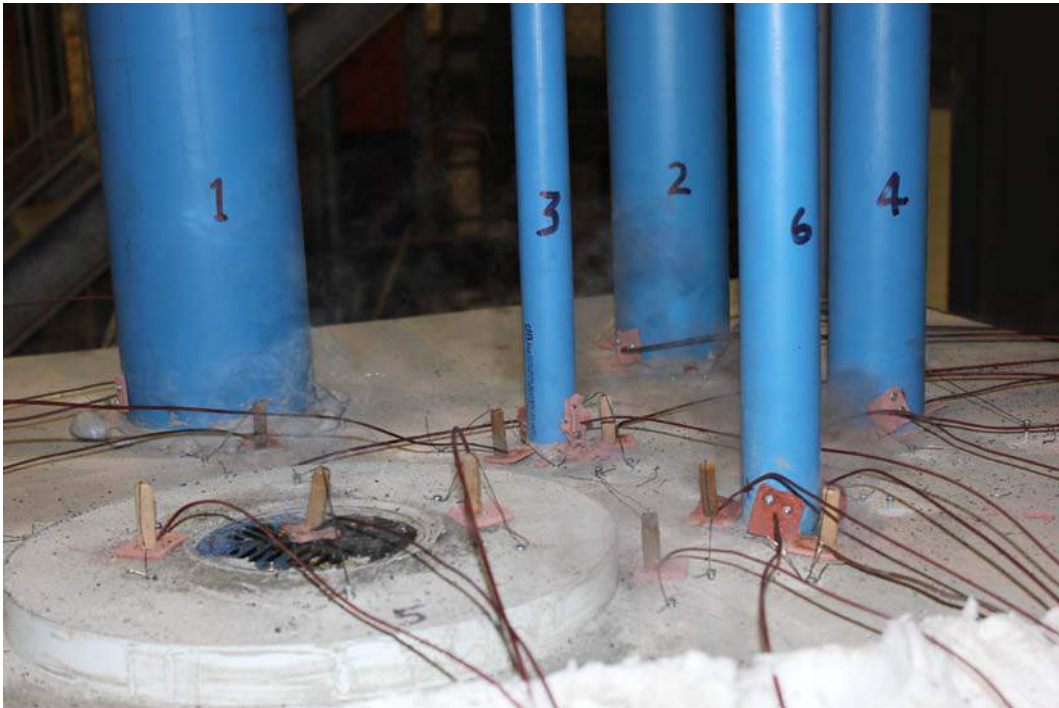
PHOTOGRAPH 4 – SPECIMENS AFTER 120 MINUTES OF TESTING

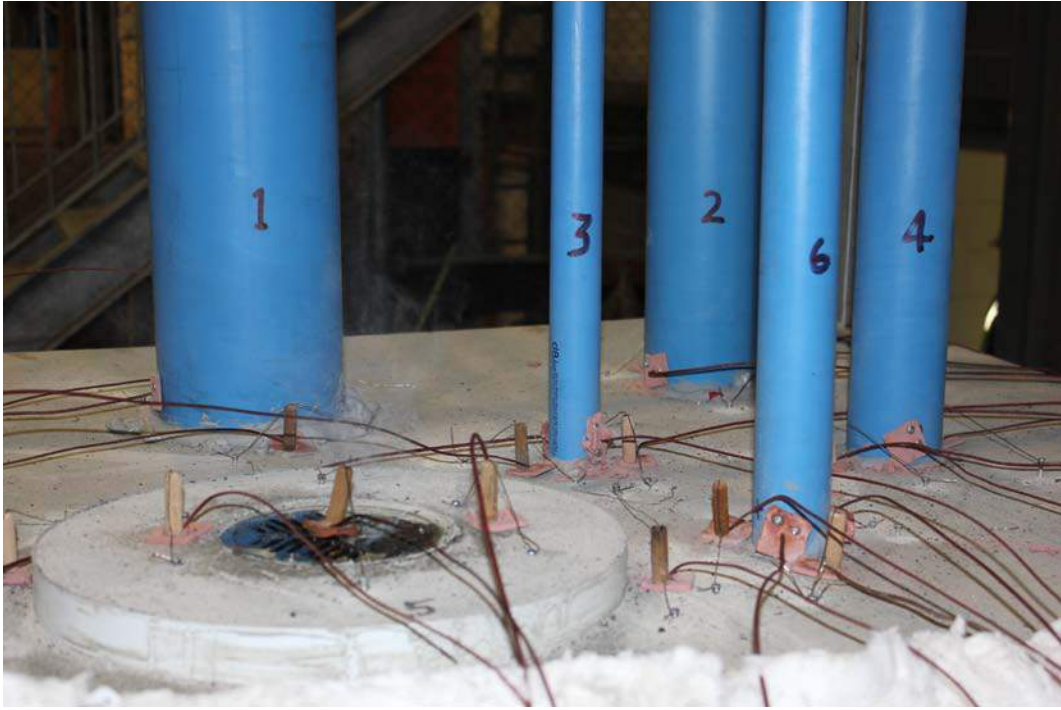
PHOTOGRAPH 5 – SPECIMENS AFTER 180 MINUTES OF TESTING

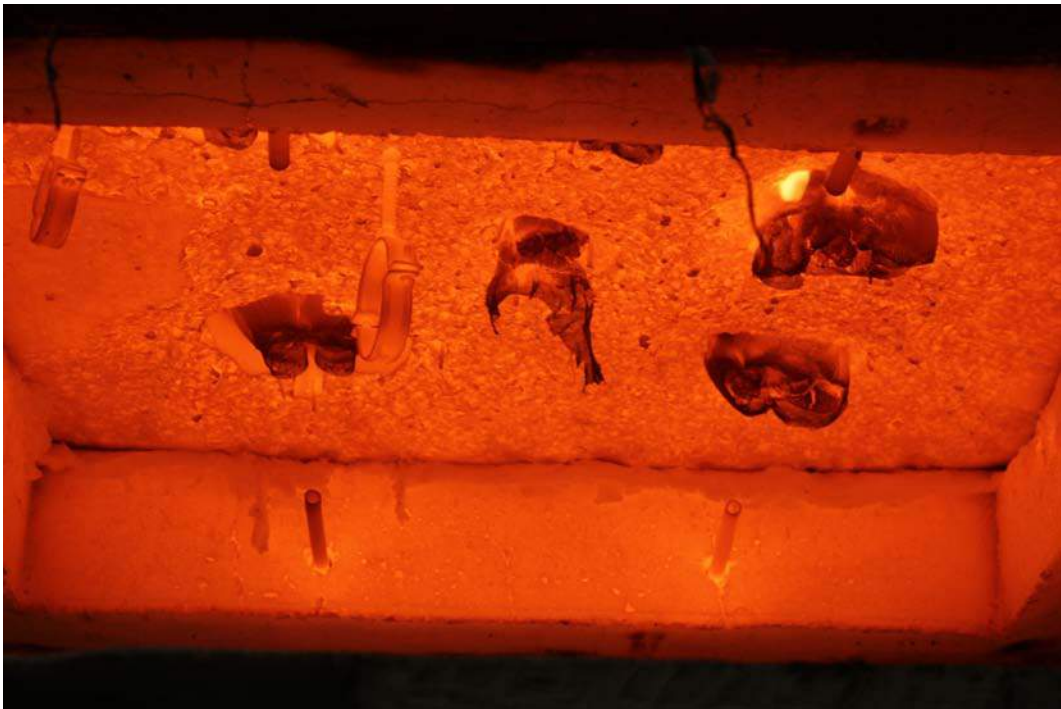
PHOTOGRAPH 6 – EXPOSED FACE OF SPECIMENS AT CONCLUSION OF TESTING

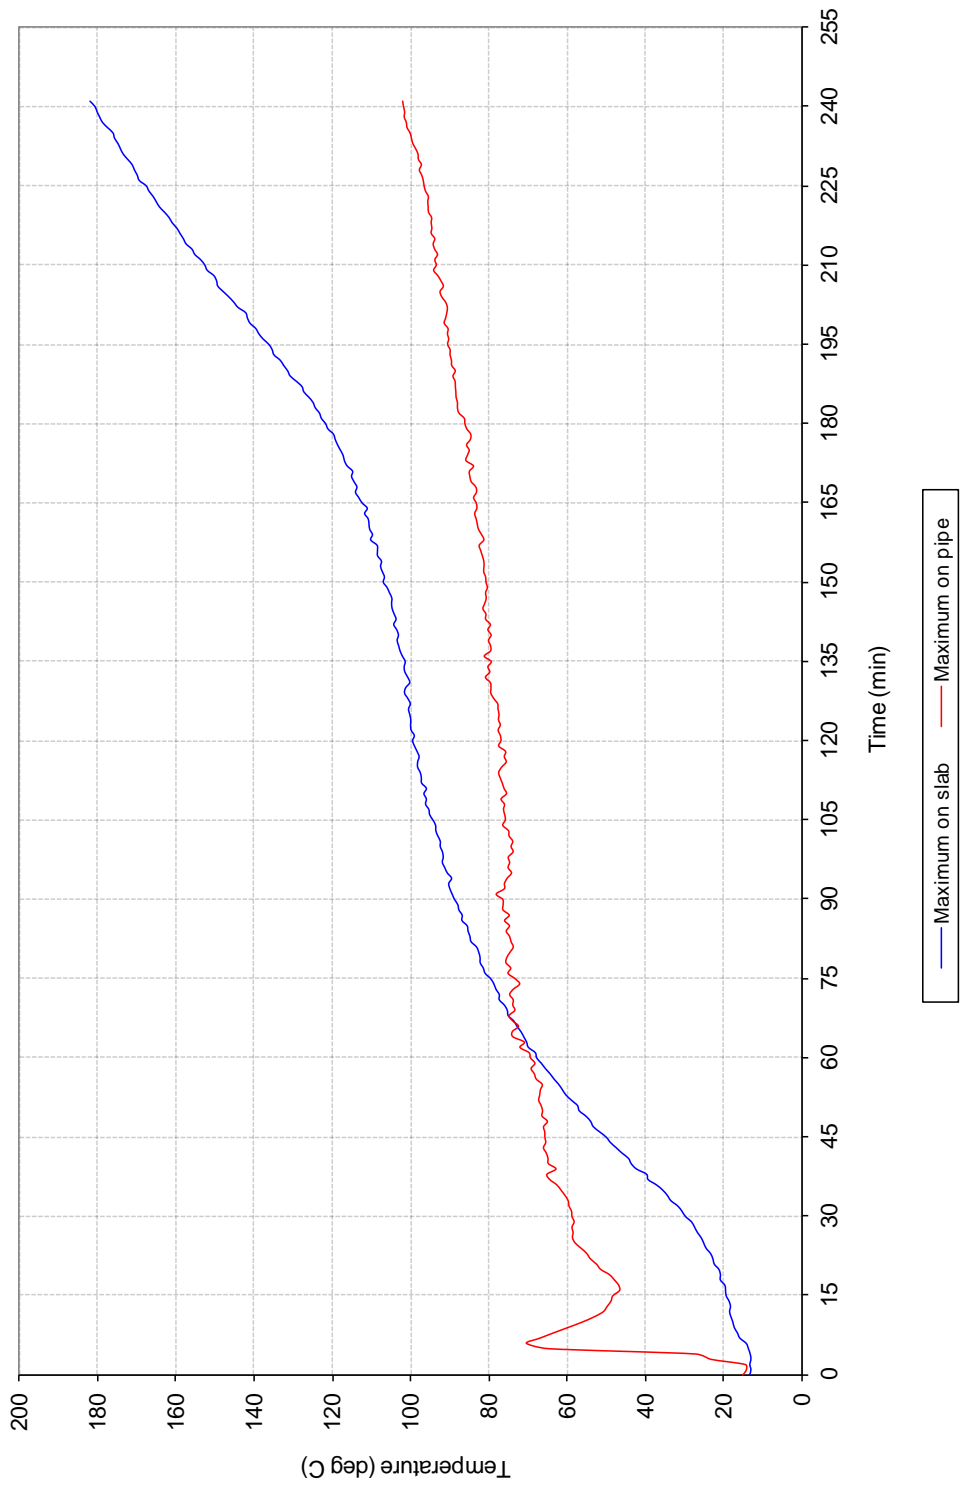
FIGURE 4 – SPECIMEN TEMPERATURE – ASSOCIATED WITH PENETRATION 2

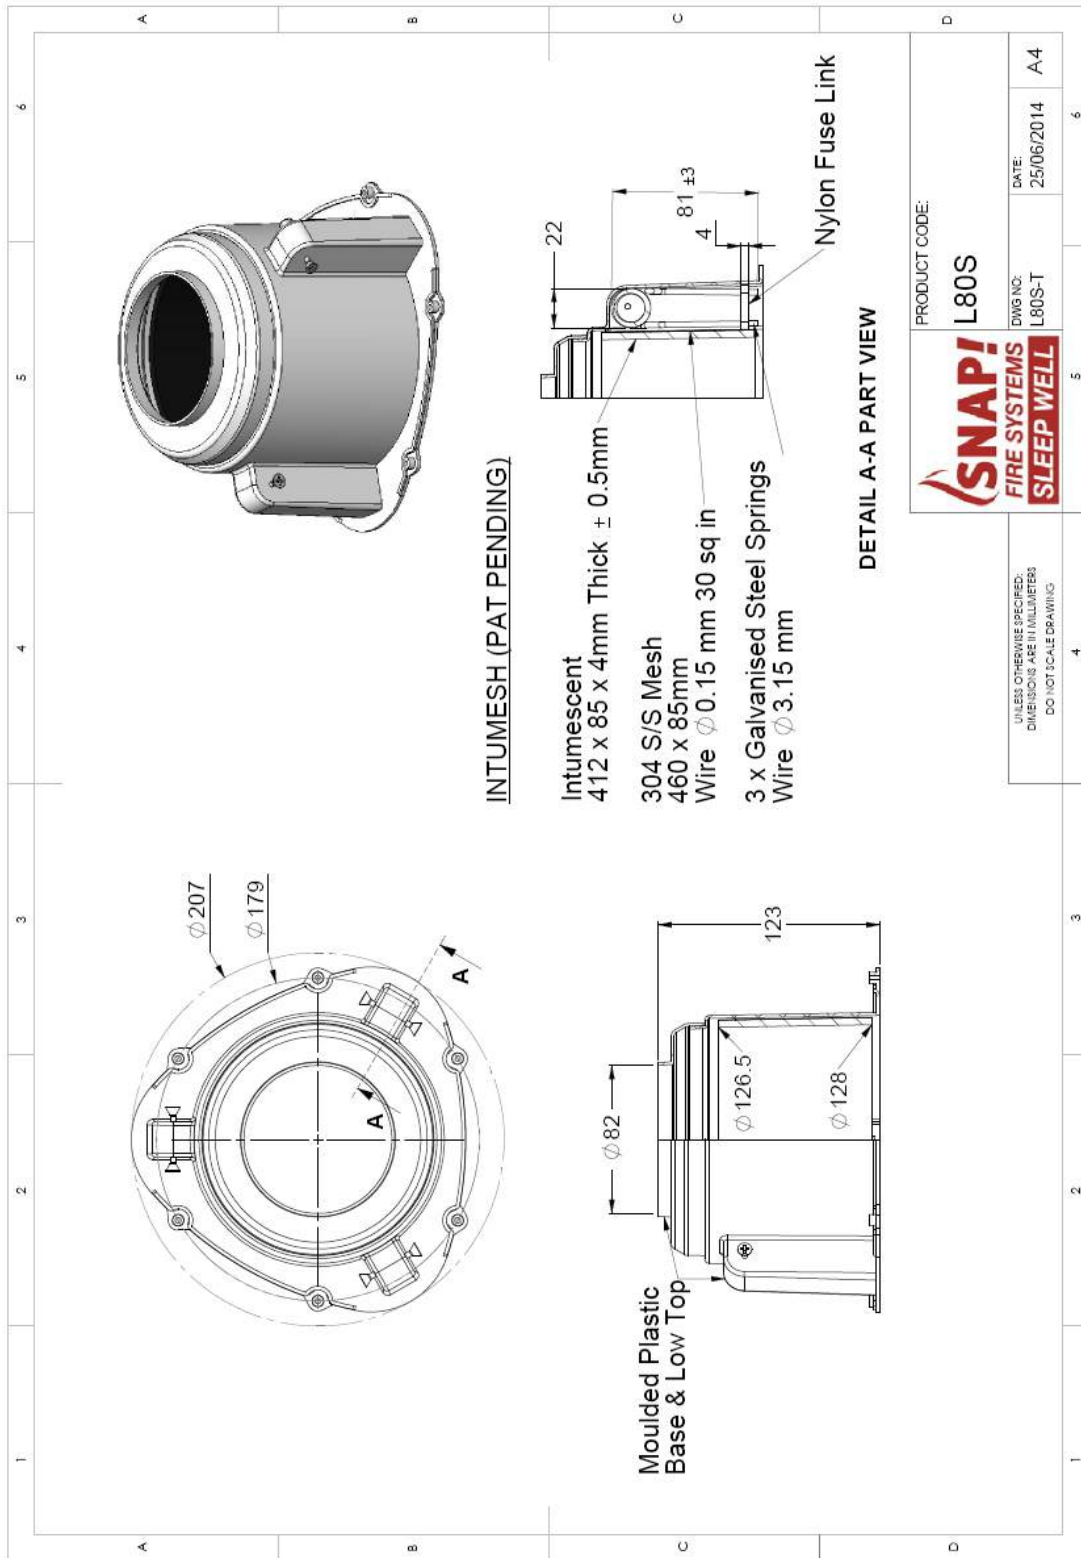
DRAWING NUMBERED L80S-T DATED 25 JUNE 2014, BY SNAP FIRE SYSTEMS PTY LTD

The SNAP Cast-in L80S fire collar comprised a 1.6-mm thick polypropelene casing with a 126.5-mm inner diameter and a 207-mm diameter base flange. The 123-mm high collar casing incorporated a 412-mm x 85-mm x 4-mm thick Intumesh intumescent material. The closing mechanism comprised three galvanised steel springs, with nylon fuse links and a 460-mm x 85-mm stainless steel mesh as shown in drawing numbered L80S-T dated 25 June 2014, by SNAP Fire Systems Pty Ltd.

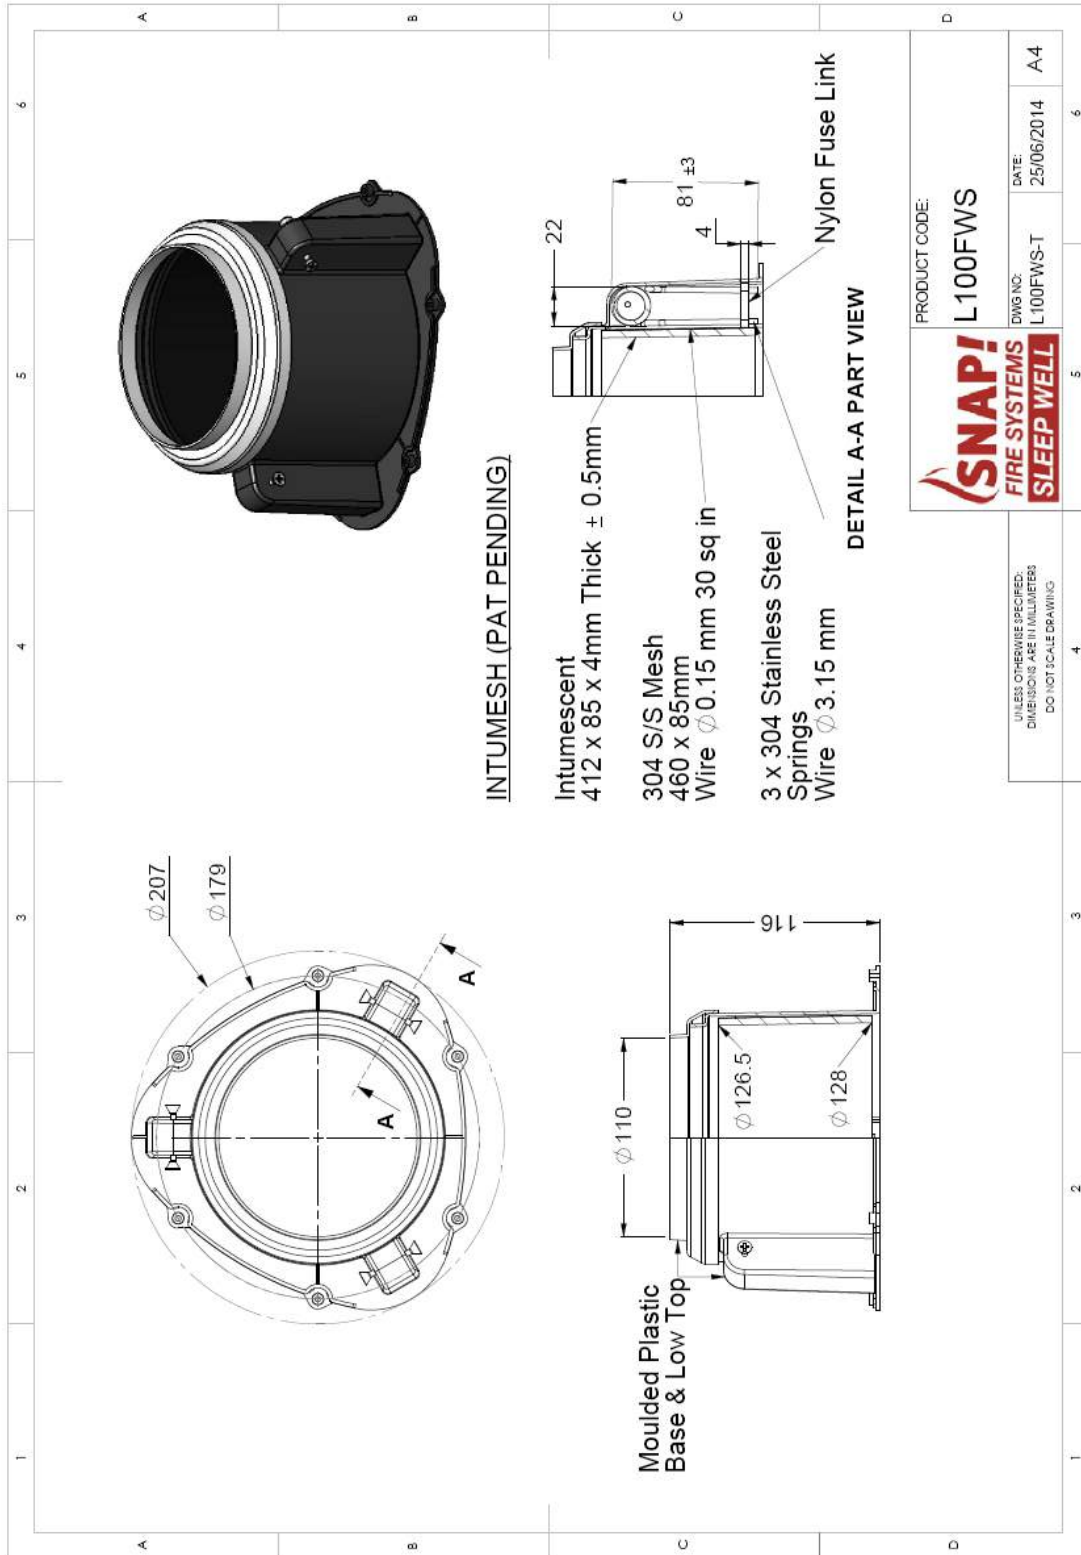
DRAWING NUMBERED L100FWS-T DATED 25 JUNE 2014, BY SNAP FIRE SYSTEMS PTY LTD

The SNAP Cast-in L100FWS fire collar comprised a 1.6-mm thick polypropelene casing with an 126.5-mm inner diameter and a 207-mm diameter base flange. The 116-mm high collar casing incorporated a 412-mm x 85-mm x 4-mm thick Intumesh intumescent material. The closing mechanism comprised three stainless steel springs, with nylon fuse links and a 460-mm x 85-mm stainless steel mesh as shown in drawing numbered L100FWS-T dated 25 June 2014, by SNAP Fire Systems Pty Ltd.

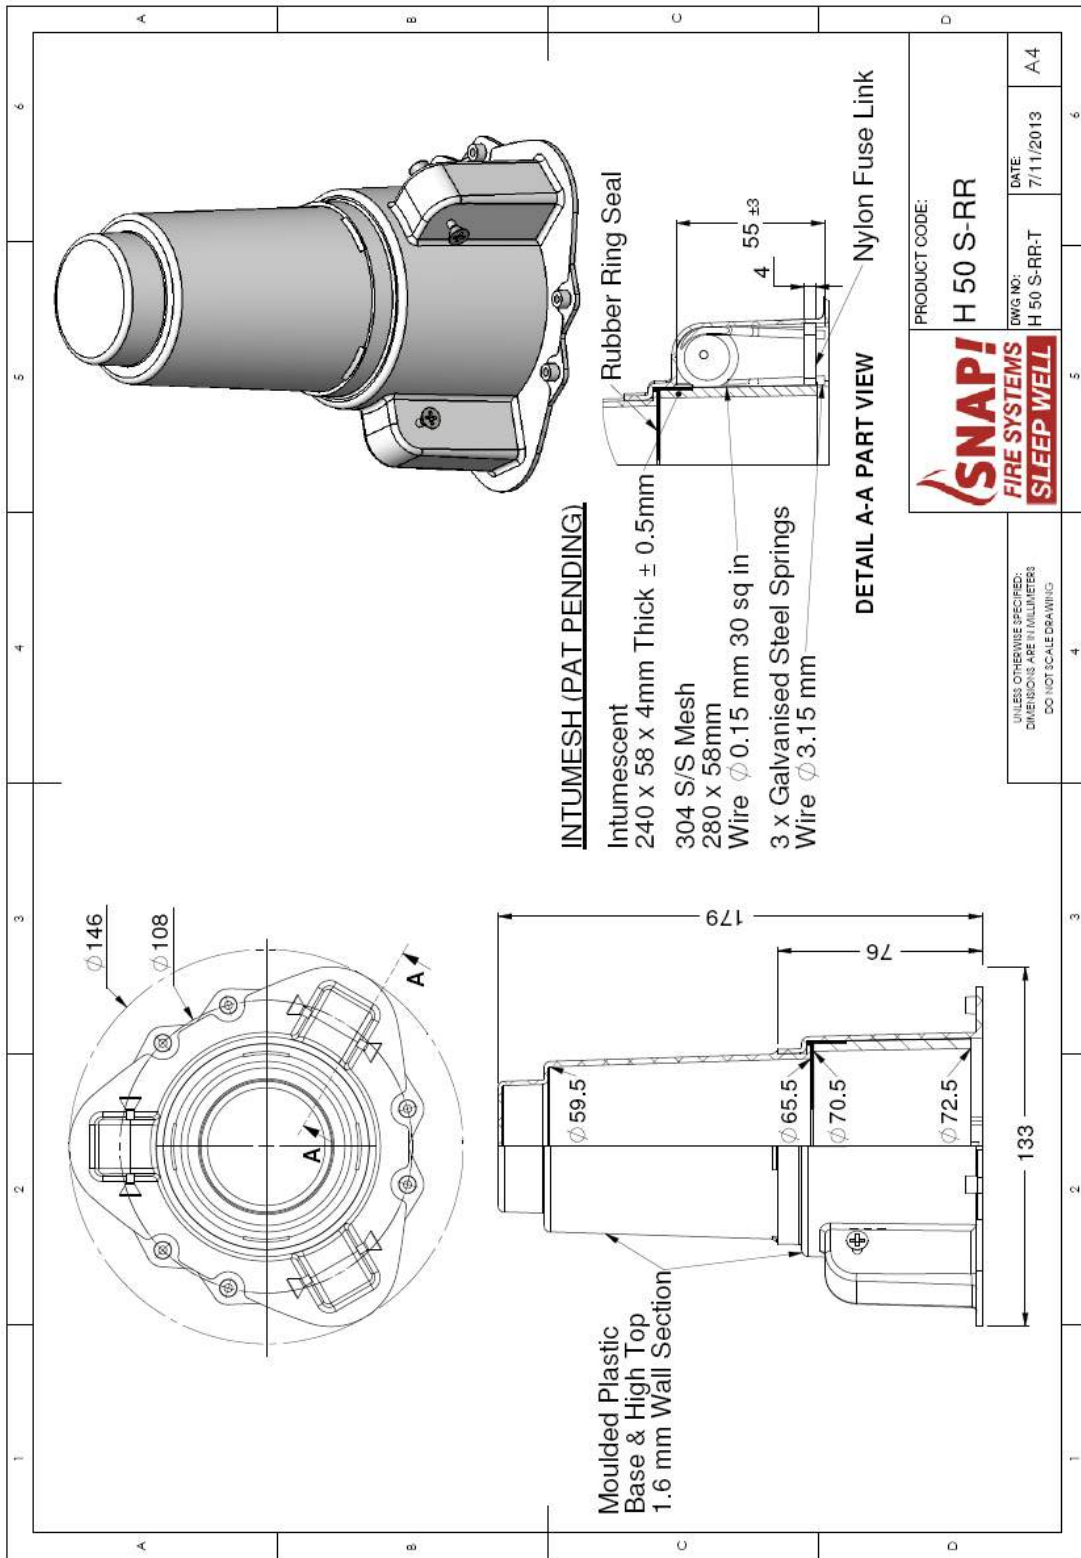
DRAWING NUMBERED H50 S-RR-T DATED 7 NOVEMBER 2013, BY SNAP FIRE SYSTEMS PTY LTD

The SNAP Cast-in H50 S-RR fire collar comprised a 1.6-mm thick polypropylene casing with a 70.5-mm inner diameter and a 146-mm diameter base flange. The 76-mm high collar casing incorporated a 240-mm x 58-mm x 4-mm thick Intumesh intumescent material and a rubber ring seal. The closing mechanism comprised three galvanised steel springs, with nylon fuse links and a 280-mm x 58-mm stainless steel mesh as shown in drawing numbered H50 S-RR-T dated 7 November 2013, by SNAP Fire Systems Pty Ltd.
