Fire-resistance test on fire collars protecting a CSR Hebel AAC block wall penetrated by services

Test Report

Author: Mario Lara-Ledermann
Report number: FSP 1659a
Date: 9 January 2015
(This issue supersedes that dated 19 December 2014)
Client: Snap Fire Systems Pty Ltd

Sponsored Investigation No. FSP 1659a

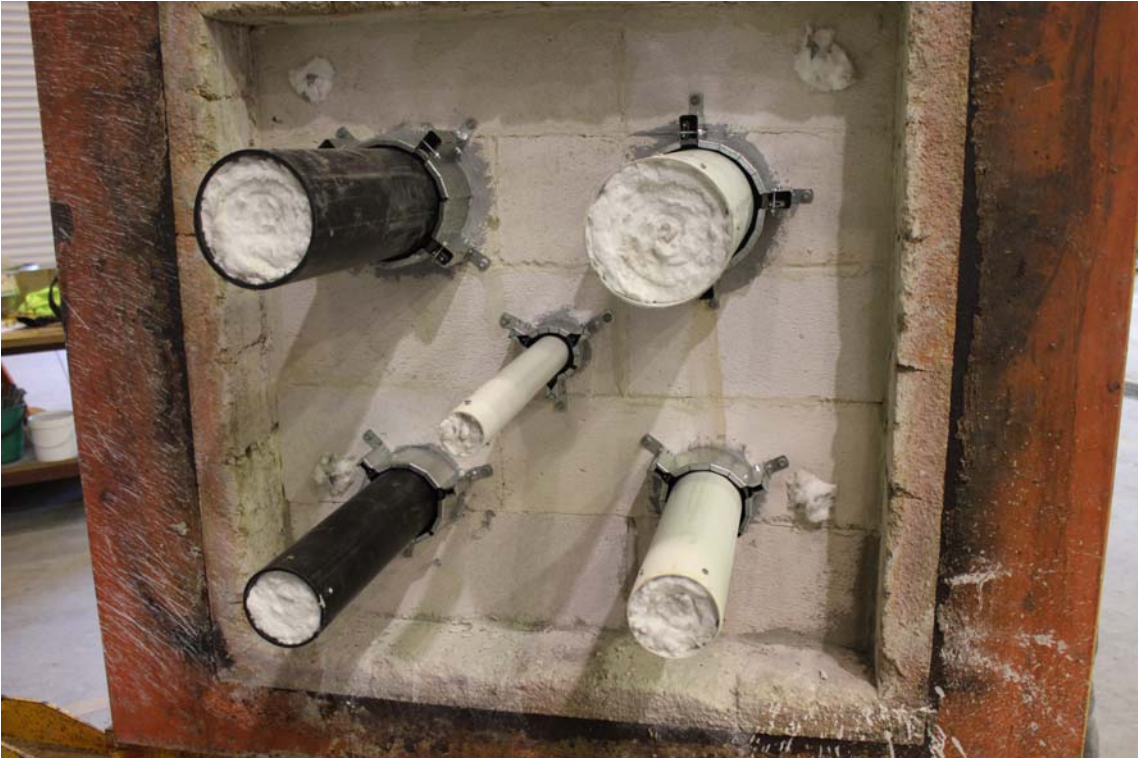
PHOTOGRAPH 1 – EXPOSED FACE OF SPECIMENS PRIOR TO TESTING

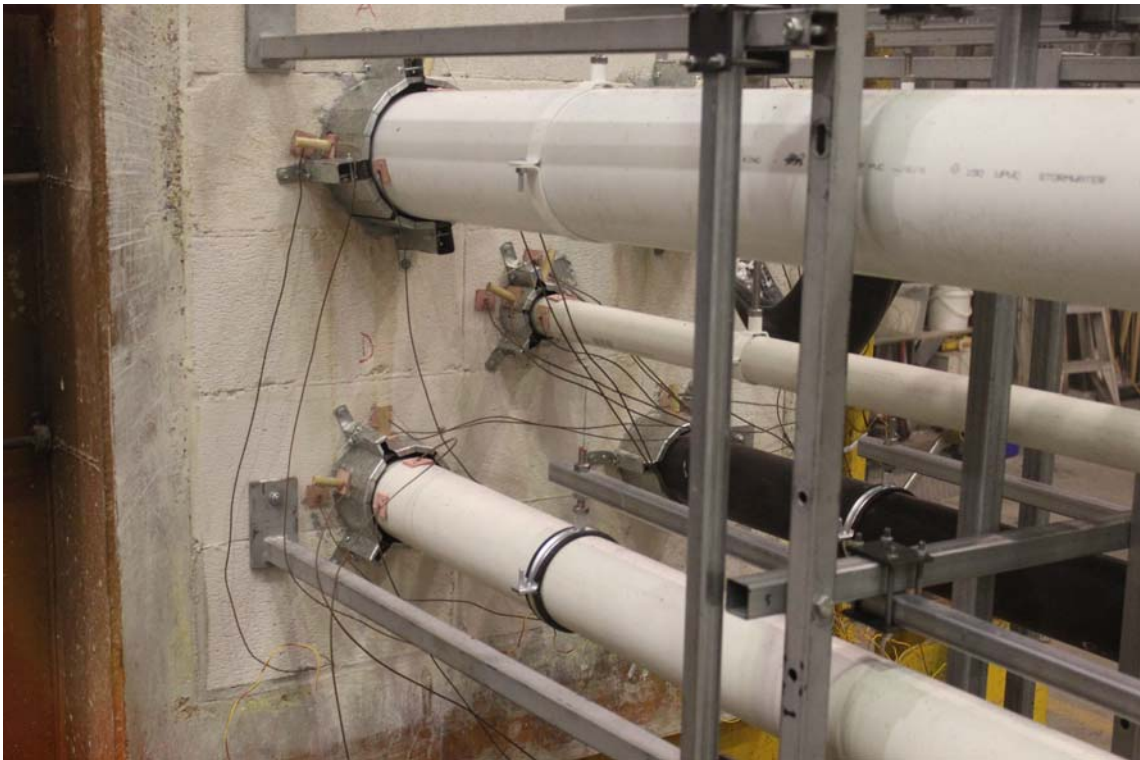
PHOTOGRAPH 3 – SPECIMENS AFTER 60 MINUTES OF TESTING

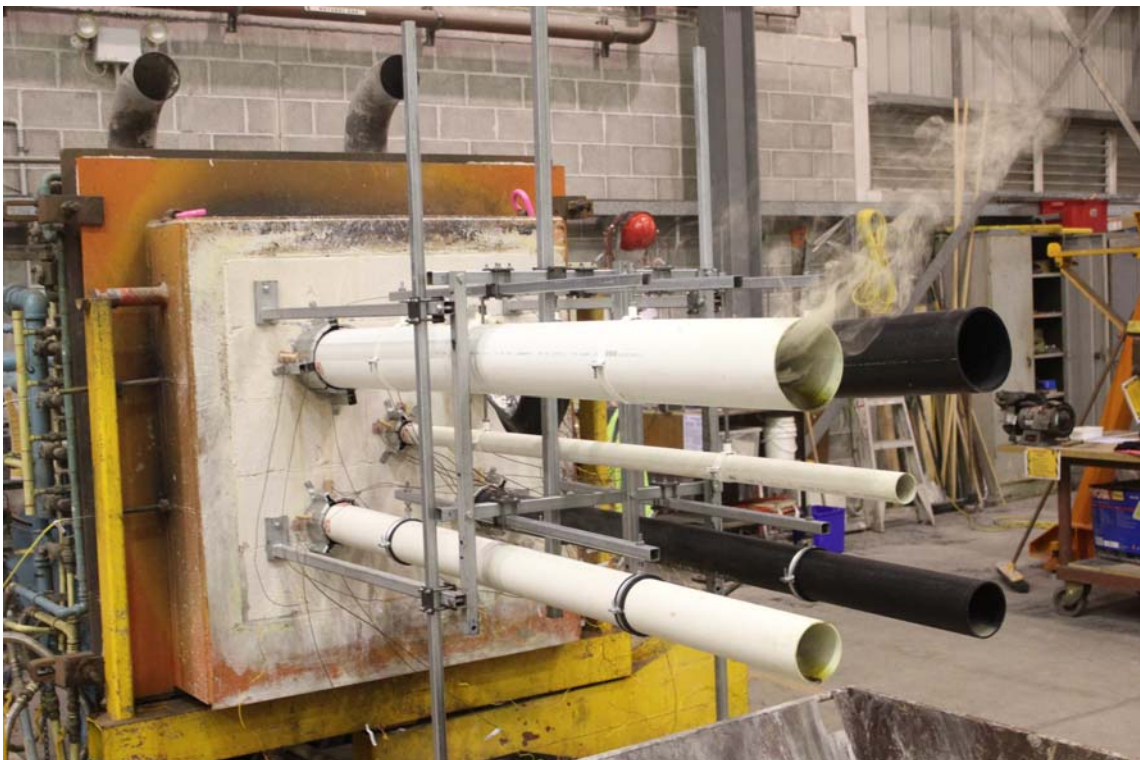
PHOTOGRAPH 4 – SPECIMENS AFTER 120 MINUTES OF TESTING

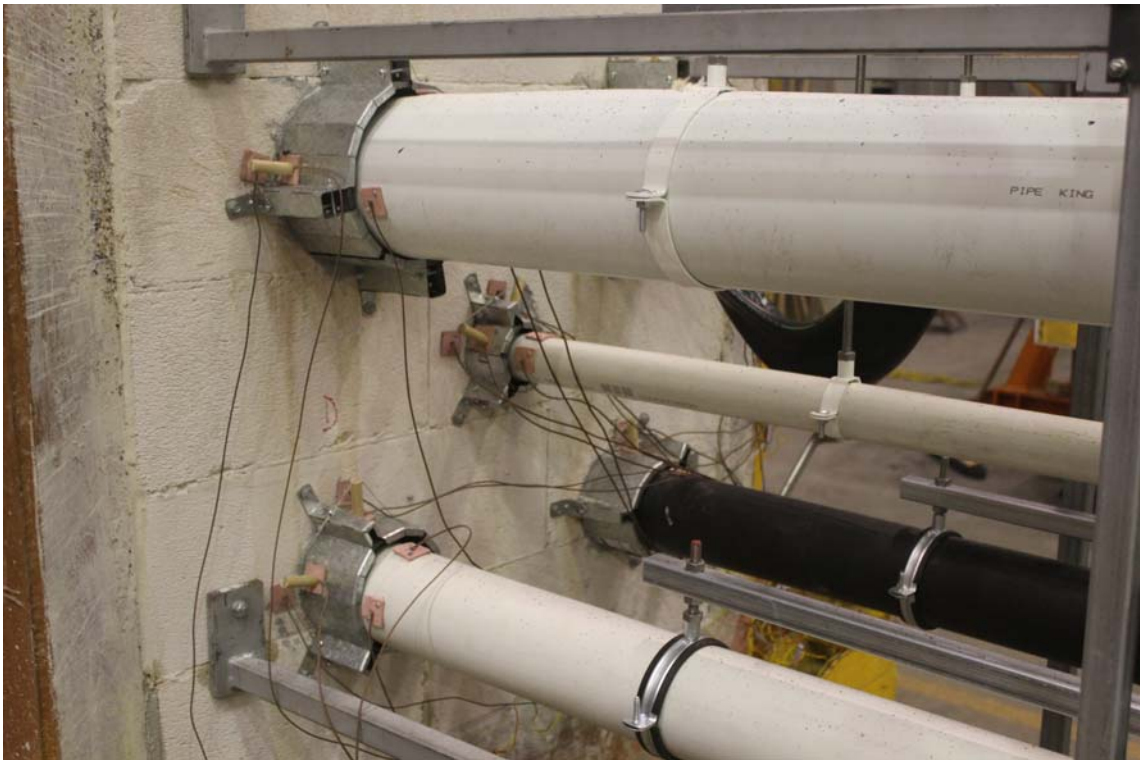
PHOTOGRAPH 5 – SPECIMENS AFTER 180 MINUTES OF TESTING

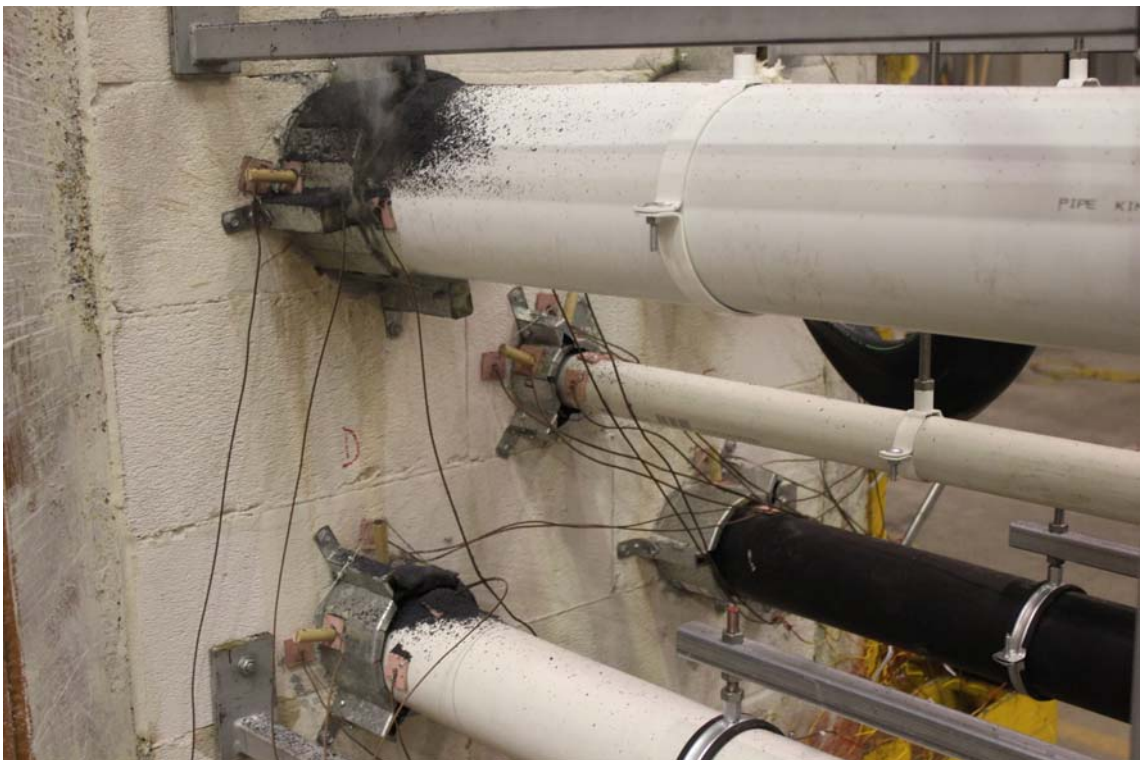
PHOTOGRAPH 5 – SPECIMENS AFTER 241 MINUTES OF TESTING

The test was terminated at 241 minutes by the agreement with the sponsor.
