Fire-resistance test on fire collars protecting a concrete slab penetrated by services

Test Report

Author: Mario Lara-Ledermann
Report number: FSP 1673
Date: 28 April 2015

Sponsored Investigation No. FSP 1673

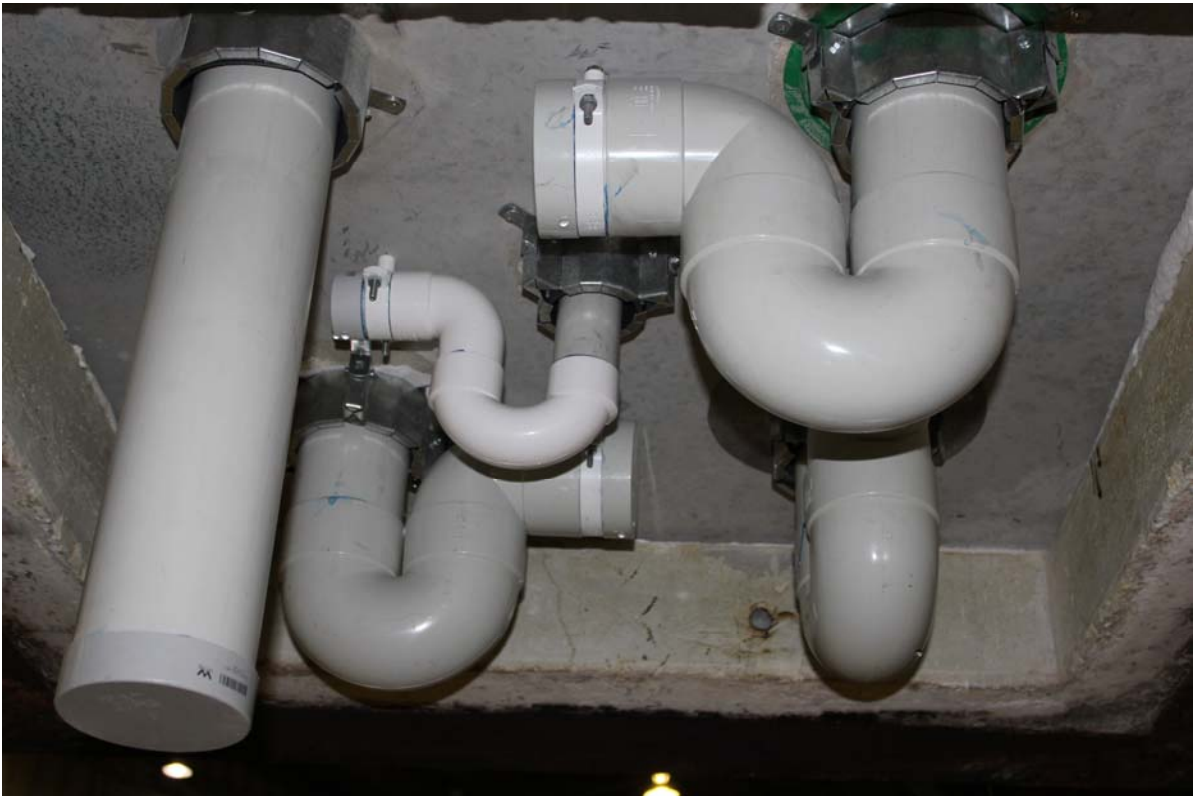
PHOTOGRAPH 1 – EXPOSED FACE OF SPECIMENS PRIOR TO TESTING

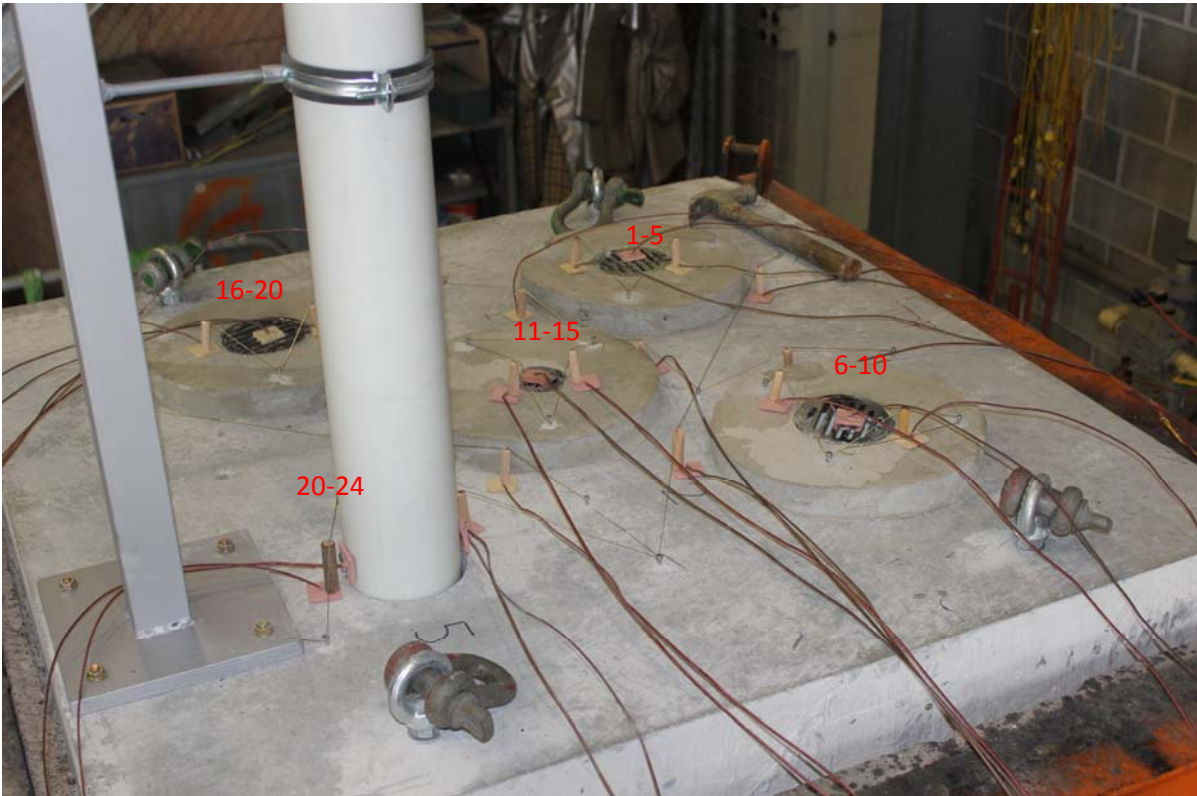
PHOTOGRAPH 2 – UNEXPOSED FACE OF SPECIMENS PRIOR TO TESTING

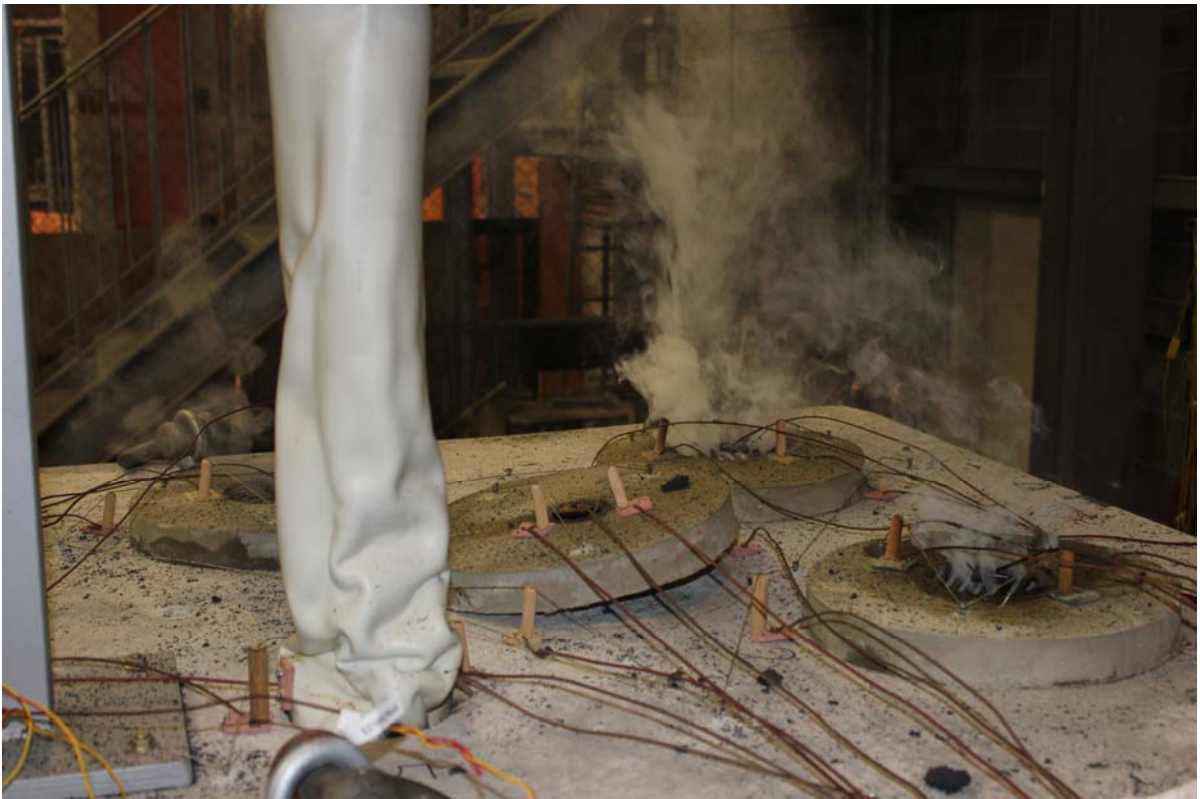
PHOTOGRAPH 4 – SPECIMENS AFTER 120 MINUTES OF TESTING

- 120 minutes - Penetration 3 is fluing smoke. Hob of Penetration 4 is now level with slab. Hob of Penetration 3 above slab (on tilt) – see photograph # 4.
- 241 minutes - Test terminated.

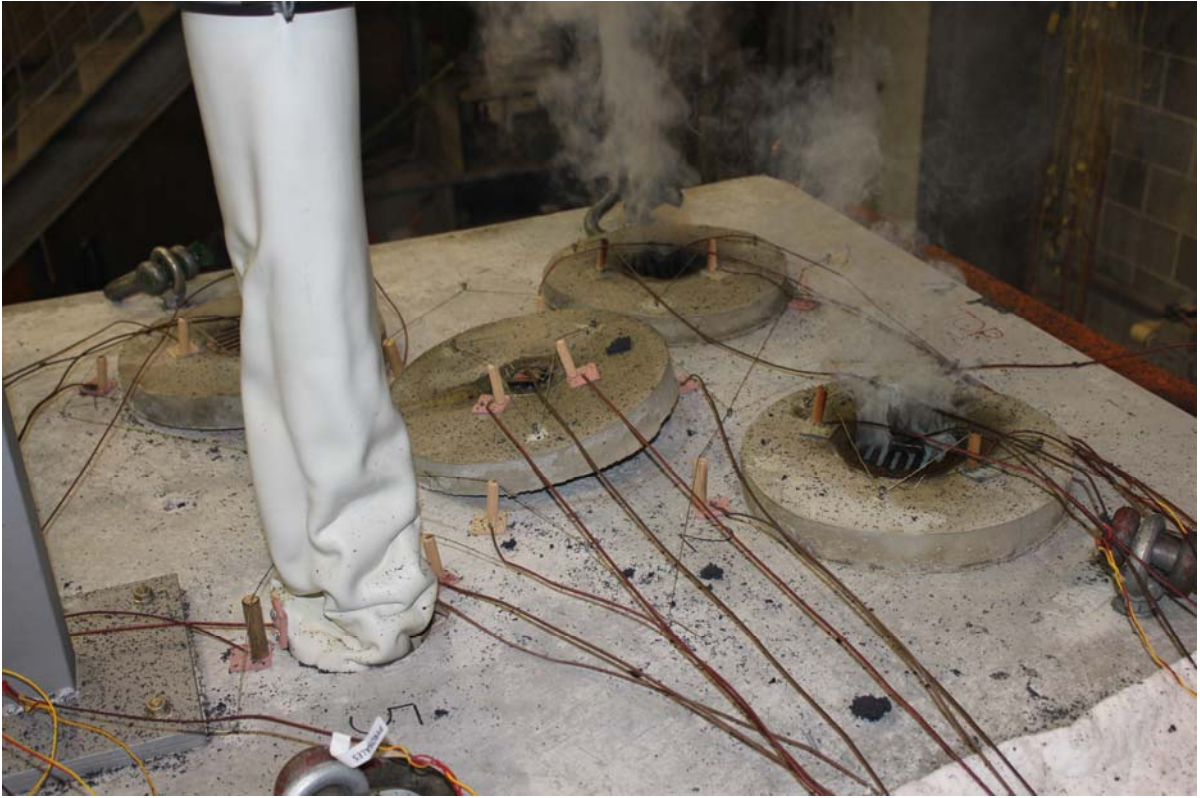
PHOTOGRAPH 5 – SPECIMENS AFTER 180 MINUTES OF TESTING

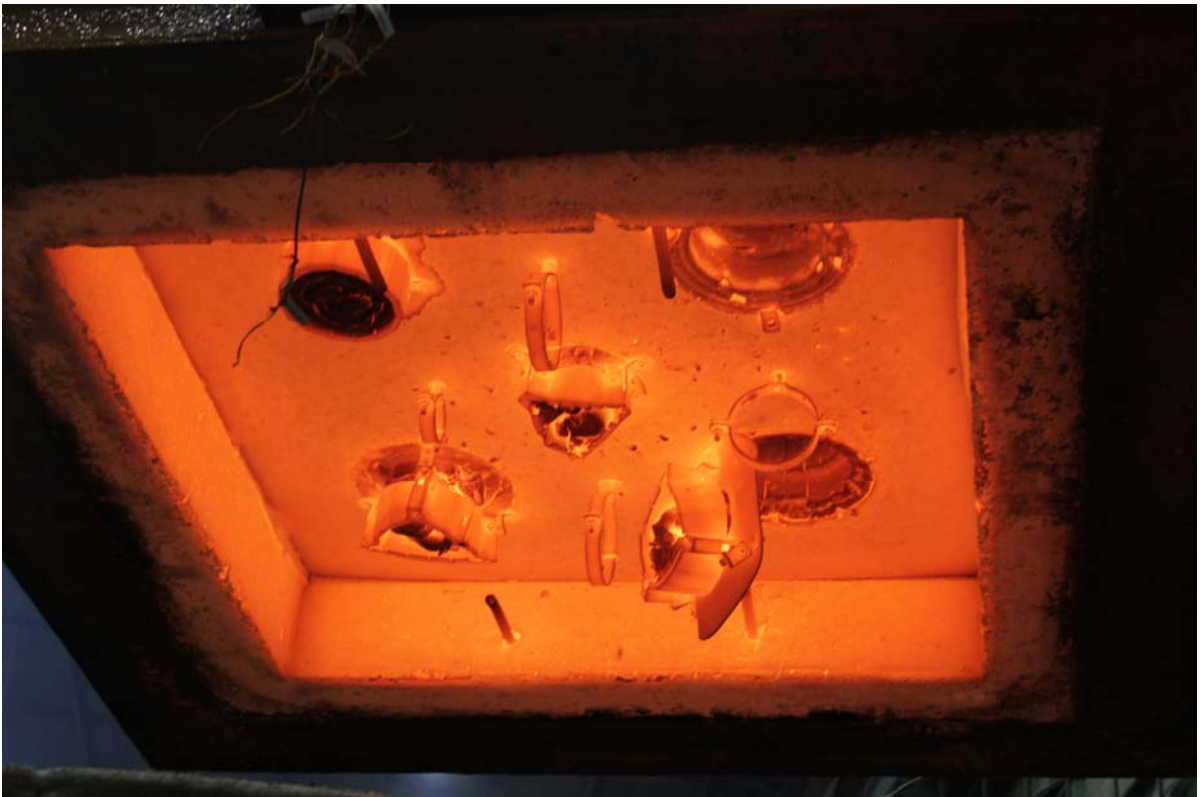
PHOTOGRAPH 6 – EXPOSED FACE OF SPECIMENS AT CONCLUSION OF TESTING
