Fire-resistance test on fire collars protecting a concrete slab penetrated by services

Test Report

Author: Mario Lara-Ledermann
Report number: FSP 1715
Date: 29 October 2015

Client: Snap Fire Systems Pty Ltd

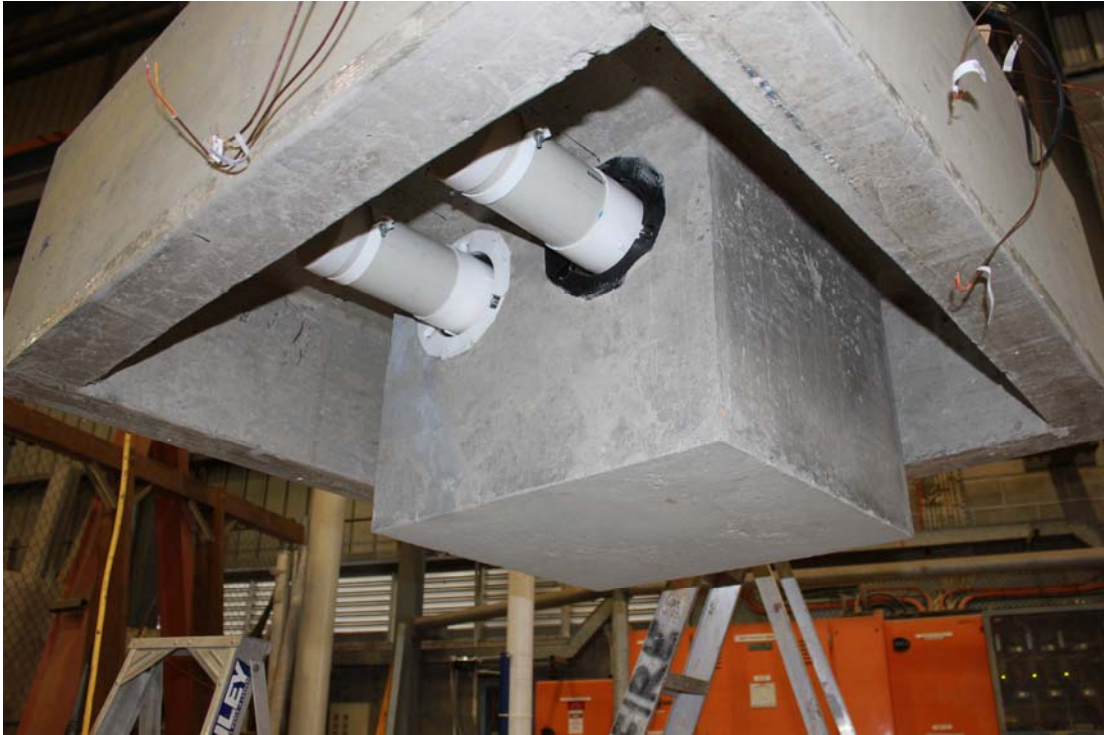
PHOTOGRAPH 1 – EXPOSED FACE OF SPECIMENS PRIOR TO TESTING

The SNAP Cast-in H100 S-RR fire collar comprised a 1.6-mm thick polypropylene casing with an 119-mm inner diameter and a 213-mm diameter base flange. The 250-mm high collar casing incorporated a 412-mm x 85-mm x 4-mm thick Intumesh intumescent material and a rubber ring seal. The closing mechanism comprised three galvanised steel springs bound with a nylon fuse link (natural) and a 460-mm x 85-mm stainless steel mesh as shown in drawing numbered H100S-RR-T dated 29 September 2015, by SNAP Fire Systems Pty Ltd. The collar was cast in the concrete beam horizontally as shown in Photograph # 1.

The SNAP Cast-in L100FWS fire collar comprised a 1.6-mm thick polypropylene casing with an 110-mm inner diameter and a 213-mm diameter base flange. The 105-mm high collar casing incorporated a 412-mm x 85-mm x 4-mm thick Intumesh intumescent material and a rubber ring seal. The closing mechanism comprised three stainless steel springs bound with nylon fuse link (black) and a 460-mm x 85-mm stainless steel mesh as shown in drawing numbered L100FWS-T dated 29 September 2015, by SNAP Fire Systems Pty Ltd. The collar was cast in the concrete beam horizontally as shown in Photograph # 1.

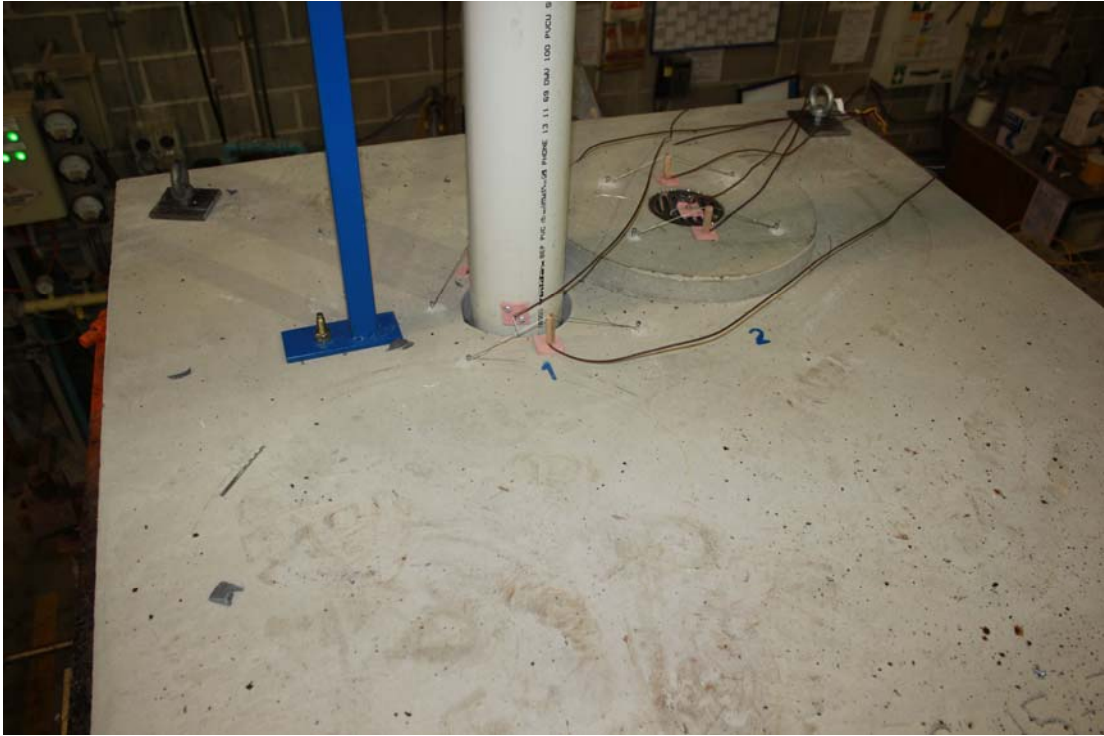
PHOTOGRAPH 2 – UNEXPOSED FACE OF SPECIMENS PRIOR TO TESTING

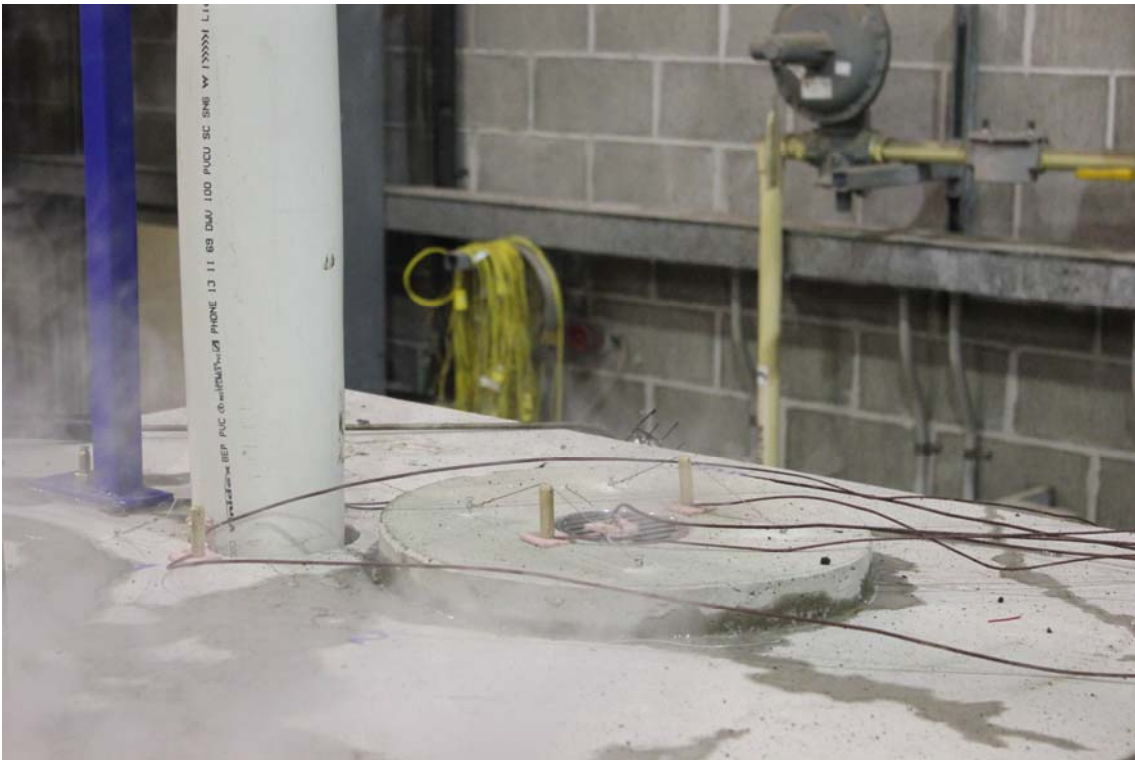
PHOTOGRAPH 3 – SPECIMENS AFTER 60 MINUTES OF TESTING

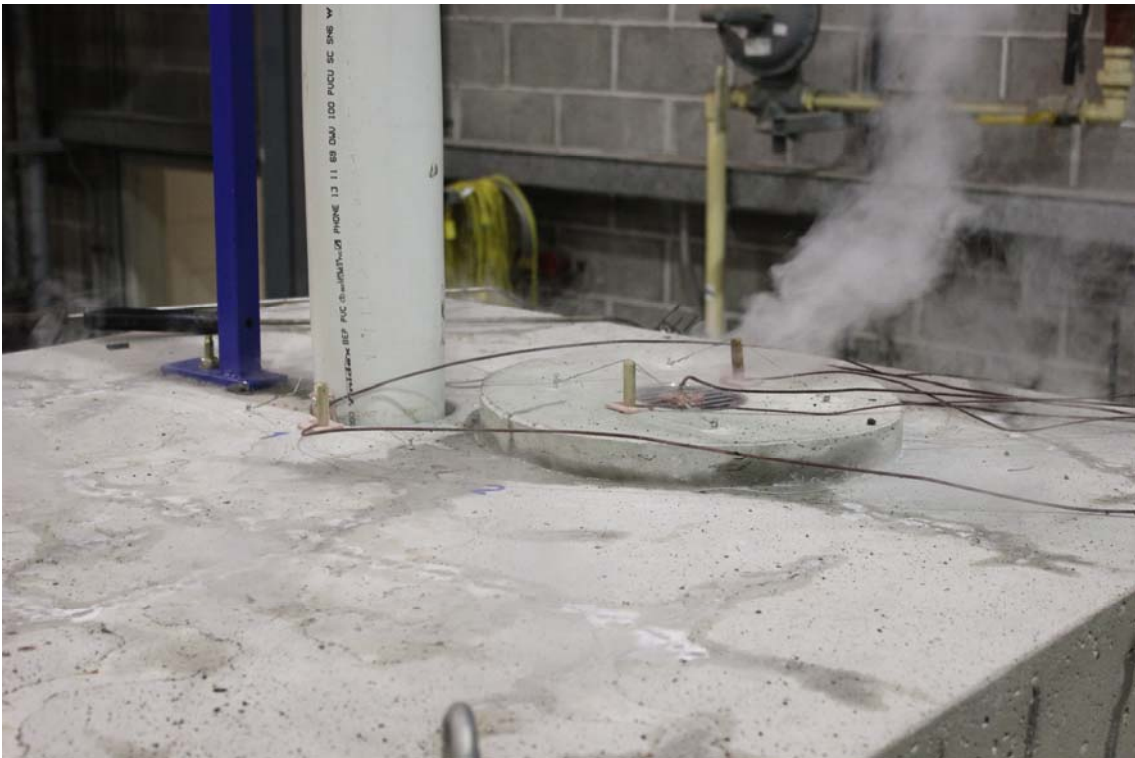
PHOTOGRAPH 4 – SPECIMENS AFTER 120 MINUTES OF TESTING

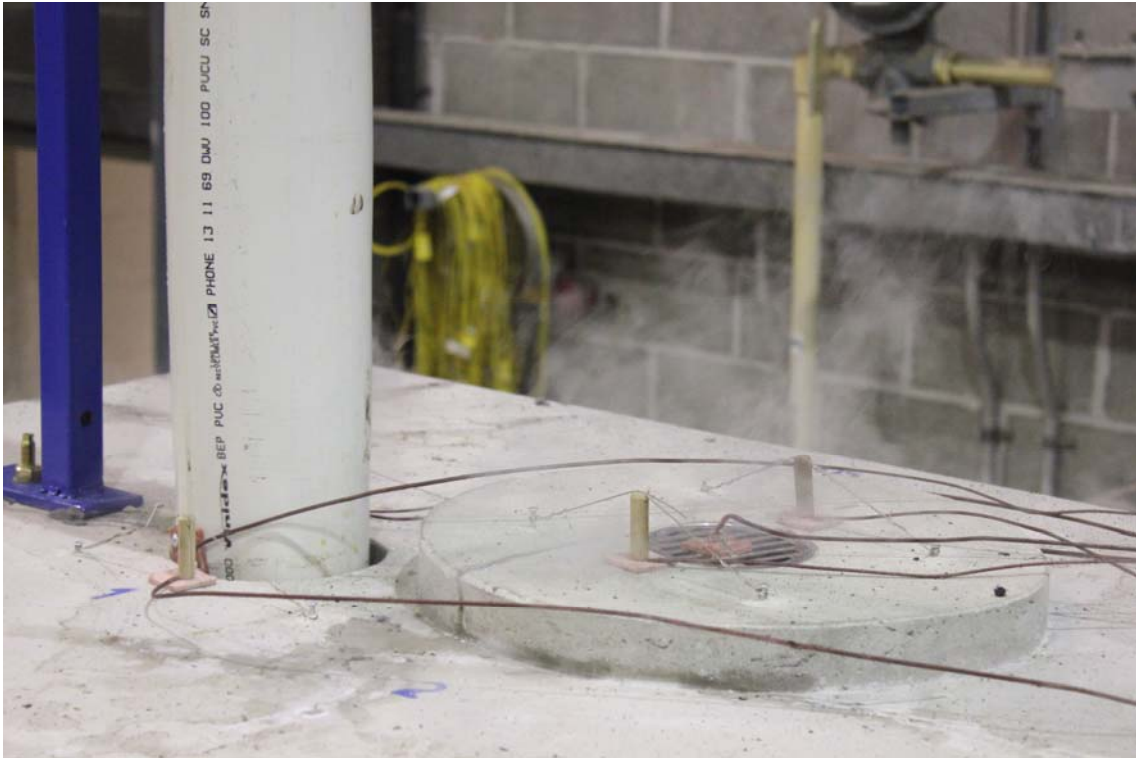
PHOTOGRAPH 5 – SPECIMENS AFTER 180 MINUTES OF TESTING
