Fire-resistance test on fire collars protecting a concrete slab penetrated by services

Test Report

Author: Chris Wojcik
Report number: FSP 1741
Date: 24 June 2016

Sponsored Investigation No. FSP 1741

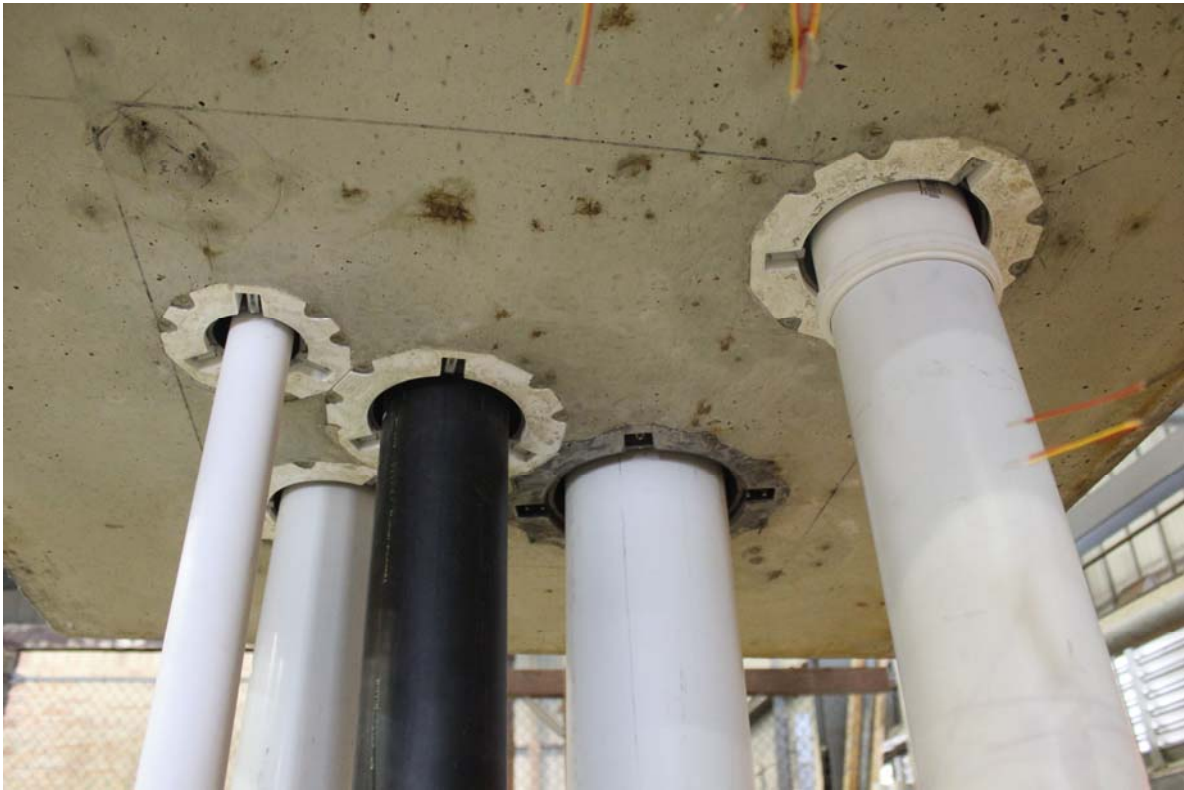
PHOTOGRAPH 1 – EXPOSED FACE OF SPECIMENS PRIOR TO TESTING

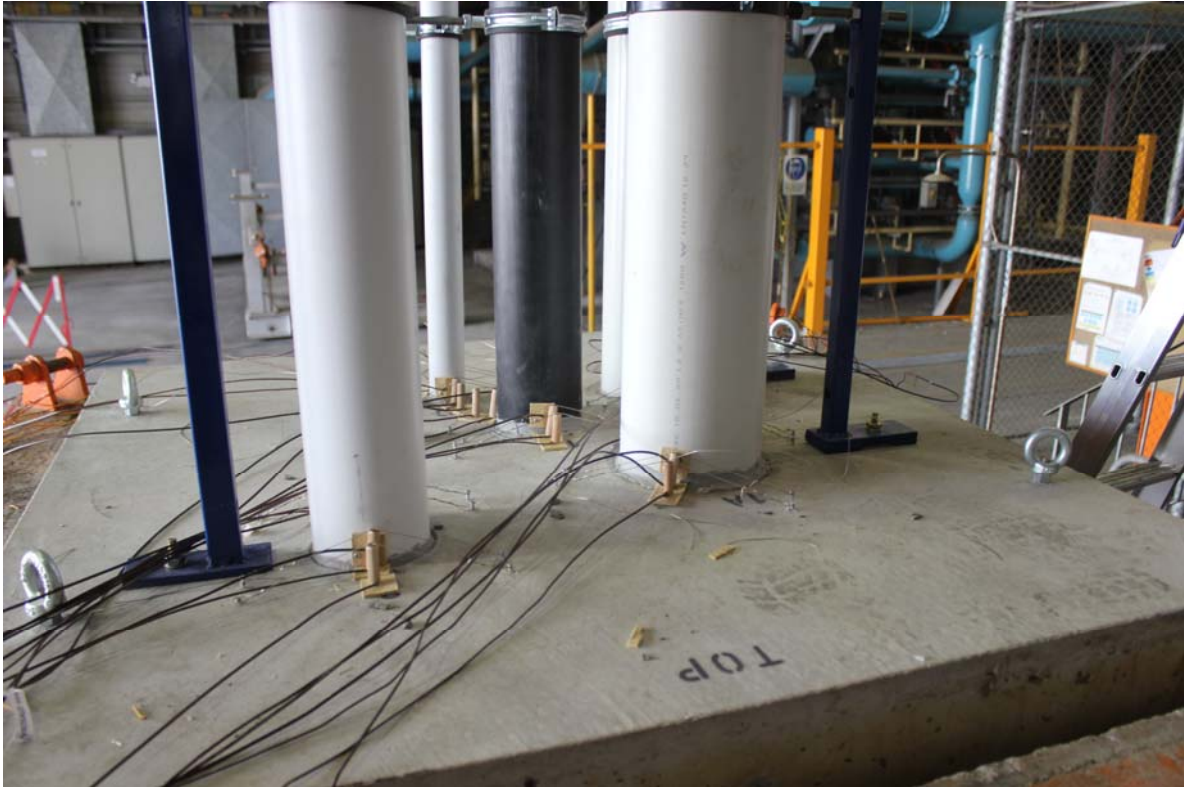
PHOTOGRAPH 2 – UNEXPOSED FACE OF SPECIMENS PRIOR TO TESTING

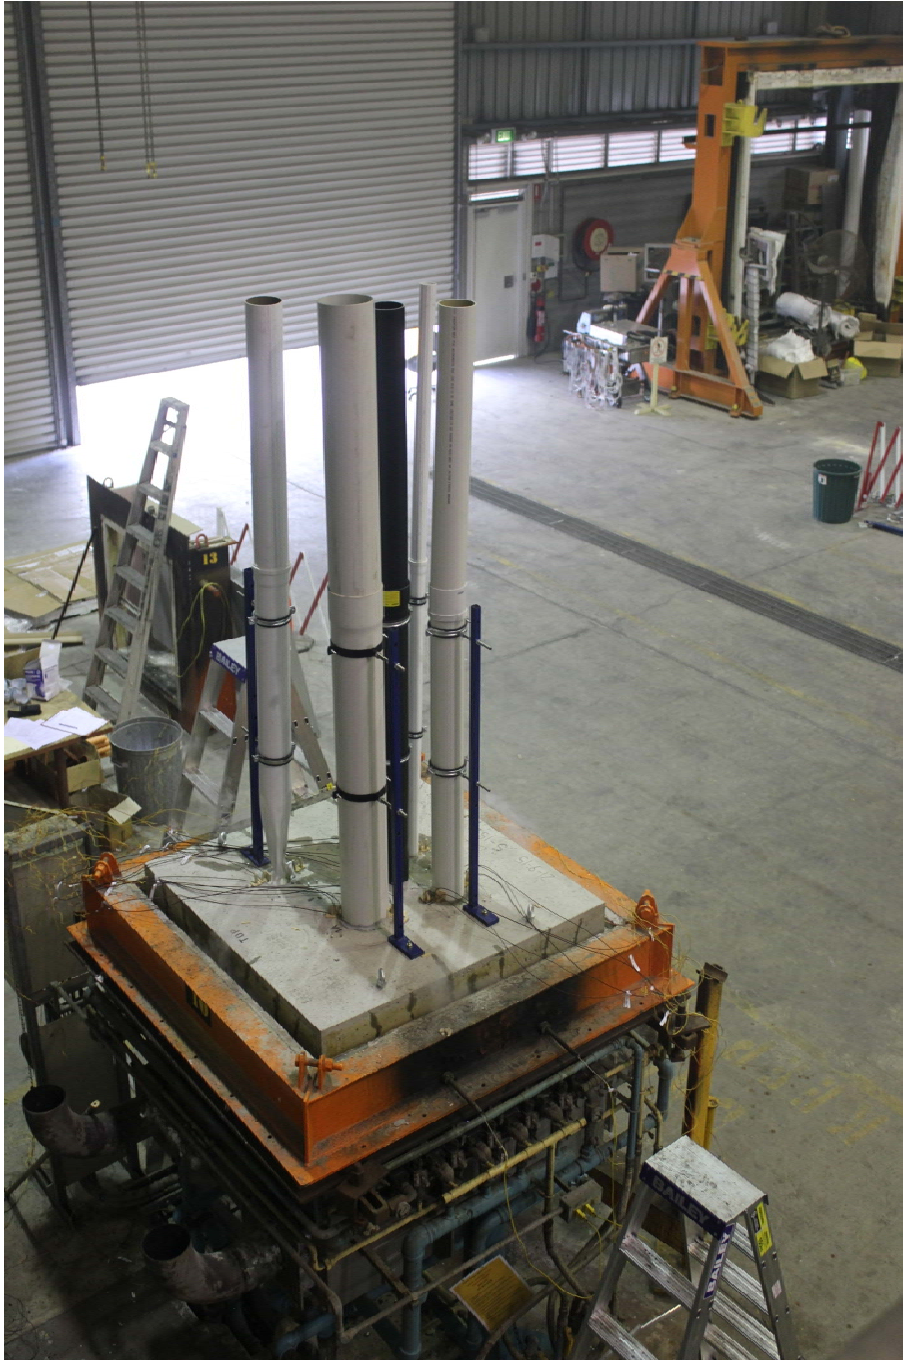
PHOTOGRAPH 3 – SPECIMENS AFTER 60 MINUTES OF TESTING

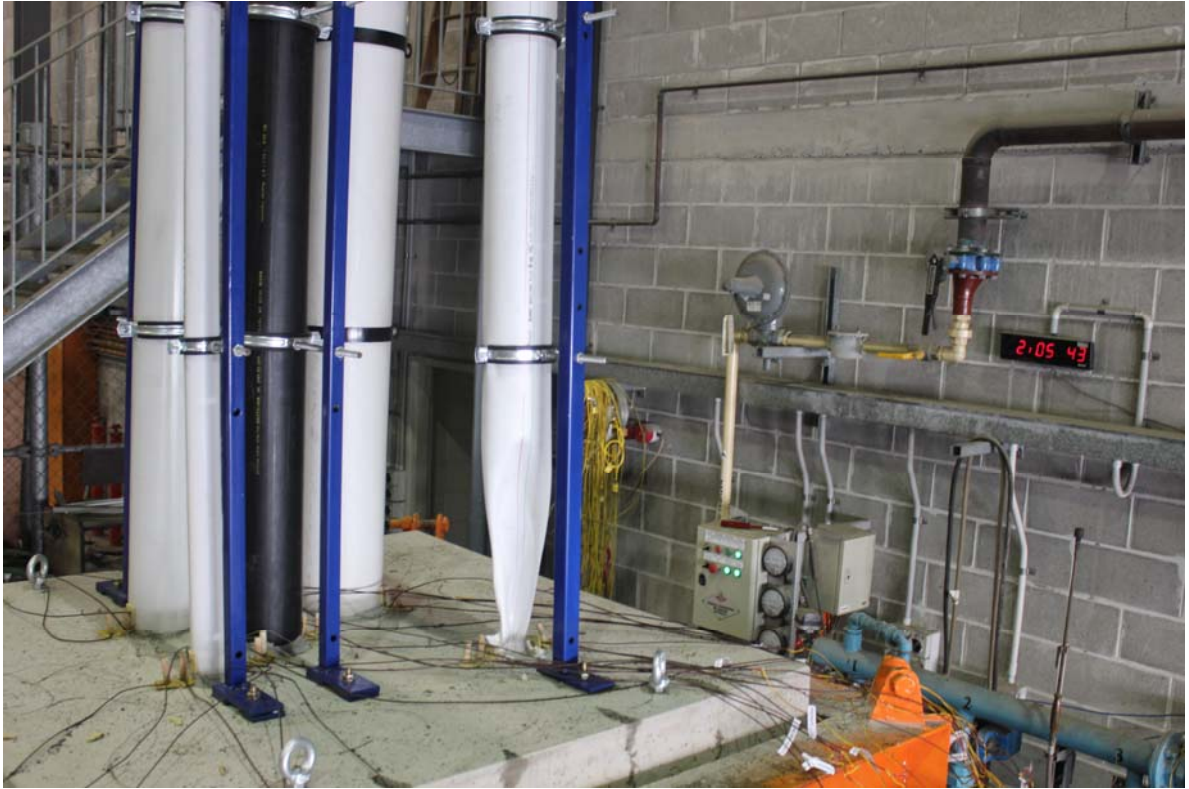
PHOTOGRAPH 4 – SPECIMENS AFTER 120 MINUTES OF TESTING

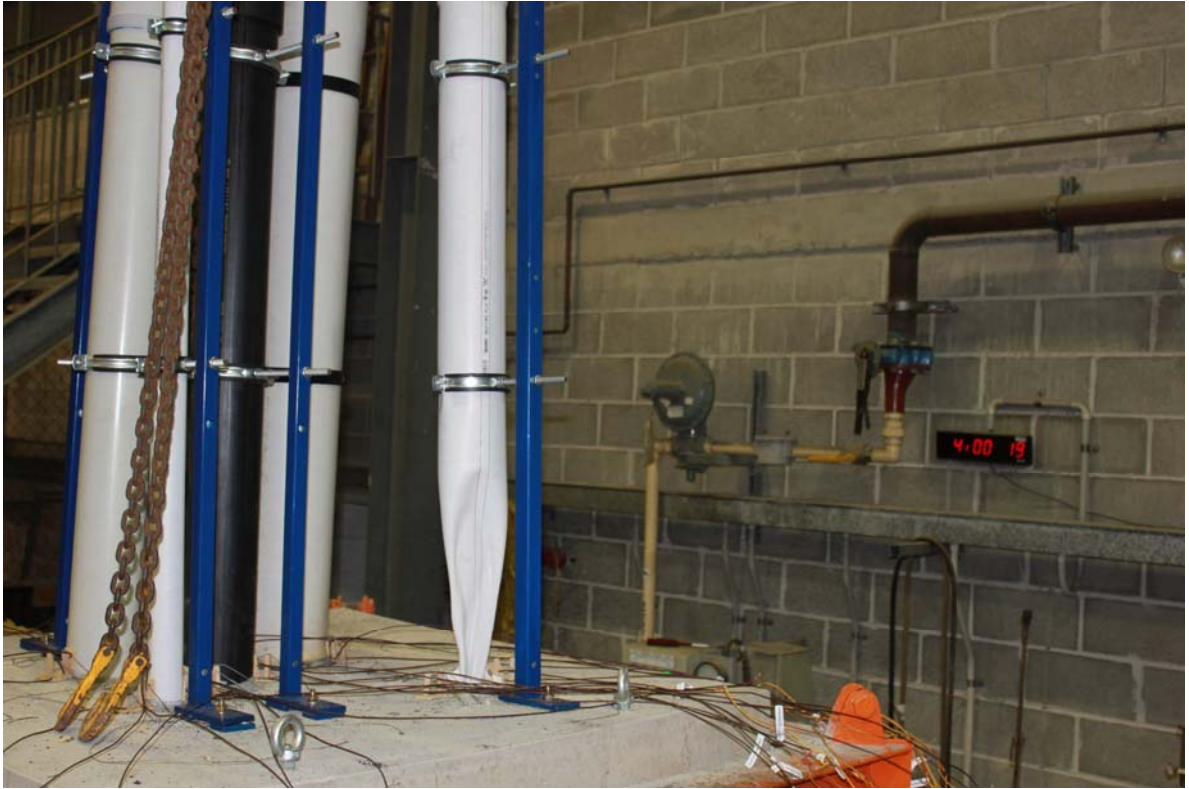
PHOTOGRAPH 6 – UNEXPOSED FACED OF SPECIMEN AT CONCLUSION OF TESTING

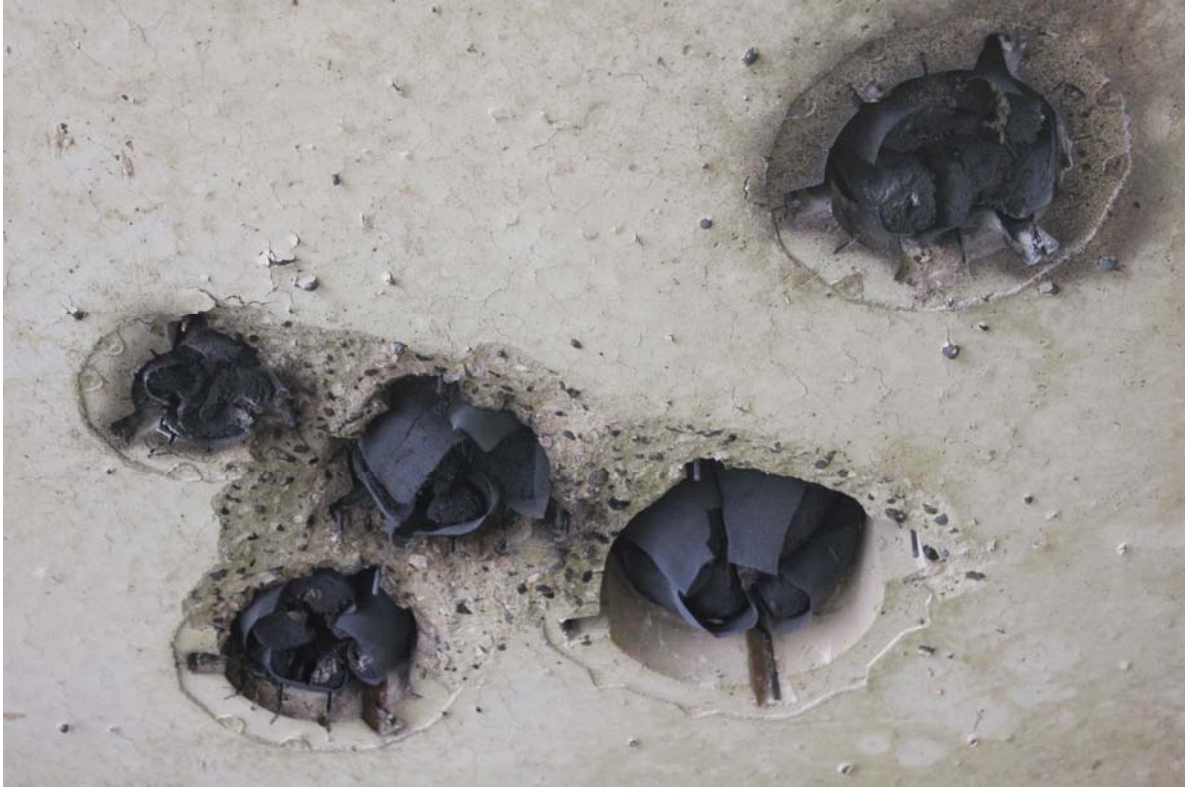
PHOTOGRAPH 7 – EXPOSED FACE OF SPECIMENS AT CONCLUSION OF TESTING
