Fire-resistance test on fire collars protecting a concrete slab penetrated by services

Test Report

Author: Chris Wojcik
Report number: FSP 1781
Date: 23 December 2016

Sponsored Investigation No. FSP 1781

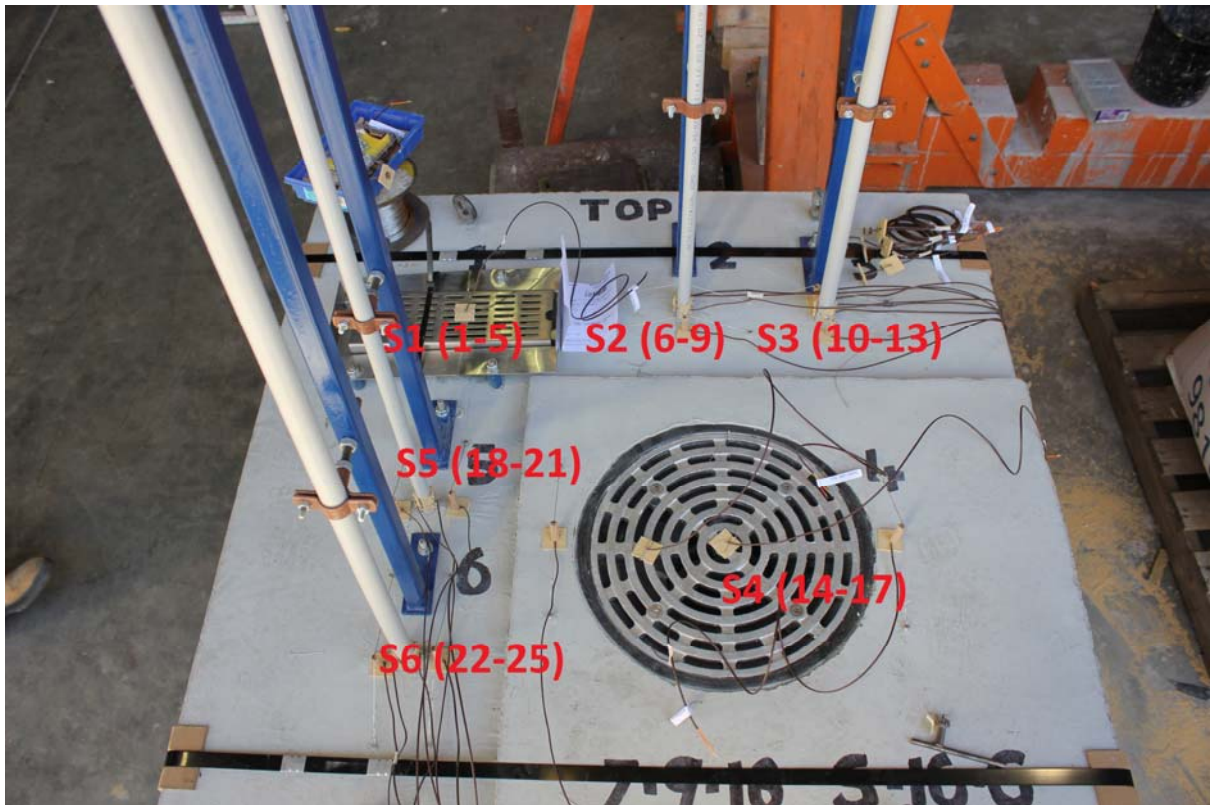
PHOTOGRAPH 1 – UNEXPOSED FACE OF SPECIMENS PRIOR TO TESTING

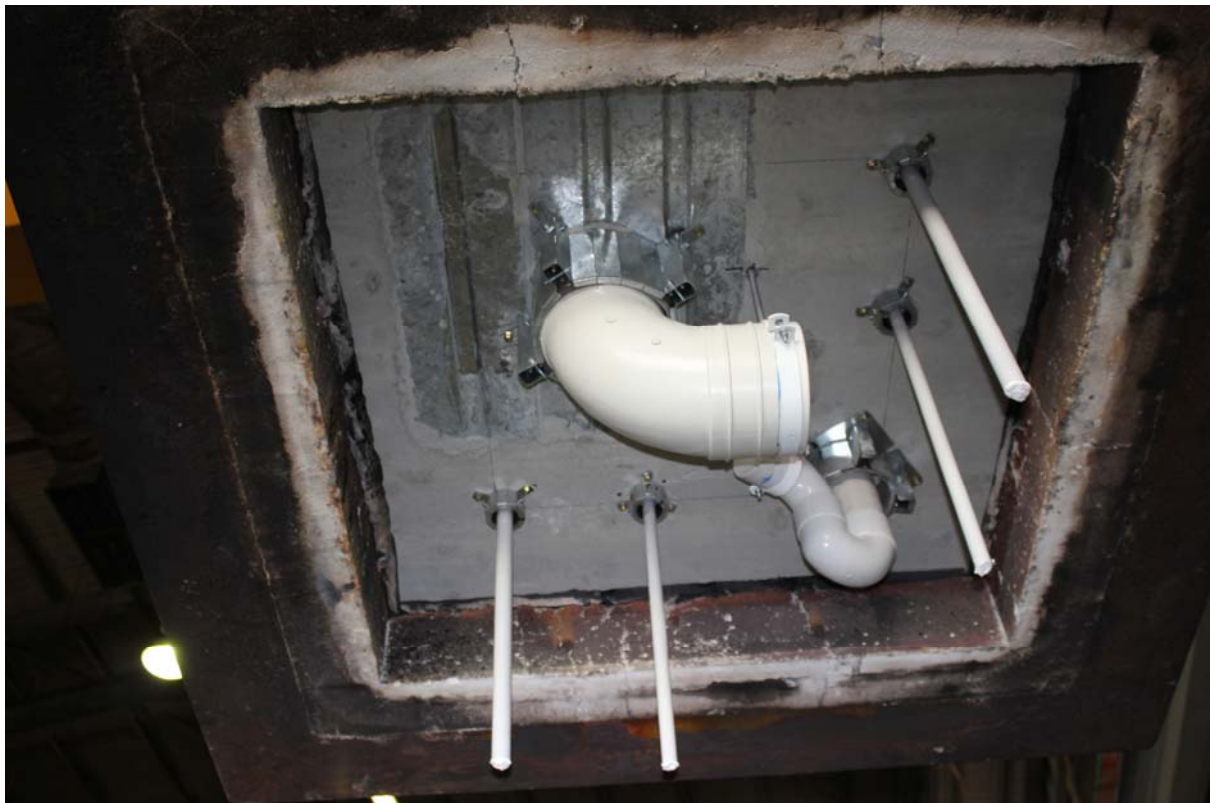
PHOTOGRAPH 2 – EXPOSED FACE OF SPECIMEN PRIOR TO TESTING

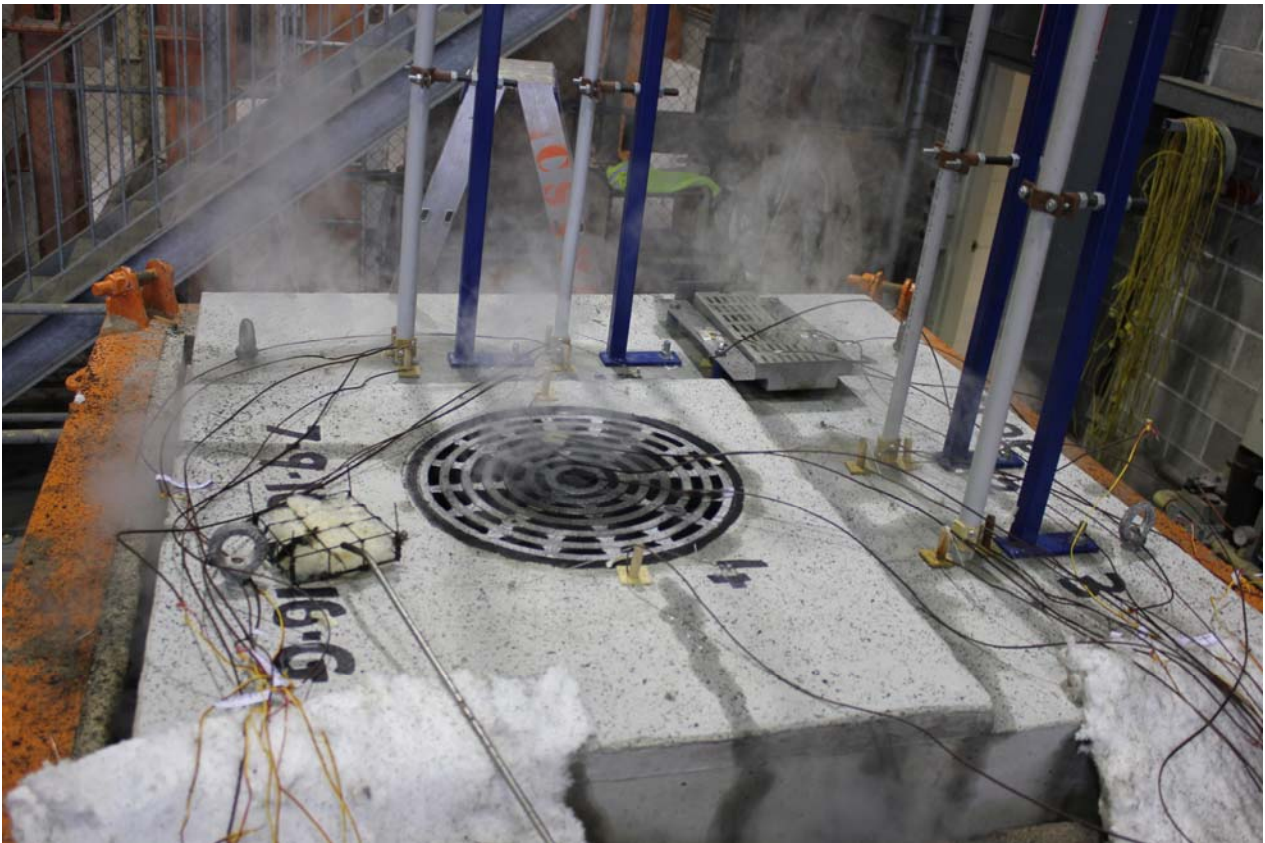
PHOTOGRAPH 3 – SPECIMENS AFTER 60 MINUTES OF TESTING

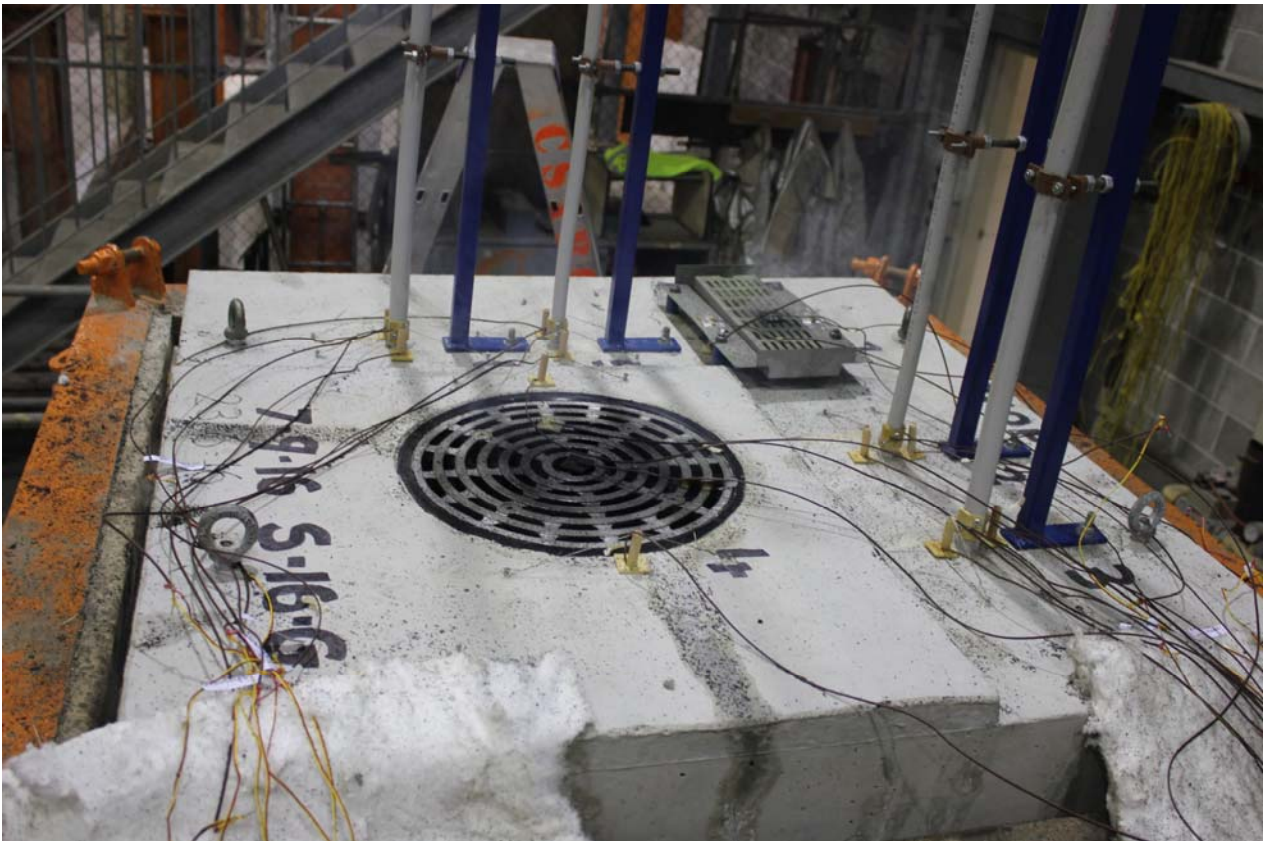
PHOTOGRAPH 5 – SPECIMENS AFTER 180 MINUTES OF TESTING
