# Fire-resistance test on fire collars protecting a wall penetrated by services

## Test Report

**Author:** Chris Wojcik  
**Report number:** FSP 1783  
**Date:** 23 February 2017

**Client:** Snap Fire Systems Pty Ltd

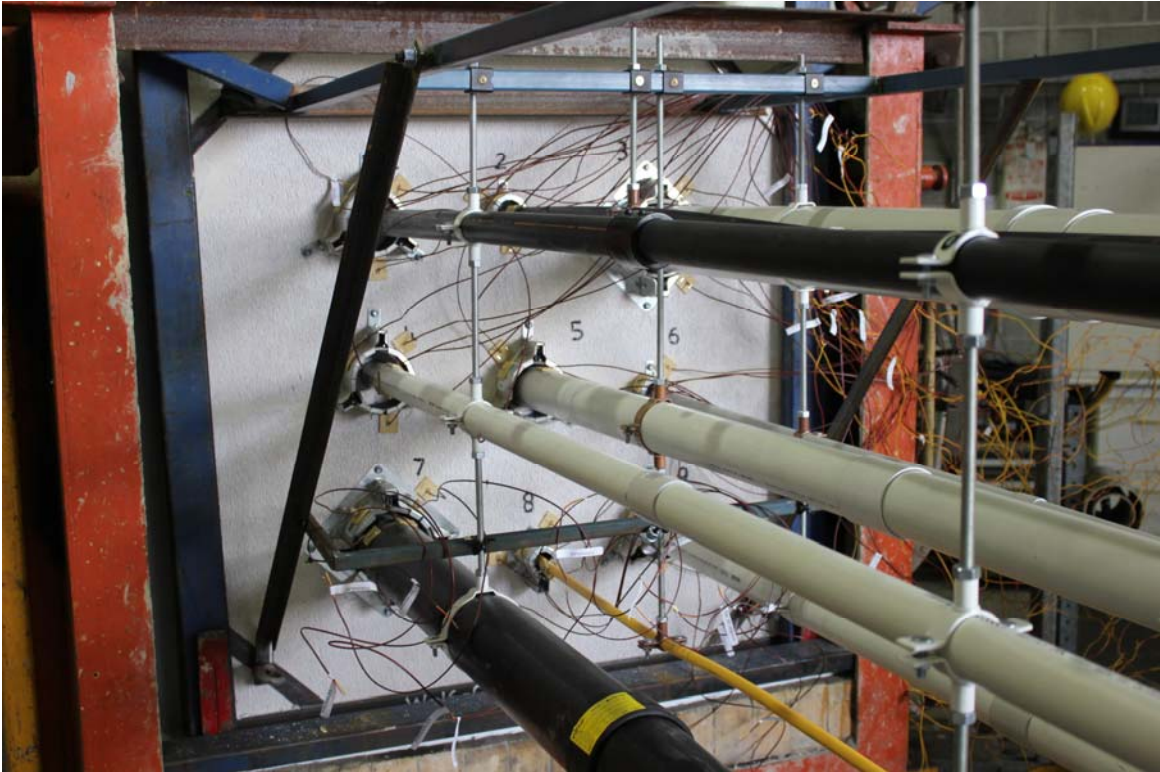
**PHOTOGRAPH 1 – UNEXPOSED FACE OF SPECIMENS PRIOR TO TESTING**

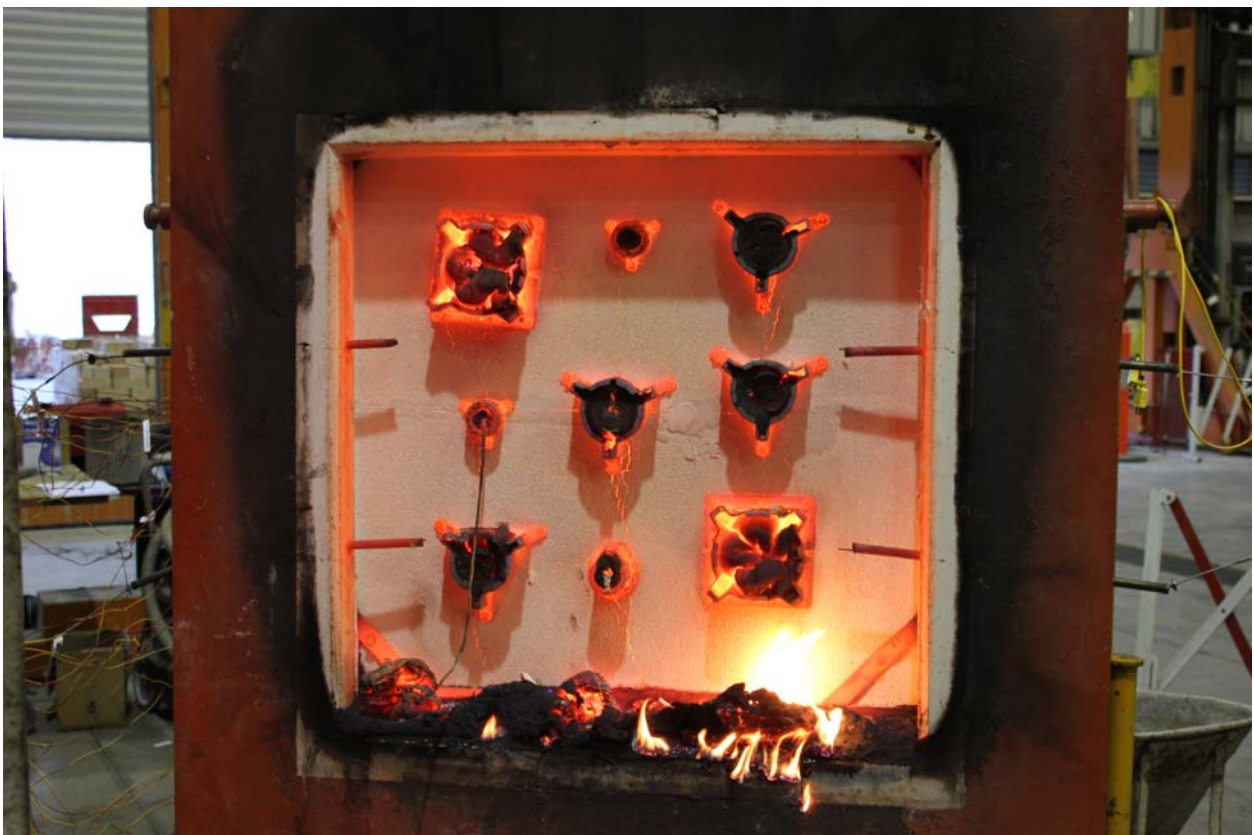
**PHOTOGRAPH 4 – EXPOSED FACE OF SPECIMENS AT CONCLUSION OF TESTING**

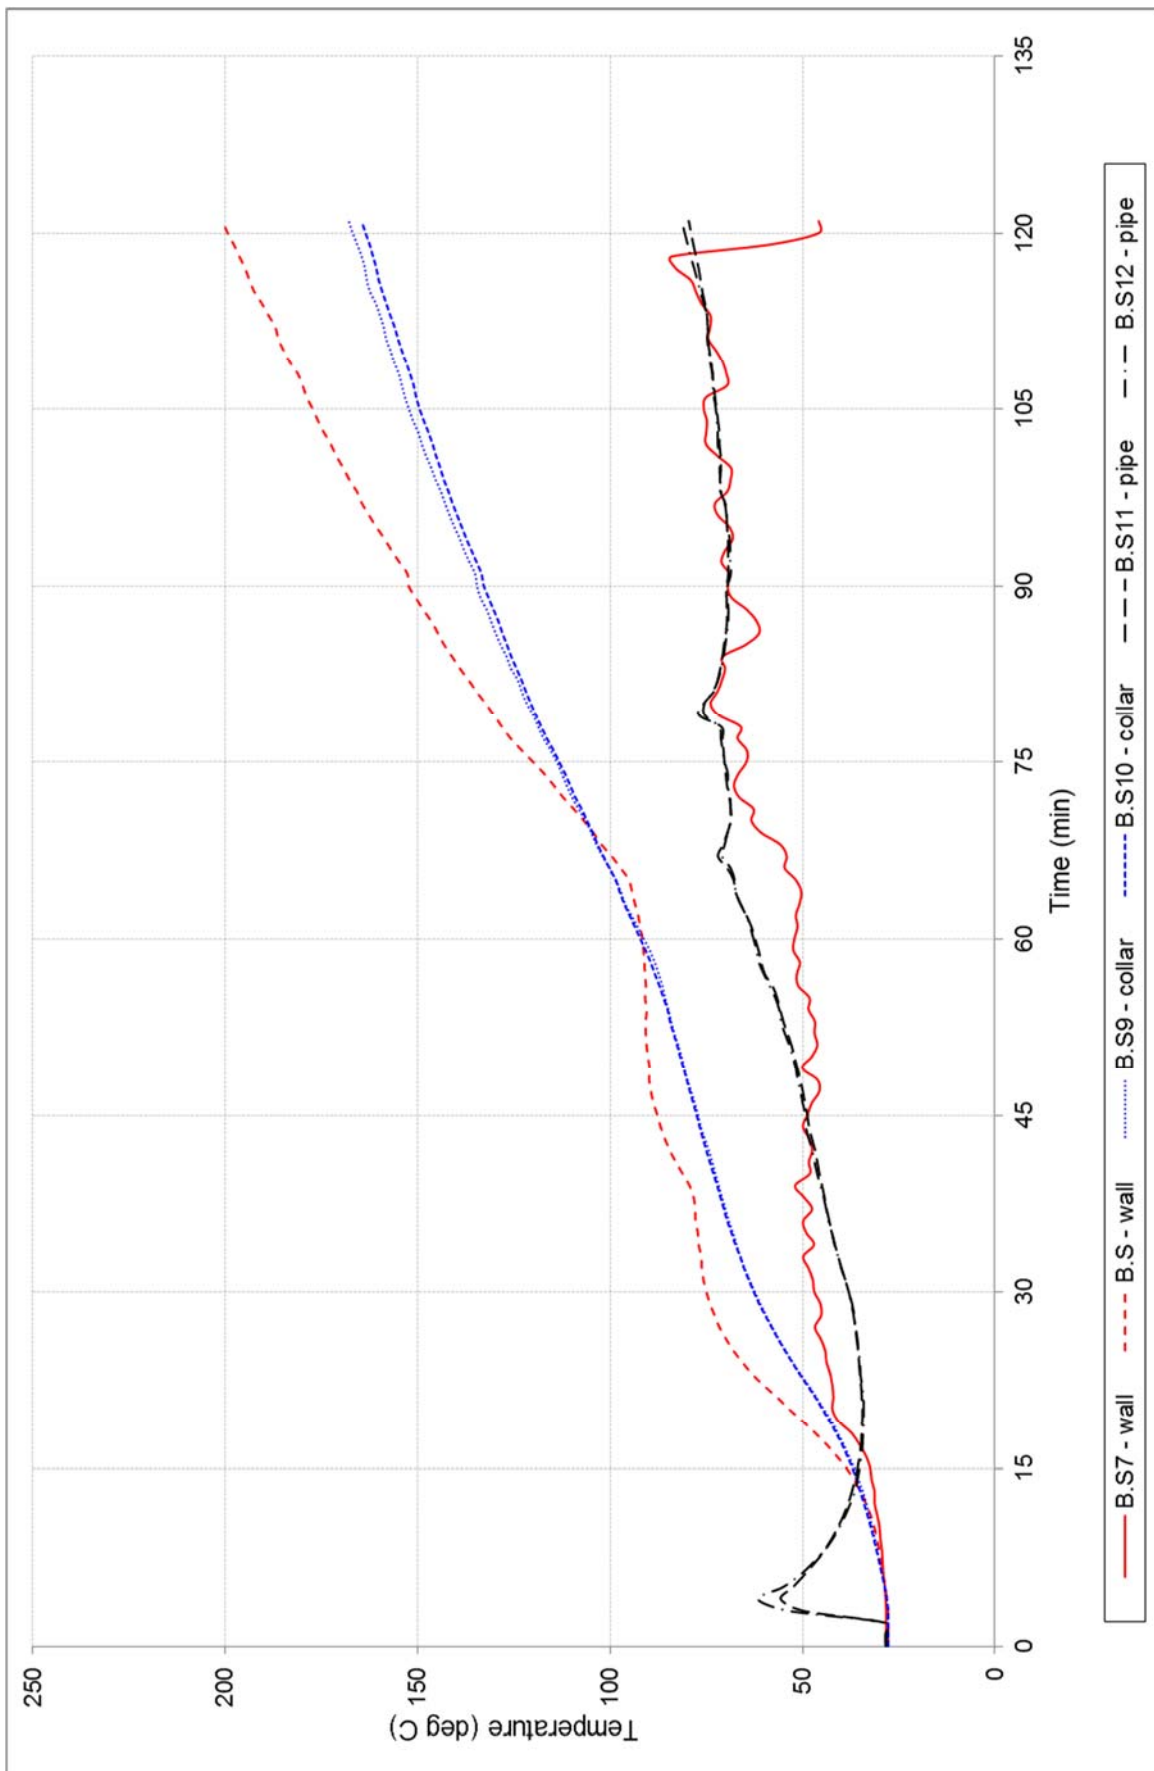
FIGURE 4 – SPECIMEN TEMPERATURE – ASSOCIATED WITH PENETRATION # 2
