Fire-resistance test on fire collars protecting a wall penetrated by services

Test Report

Author: Chris Wojcik
Report number: FSP 1807
Date: 23 March 2017

Sponsored Investigation No. FSP 1807

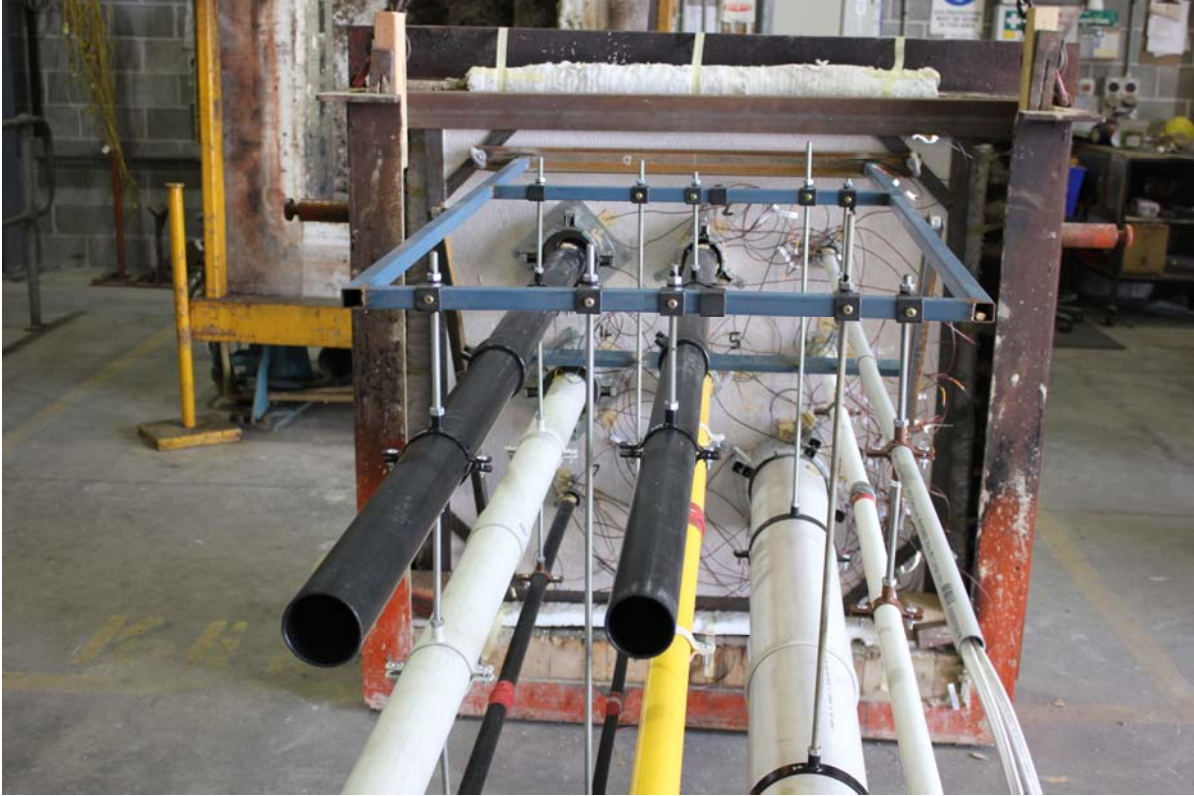
PHOTOGRAPH 1 – UNEXPOSED FACE OF SPECIMENS PRIOR TO TESTING

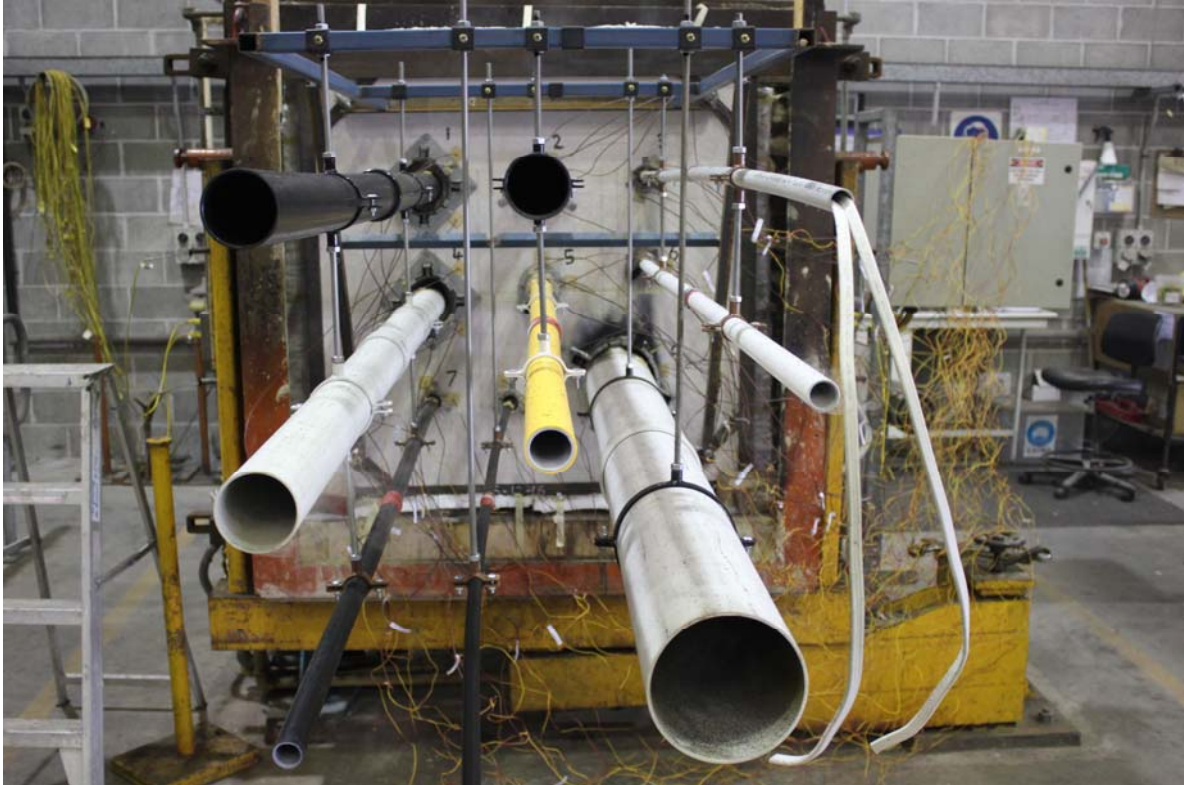
PHOTOGRAPH 2 – SPECIMENS AFTER 60 MINUTES OF TESTING

- 48 minutes - Light smoke is evident between the pipe and the collar on Penetration 1. Slight smoke is evident from collar of Penetration 5.
- 60 minutes - Slight fluing is noted from end of Penetrations 4 and 9. Slight smoke is noted around the collar on Penetration 4.

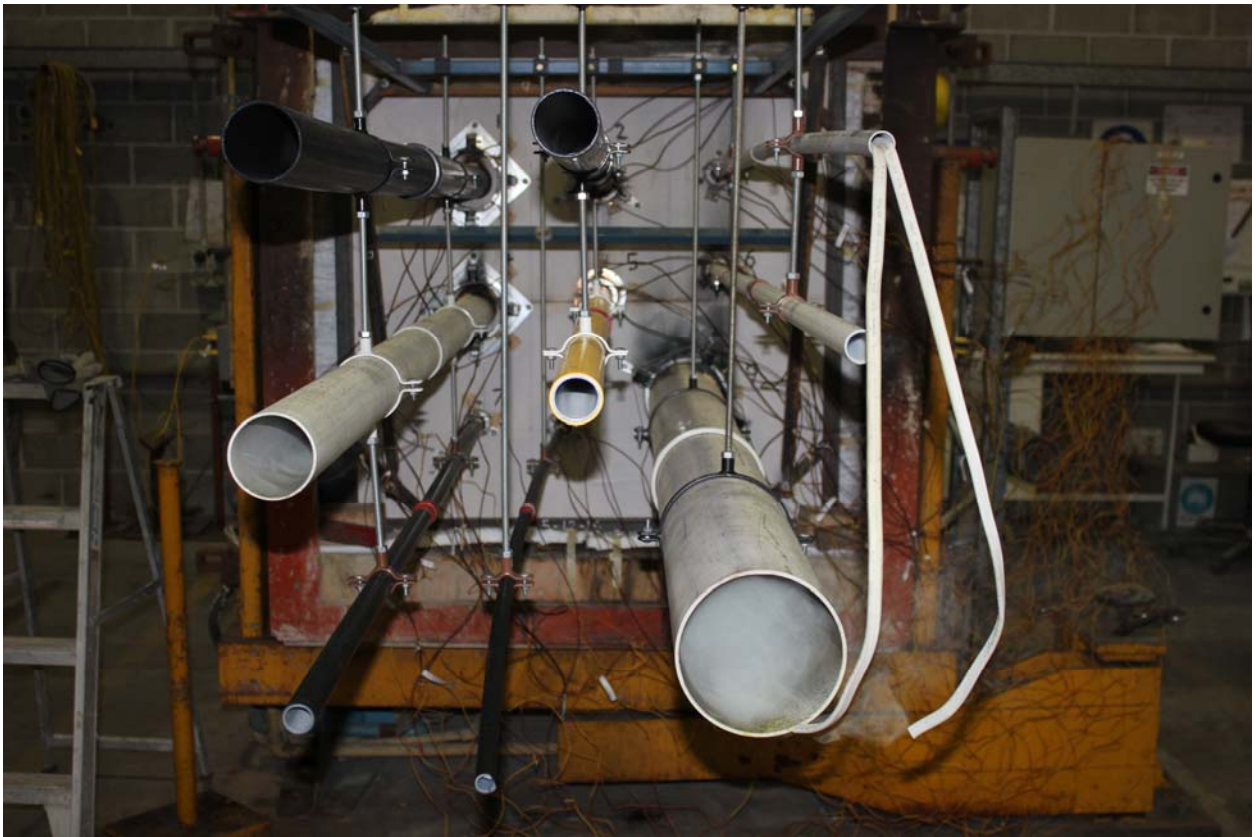
PHOTOGRAPH 3 – SPECIMENS AFTER 120 MINUTES OF TESTING

- 79 minutes - Insulation failure of Penetration 5.
- 85 minutes - Furnace glow is visible between pipe and collar of Penetration 4.
- 90 minutes - Vertical cracks are forming in the AAC between Penetration 2 and 5, above Penetration 6 and Penetration 5 and 8.

- 91 minutes - Insulation failure of Penetration 2.
- 110 minutes - Furnace is visible through the cracks.
- 114 minutes - Insulation failure of Penetration 4.
