# Fire-resistance test on fire collars protecting a concrete floor slab penetrated by services

## Test Report

**Author:** Chris Wojcik  
**Report number:** FSP 1849  
**Date:** 21 January 2025

Sponsored Investigation No. FSP 1849

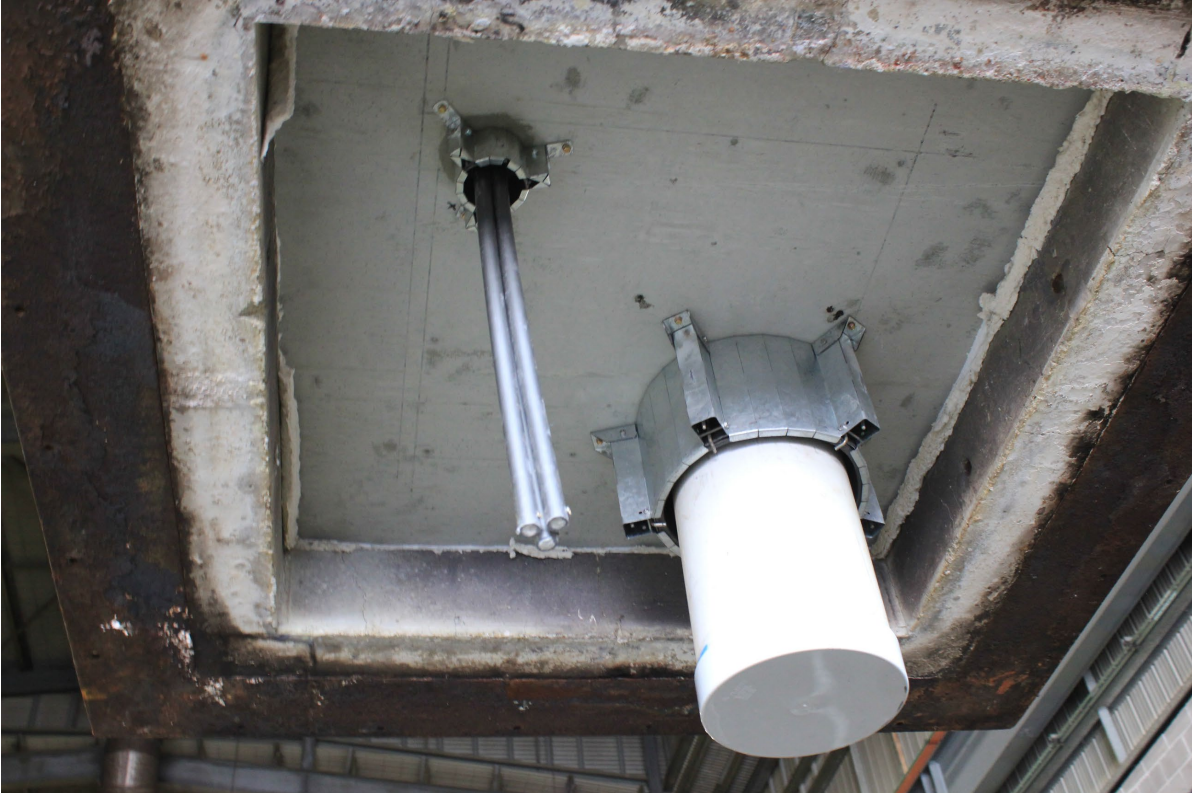
**PHOTOGRAPH 1 – EXPOSED FACE OF SPECIMENS PRIOR TO TESTING**

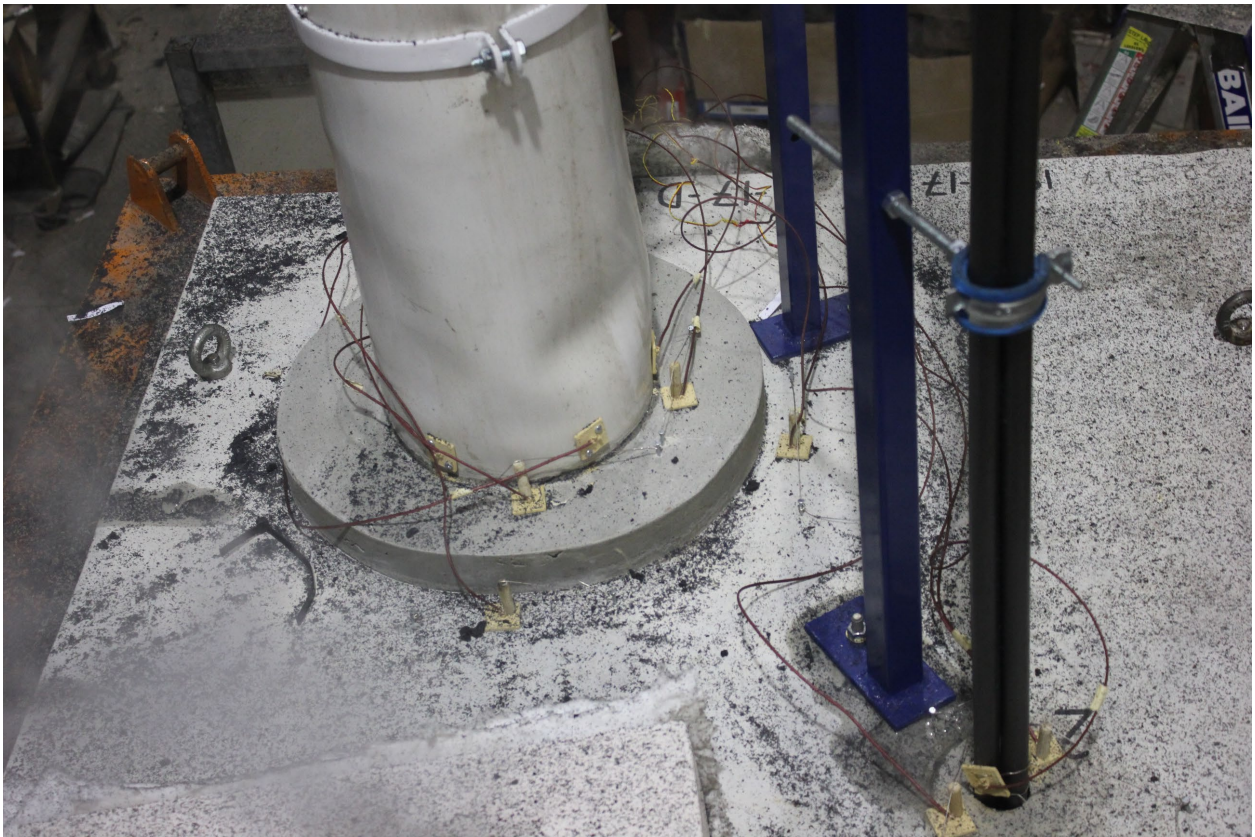
**PHOTOGRAPH 3 – SPECIMENS AFTER 60 MINUTES OF TESTING**

<b>Time</b>	<b>Observation</b>
1:30 minutes -	Fluing is noted on Penetration 2.
2 minutes -	Fluing continues on Penetration 2.
3 minutes -	Fluing is noted on Penetration 1.
4 minutes -	Flaming is noted on Penetration 1.
7 minutes -	Penetration 1 is starting to deform.
8 minutes -	Penetration 2 has ceased fluing.
12 minutes -	A popping sound (spalling) is audible from the furnace.
25 minutes -	No further spalling sounds are audible from the furnace.
60 minutes -	Light smoke is visible between the pipes in Penetration 2, at the base.
241 minutes -	Test terminated.

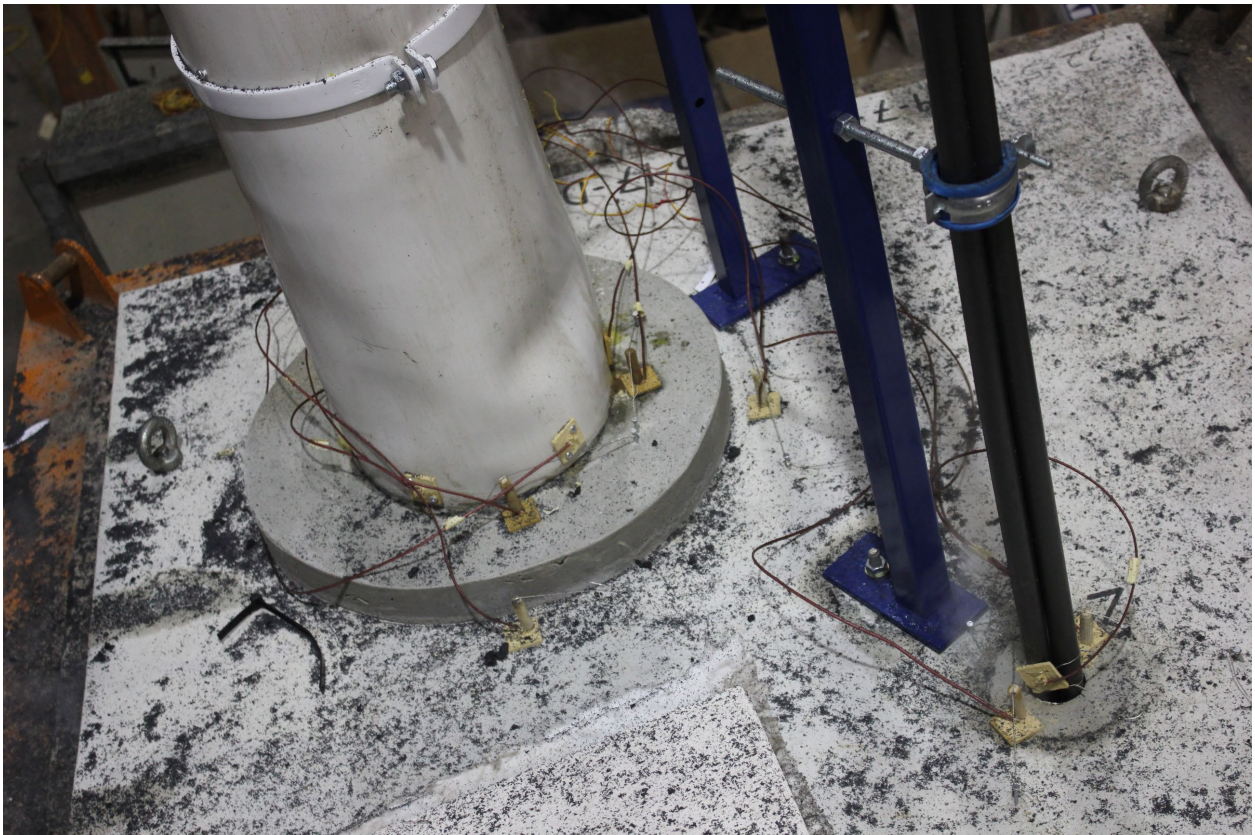
**PHOTOGRAPH 4 – SPECIMENS AFTER 120 MINUTES OF TESTING**
