# Fire-resistance test on fire collars protecting a concrete floor slab penetrated by services

## Test Report

**Author:** Chris Wojcik  
**Report number:** FSP 1849  
**Date:** 12 September 2017

Sponsored Investigation No. FSP 1849

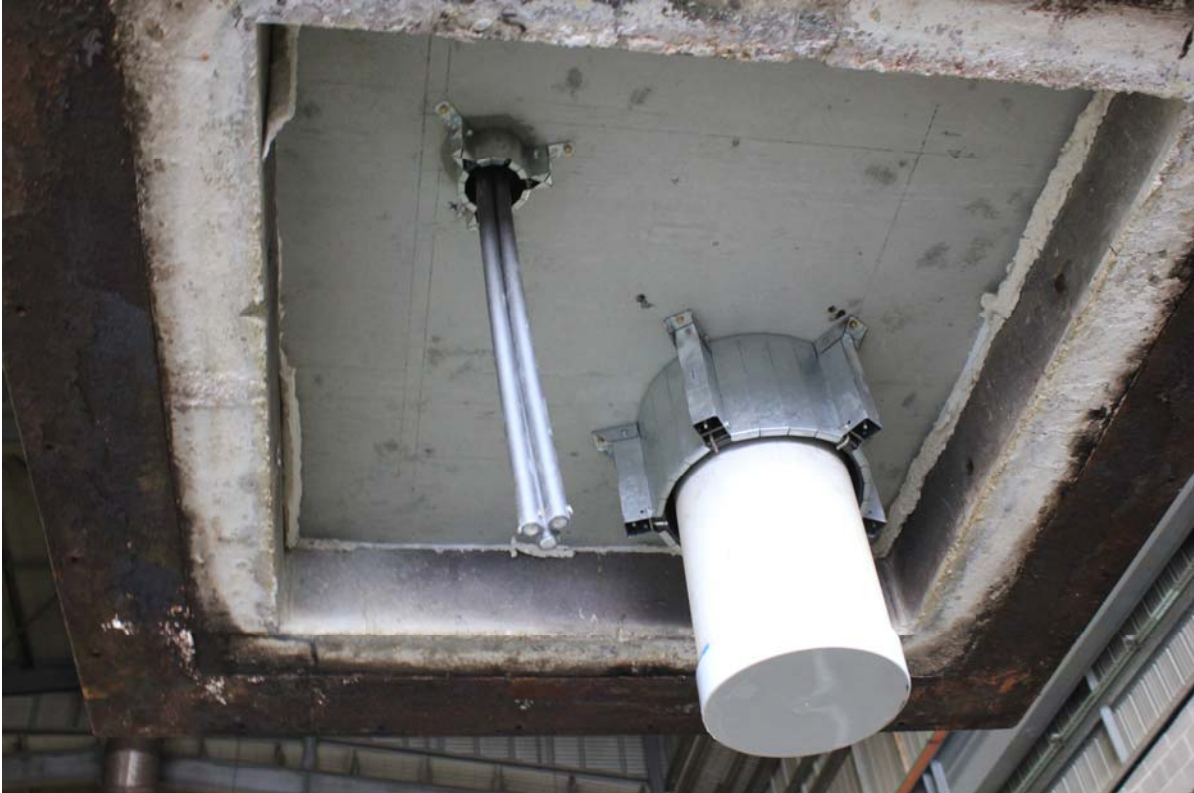
**PHOTOGRAPH 1 – EXPOSED FACE OF SPECIMENS PRIOR TO TESTING**

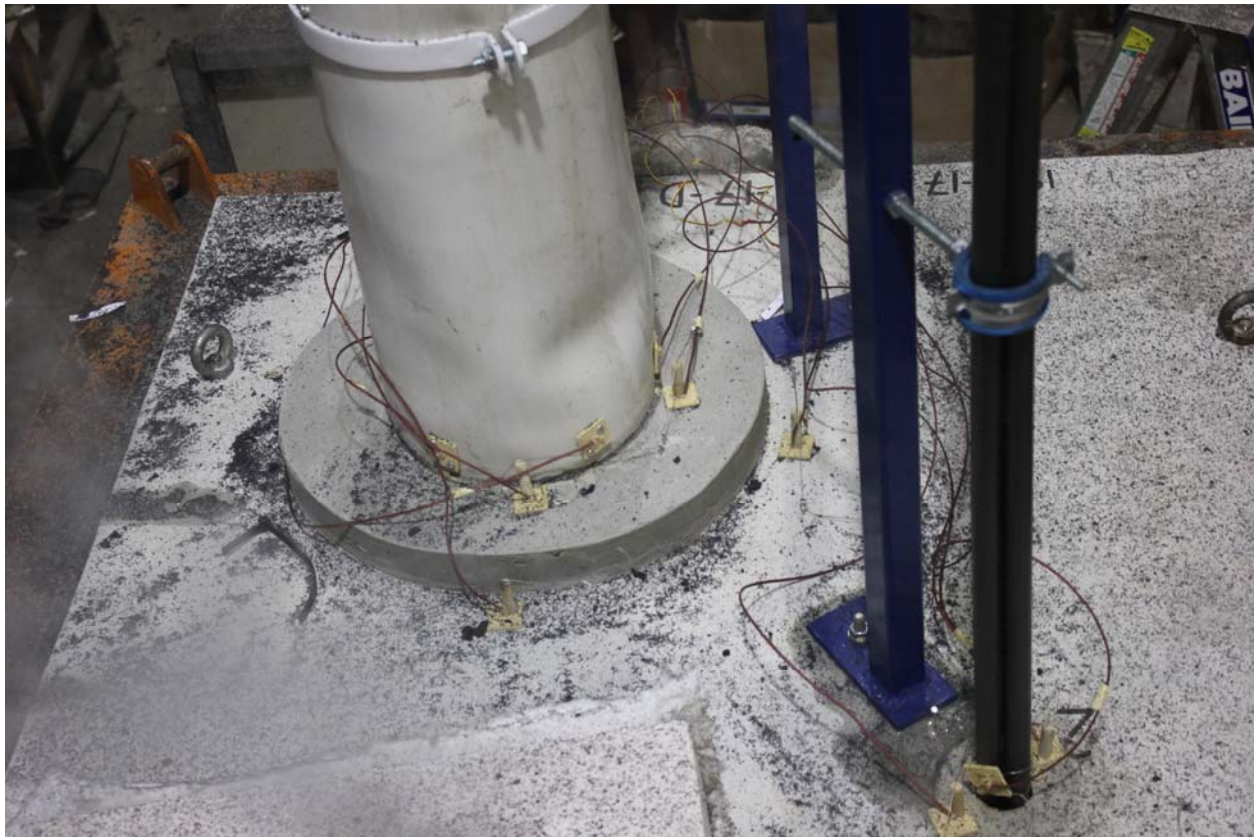
**PHOTOGRAPH 3 – SPECIMENS AFTER 60 MINUTES OF TESTING**

<b>Time</b>	<b>Observation</b>
1:30 minutes -	Fluing is noted on Penetration 2.
2 minutes -	Fluing continues on Penetration 2.
3 minutes -	Fluing is noted on Penetration 1.
4 minutes -	Flaming is noted on Penetration 1.
7 minutes -	Penetration 1 is starting to deform.
8 minutes -	Penetration 2 has ceased fluing.
12 minutes -	A popping sound (spalling) is audible from the furnace.
25 minutes -	No further spalling sounds are audible from the furnace.
60 minutes -	Light smoke is visible between the pipes in Penetration 2, at the base.
241 minutes -	Test terminated.

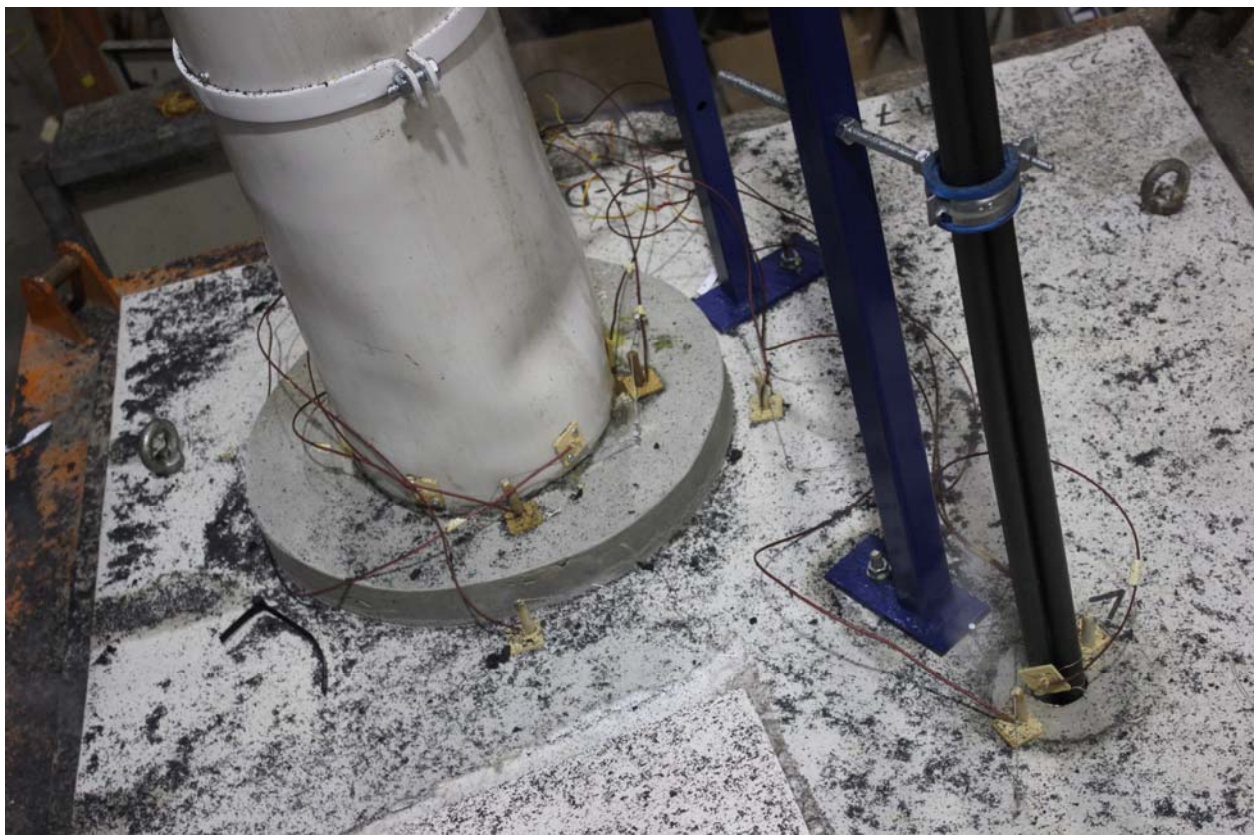
**PHOTOGRAPH 4 – SPECIMENS AFTER 120 MINUTES OF TESTING**

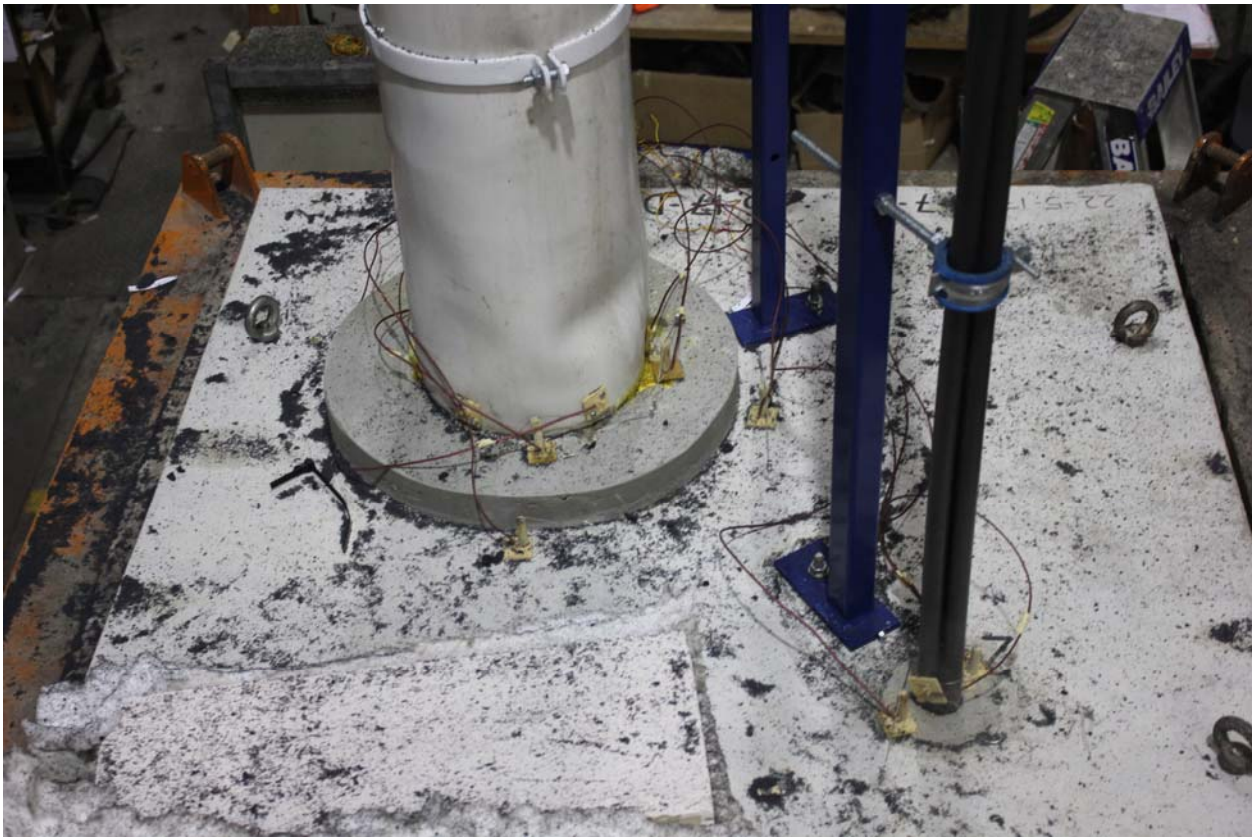
**PHOTOGRAPH 5 – SPECIMENS AFTER 180 MINUTES OF TESTING**

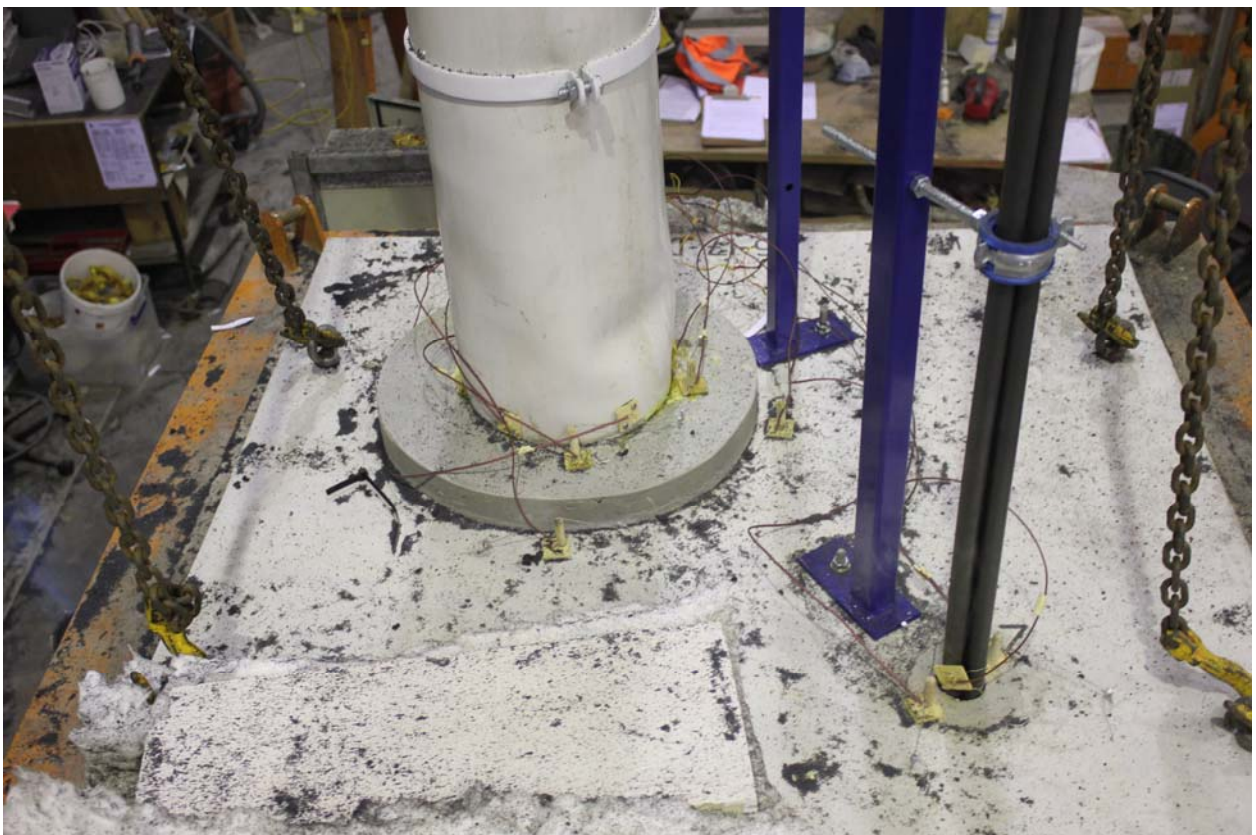
**PHOTOGRAPH 6 – UNEXPOSED FACED OF SPECIMEN AT CONCLUSION OF TESTING**

Structural adequacy	-	not applicable
Integrity	-	no failure at 241 minutes
Insulation	-	no failure at 241 minutes

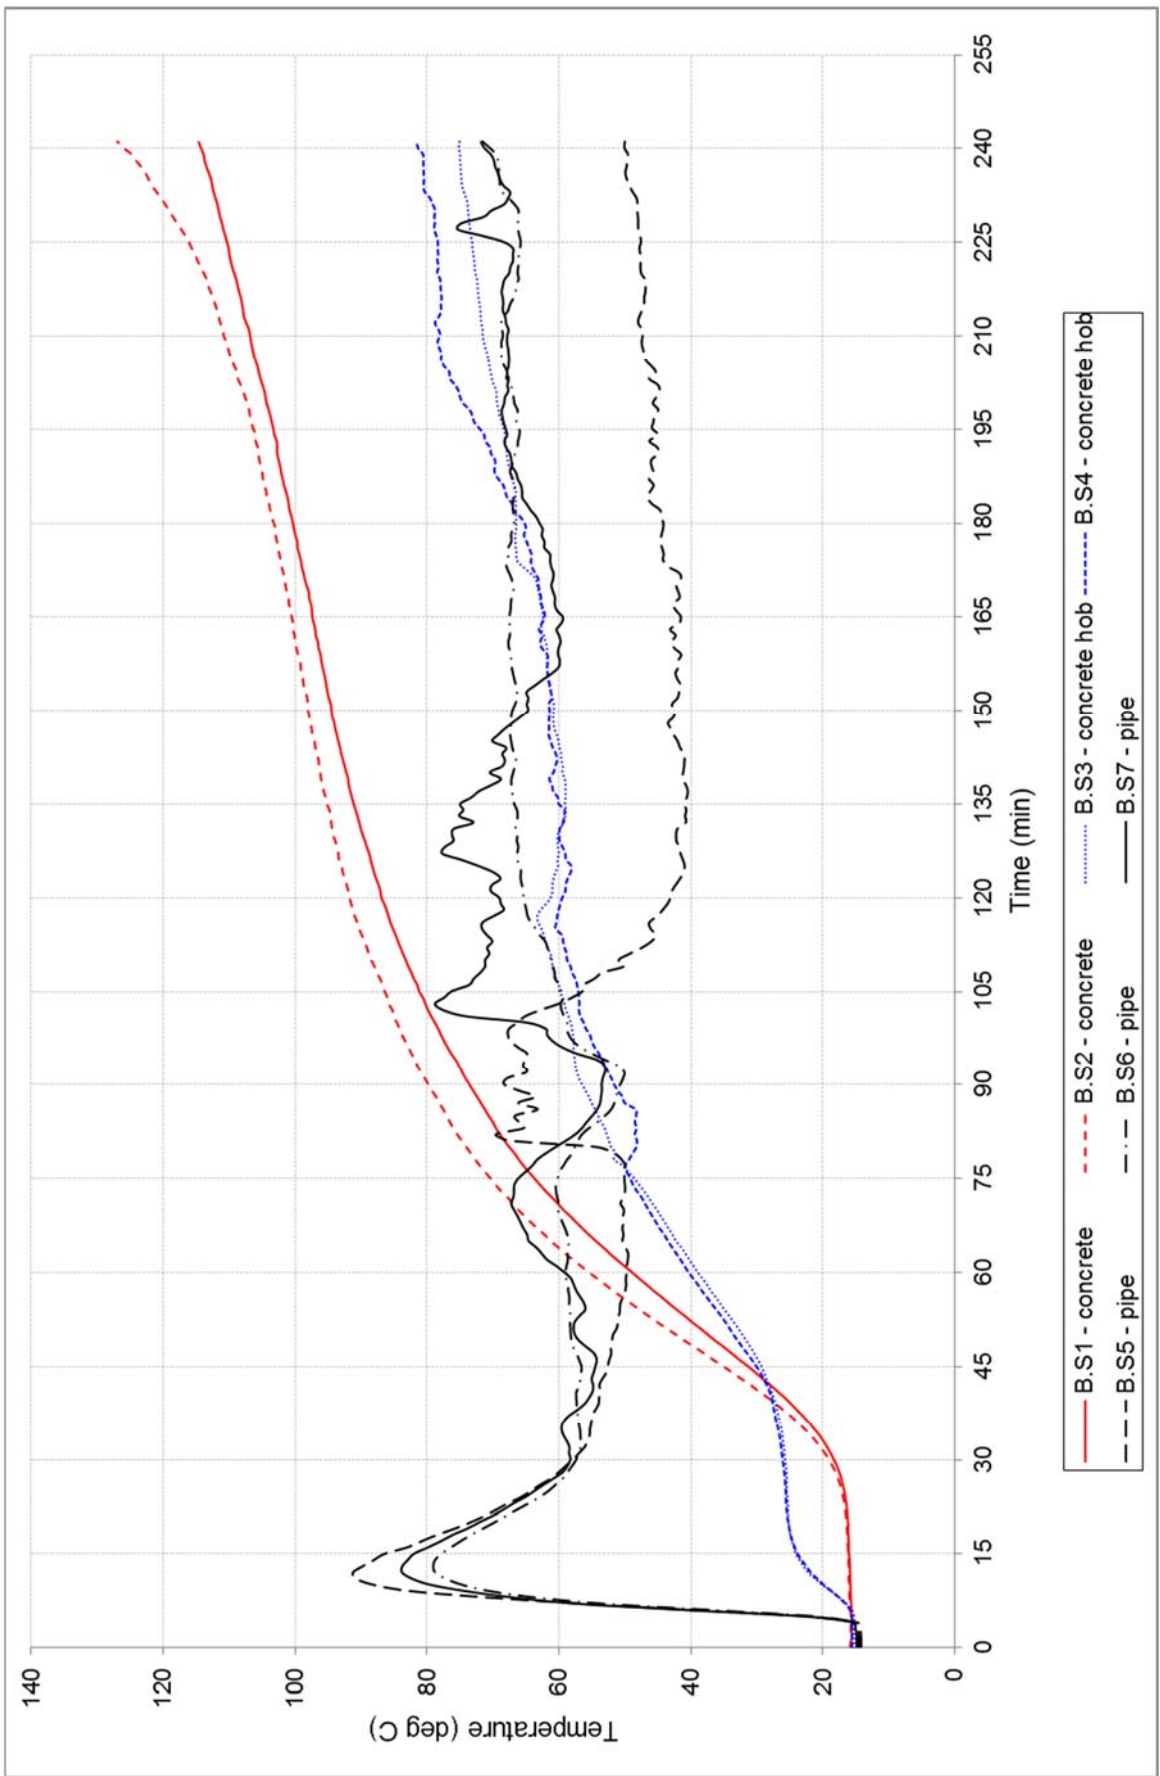
FIGURE 3 – SPECIMEN TEMPERATURE – ASSOCIATED WITH PENETRATION # 1

Figure 3 shows the curve of maximum temperature versus time associated with Penetration 1.
