Fire-resistance test on fire collars protecting a concrete floor slab penetrated by services

Test Report

Report number: FSP 1872

Sponsored Investigation No. FSP 1872

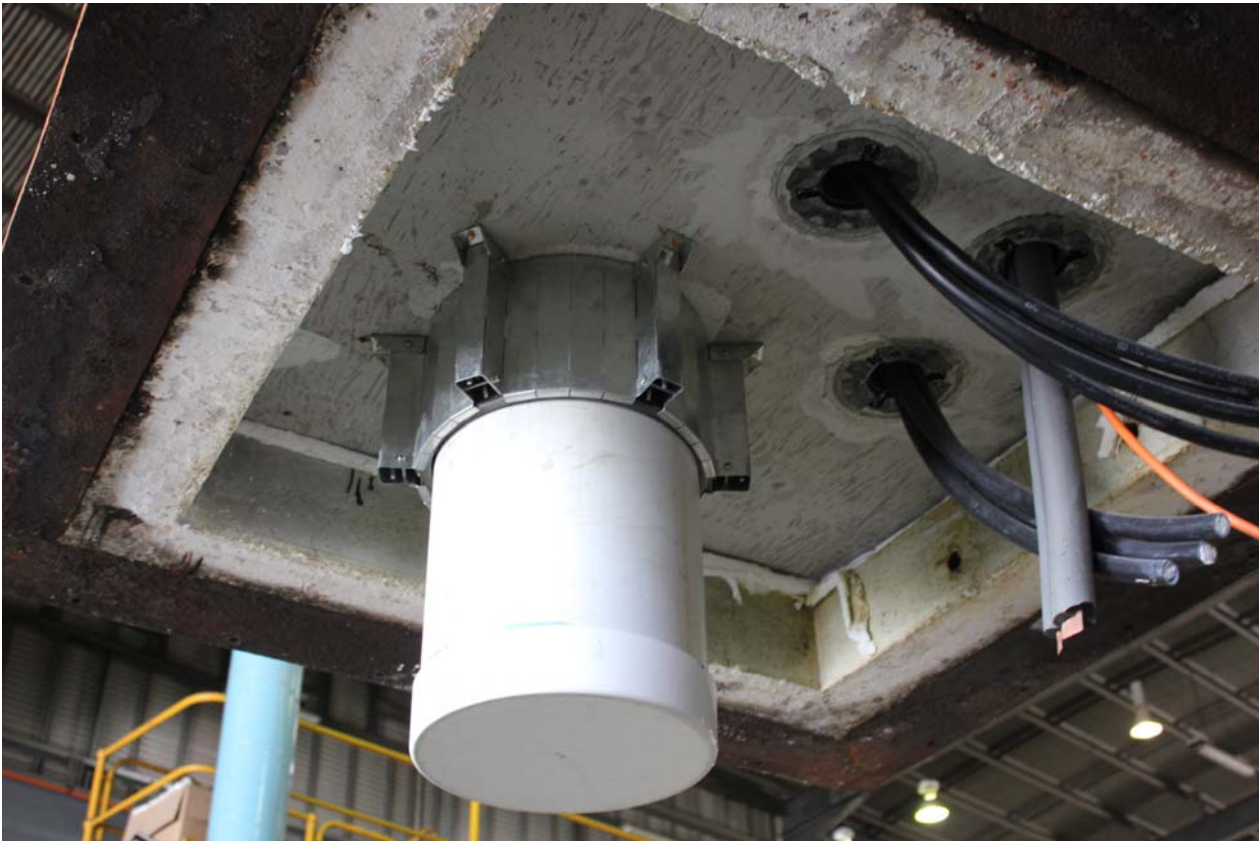
PHOTOGRAPH 1 – EXPOSED FACE OF SPECIMENS PRIOR TO TESTING

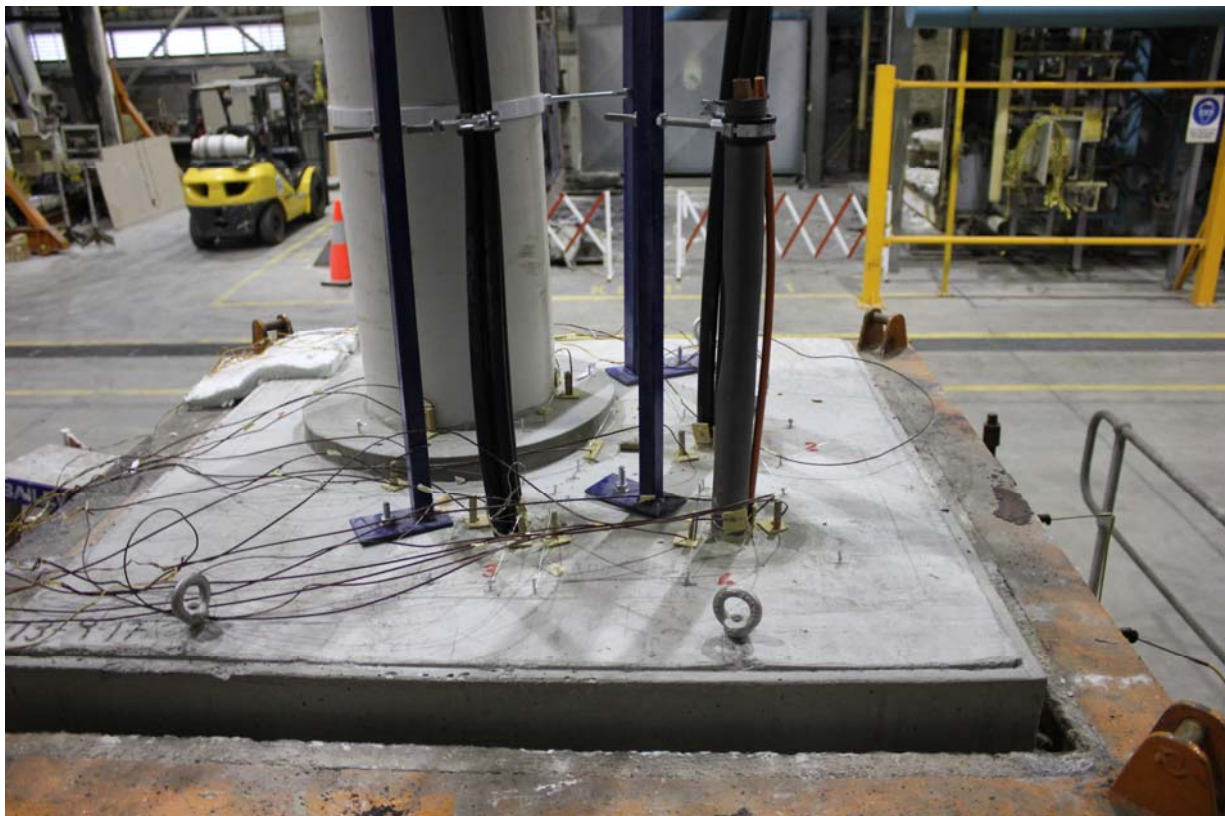
PHOTOGRAPH 2 – UNEXPOSED FACE OF PENETRATIONS PRIOR TO TESTING

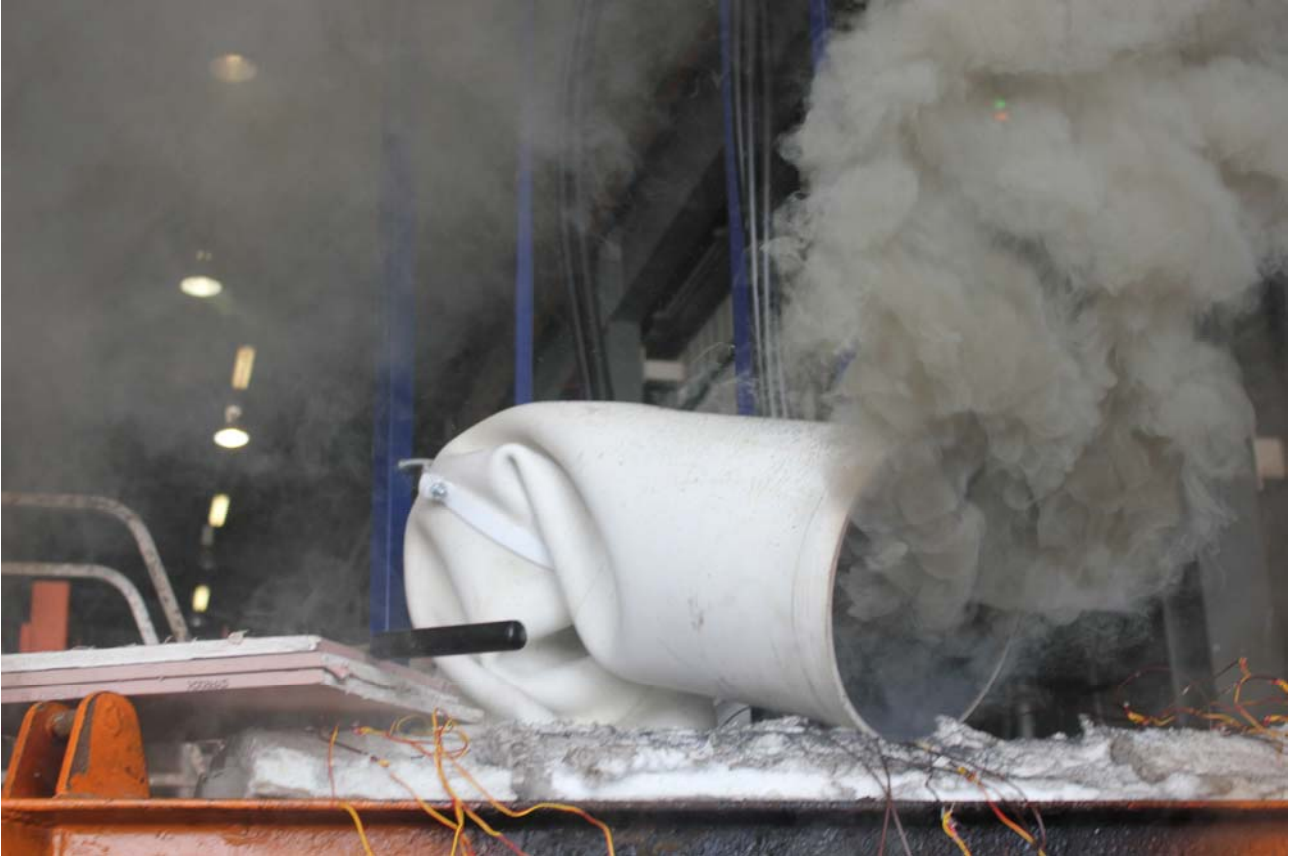
PHOTOGRAPH 3 – PENETRATION 1 AFTER 7 MINUTES OF TESTING

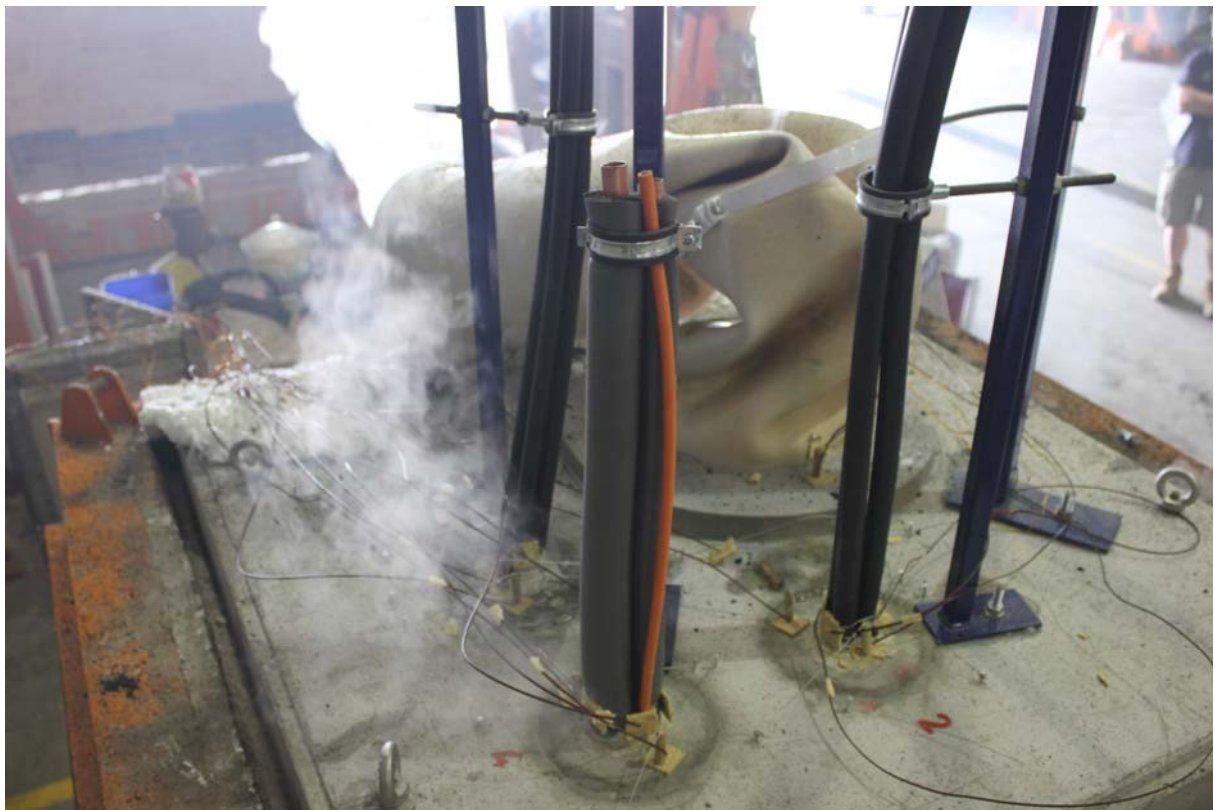
PHOTOGRAPH 4 – PENETRATIONS AFTER 30 MINUTES OF TESTING

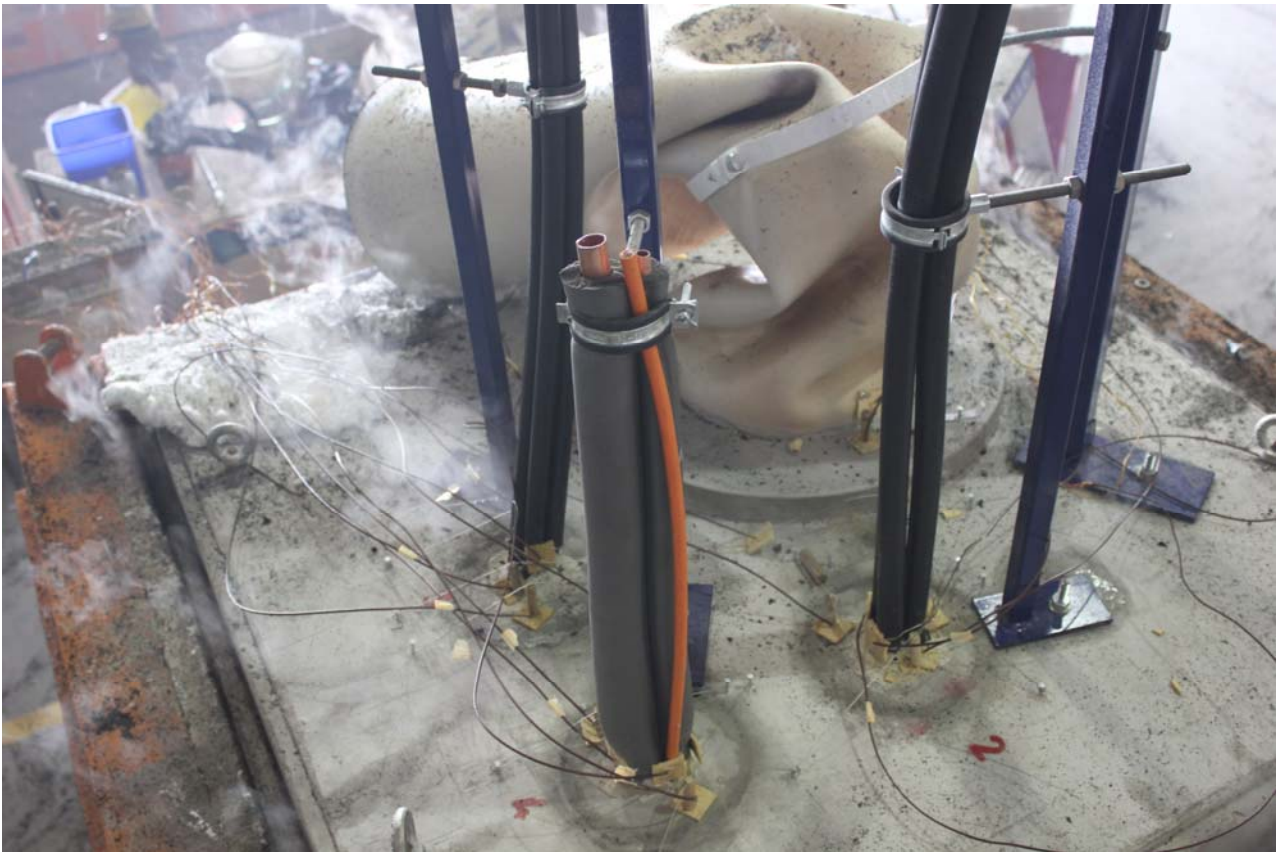
PHOTOGRAPH 5 – PENETRATIONS AFTER 60 MINUTES OF TESTING

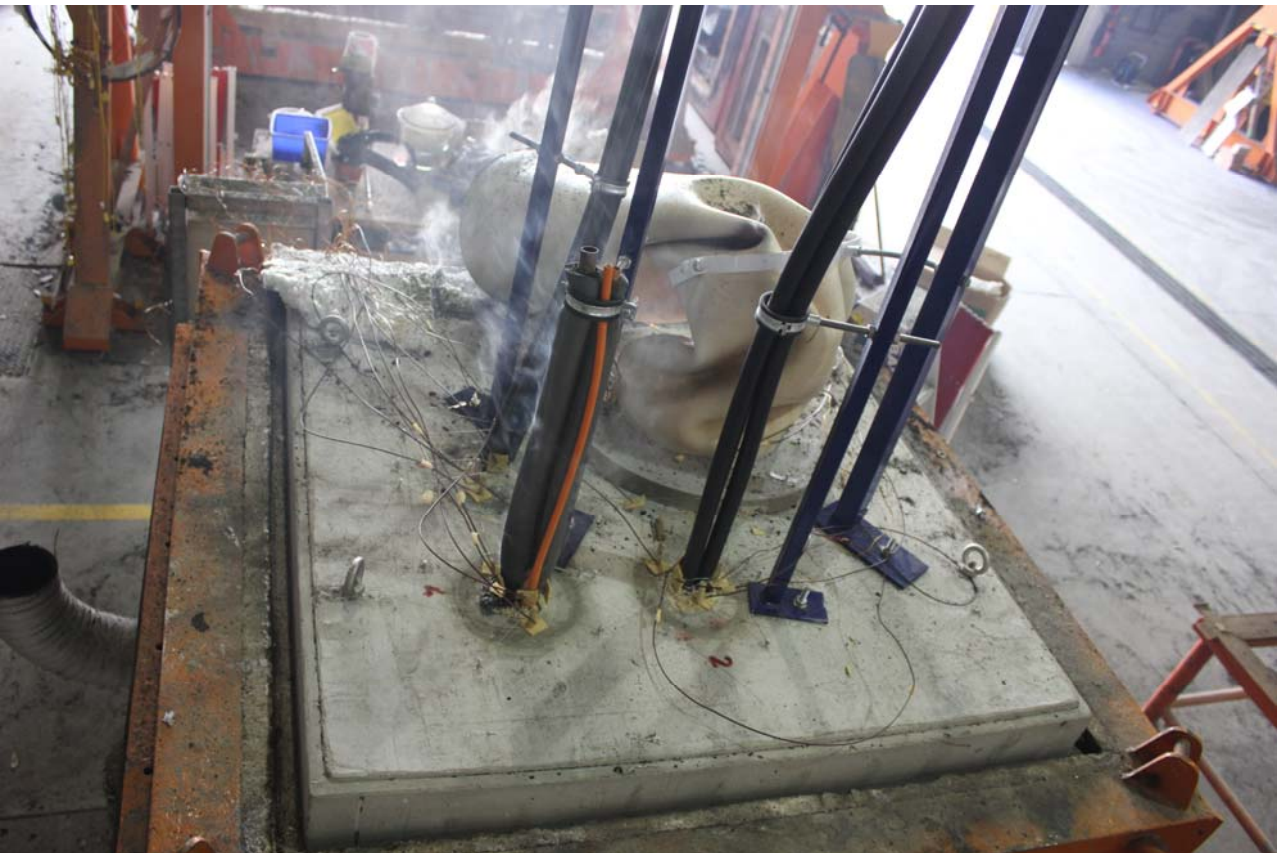
PHOTOGRAPH 6 – PENETRATIONS AFTER 120 MINUTES OF TESTING

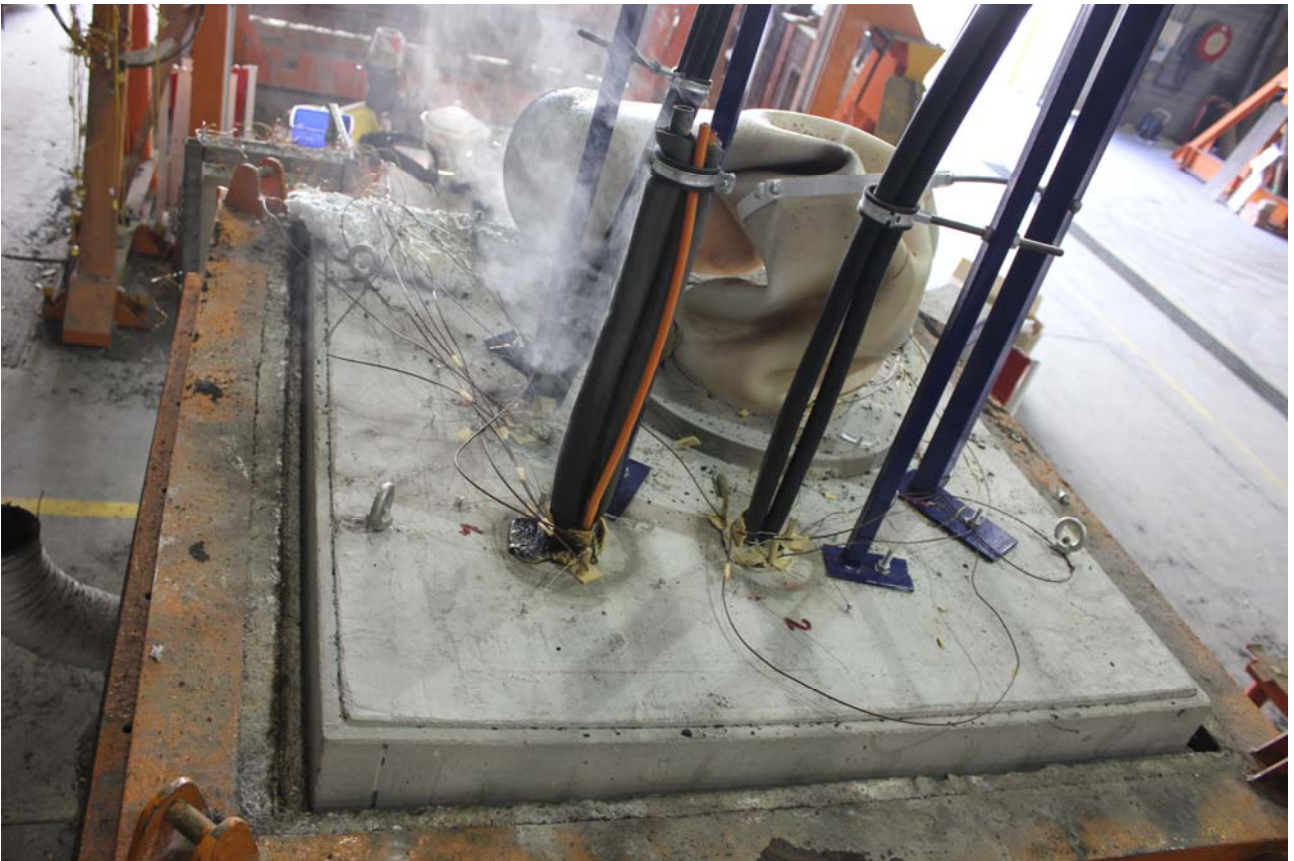
PHOTOGRAPH 7 – PENETRATIONS AFTER 180 MINUTES OF TESTING

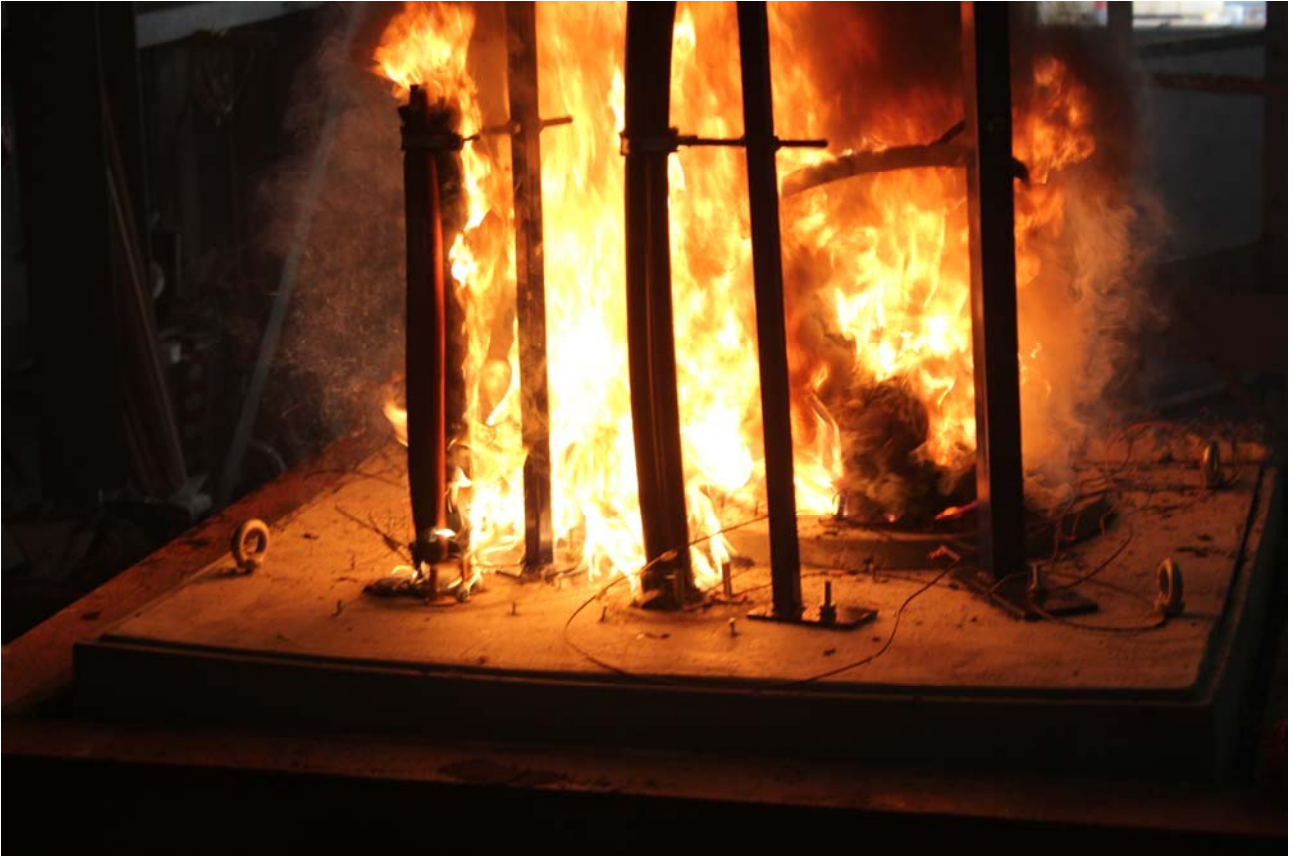
PHOTOGRAPH 8 – UNEXPOSED FACED OF PENETRATION AT CONCLUSION OF TESTING

- 199 minutes - Insulation Failure Penetration 1 – maximum temperature rise of 180K is exceeded on pipe of Penetration 1 - Thermocouple S7.
- 200 minutes - Integrity Failure Penetration 1 – Flaming for a duration of greater than 10 seconds observed on the unexposed face of Penetration 1.

- 201 minutes - Integrity Failure Penetrations 2, 3 and 4 – Flaming for a duration of greater than 10 seconds observed on the unexposed face of Penetrations 2, 3 and 4. (As flaming spread from Penetration 1.)

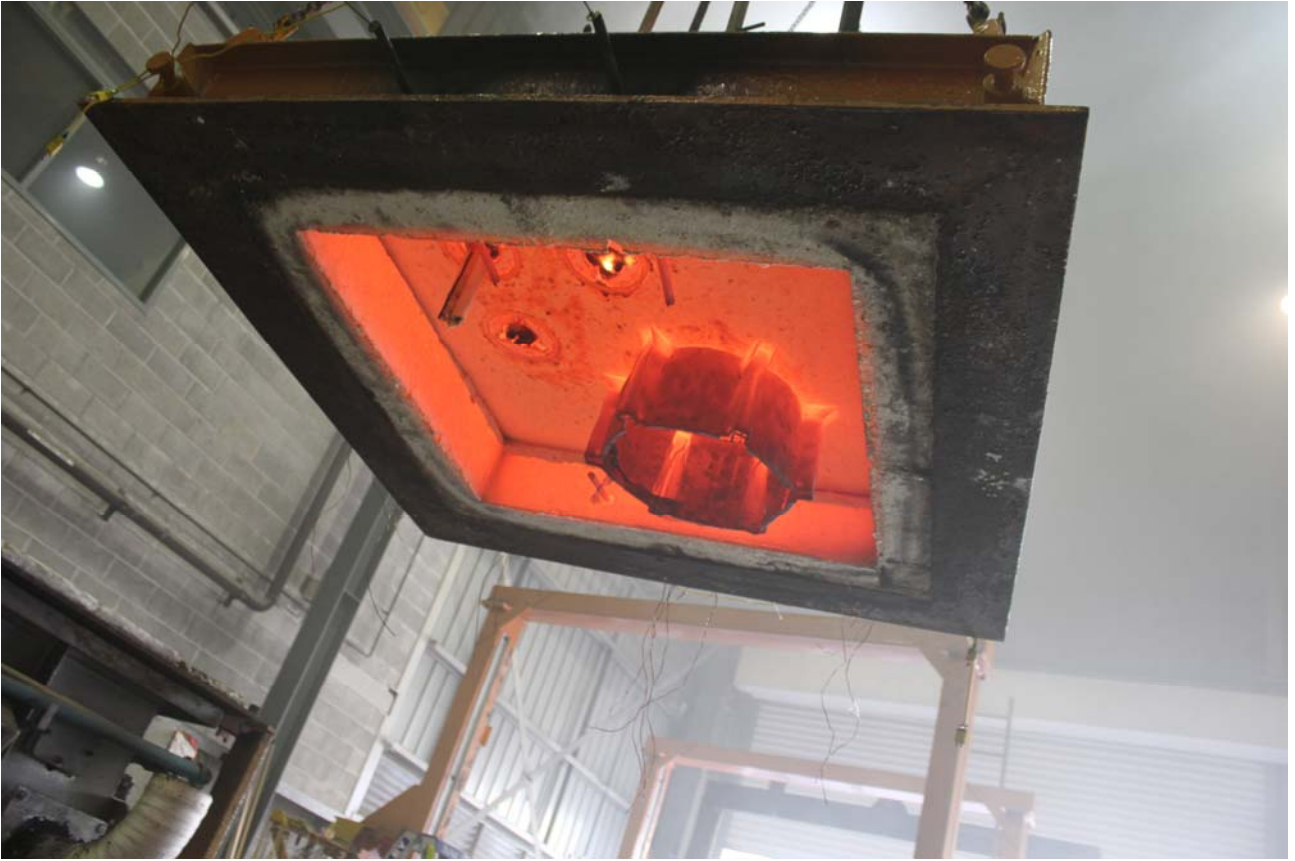
PHOTOGRAPH 9 – EXPOSED FACE OF PENETRATIONS AT CONCLUSION OF TESTING

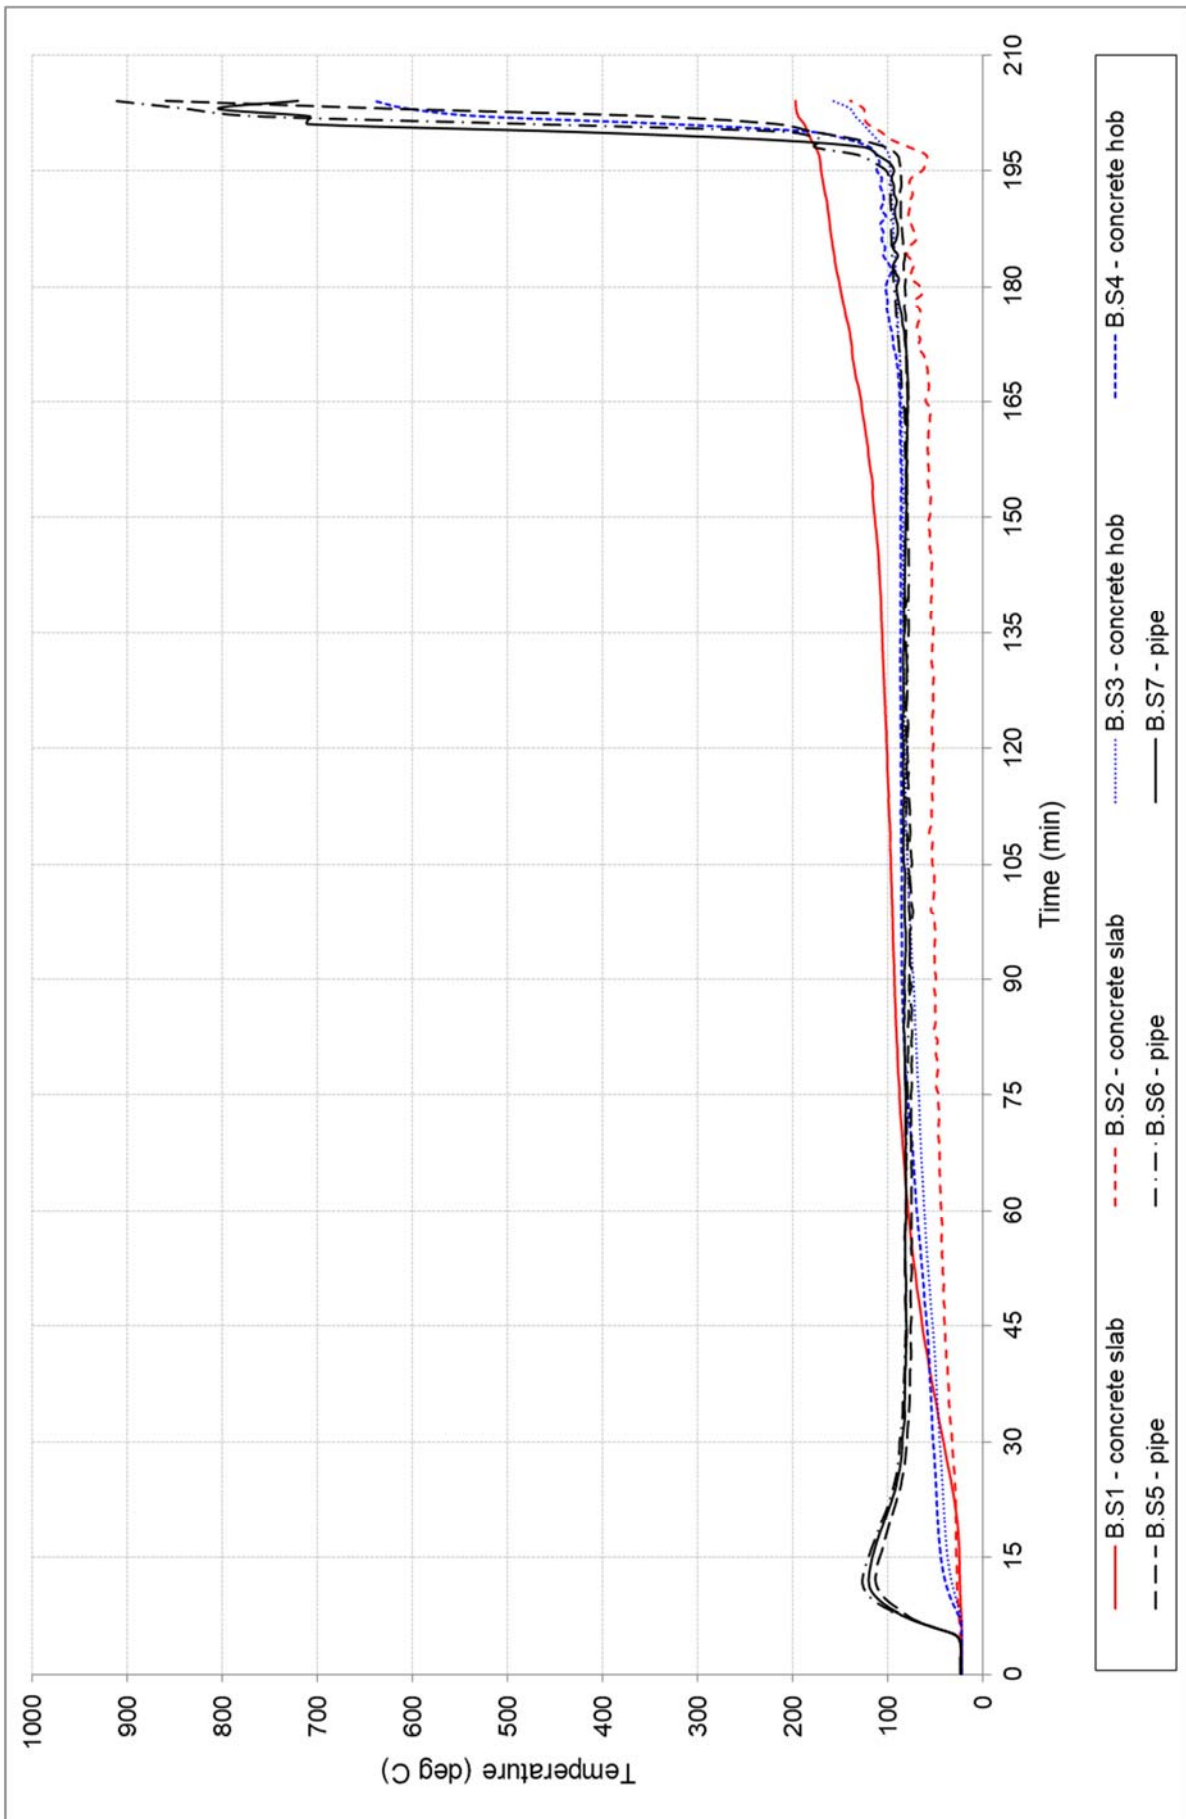
FIGURE 3 – SPECIMEN TEMPERATURE – ASSOCIATED WITH PENETRATION # 1

Figure 3 shows the curve of maximum temperature versus time associated with Penetration 1.

Structural adequacy	-	not applicable
Integrity	-	200 minutes
Insulation	-	199 minutes

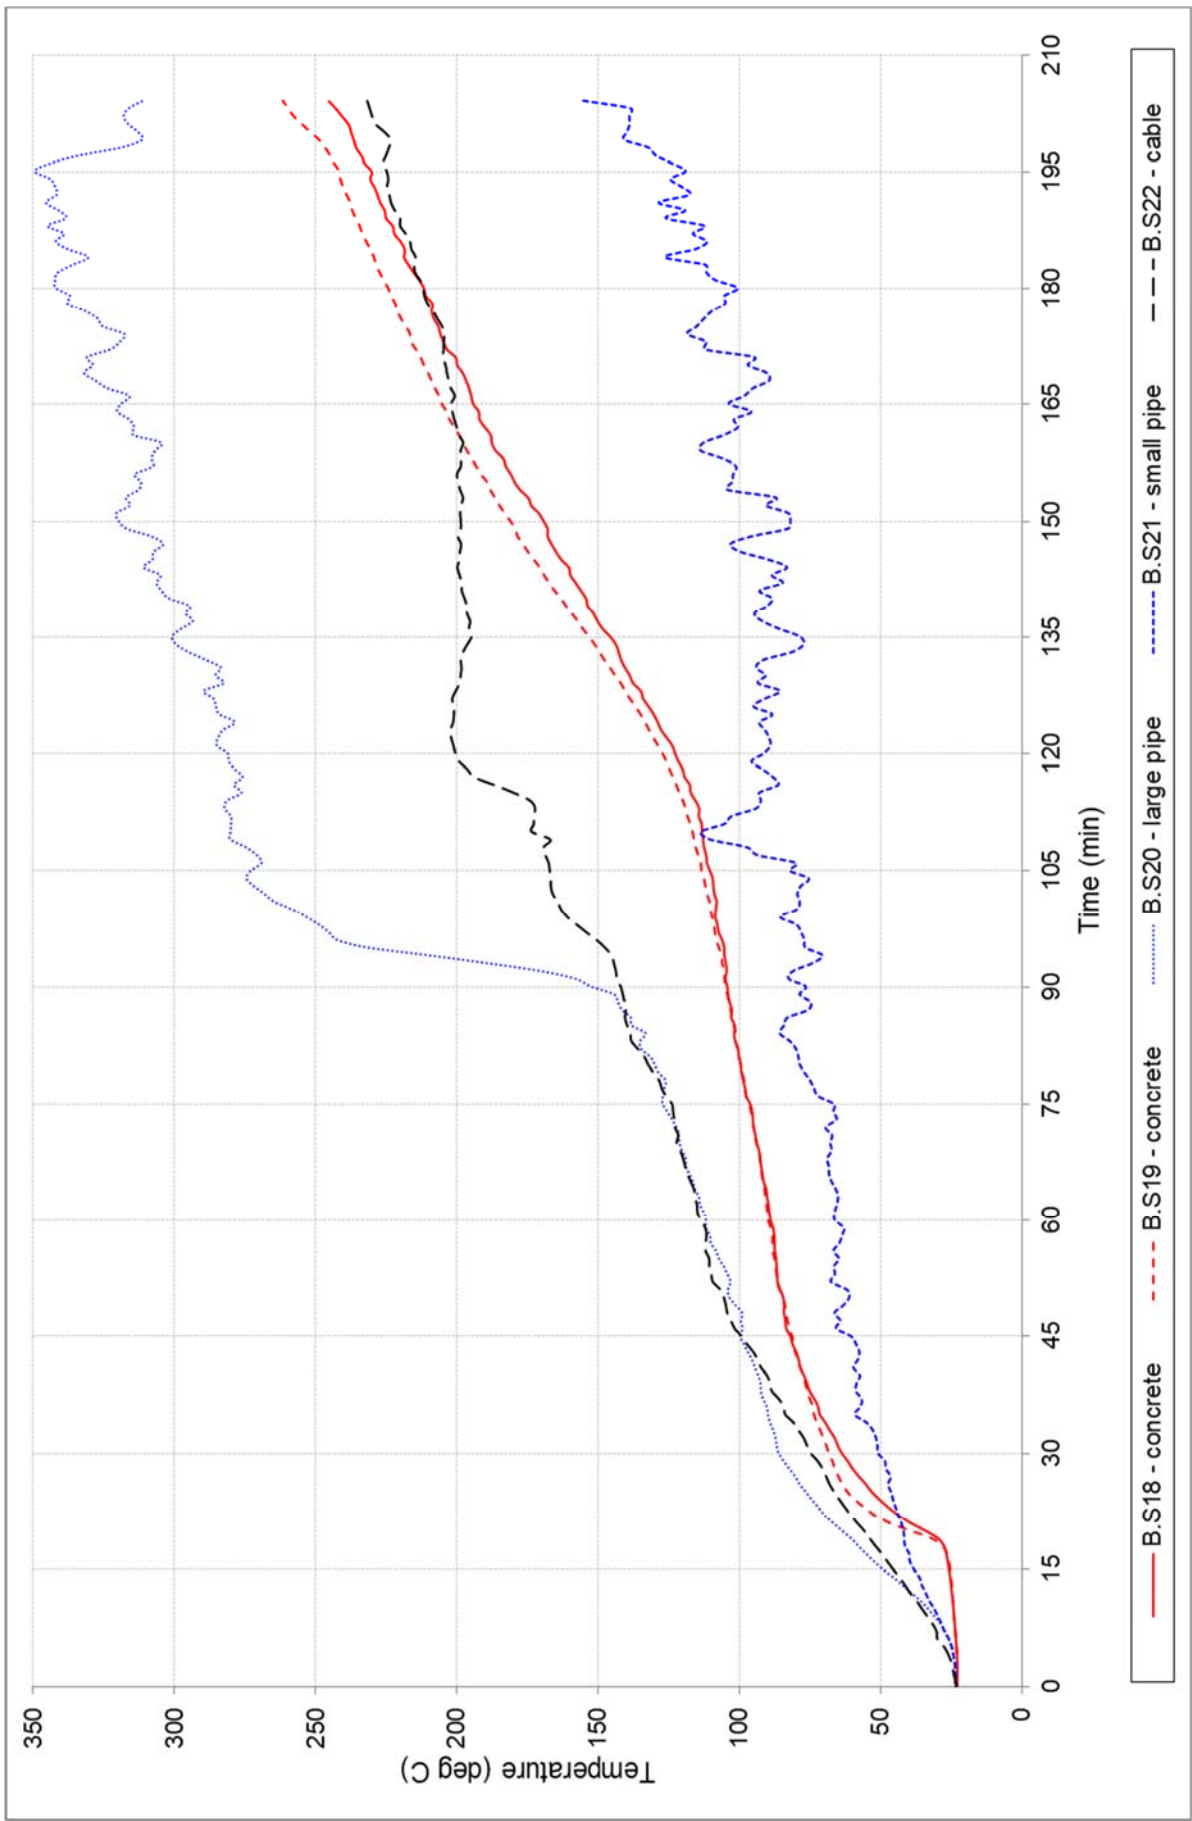
FIGURE 6 – SPECIMEN TEMPERATURE – ASSOCIATED WITH PENETRATION # 4

Figure 6 shows the curve of maximum temperature versus time associated with Penetration 4.

Structural adequacy	-	not applicable
Integrity	-	201 minutes
Insulation	-	94 minutes
