Fire-resistance test on fire collars protecting a plasterboard wall penetrated by services

Test Report

Author: Peter Gordon
Report number: FSP 1902
Date: 10 September 2018

Sponsored Investigation No. FSP 1902

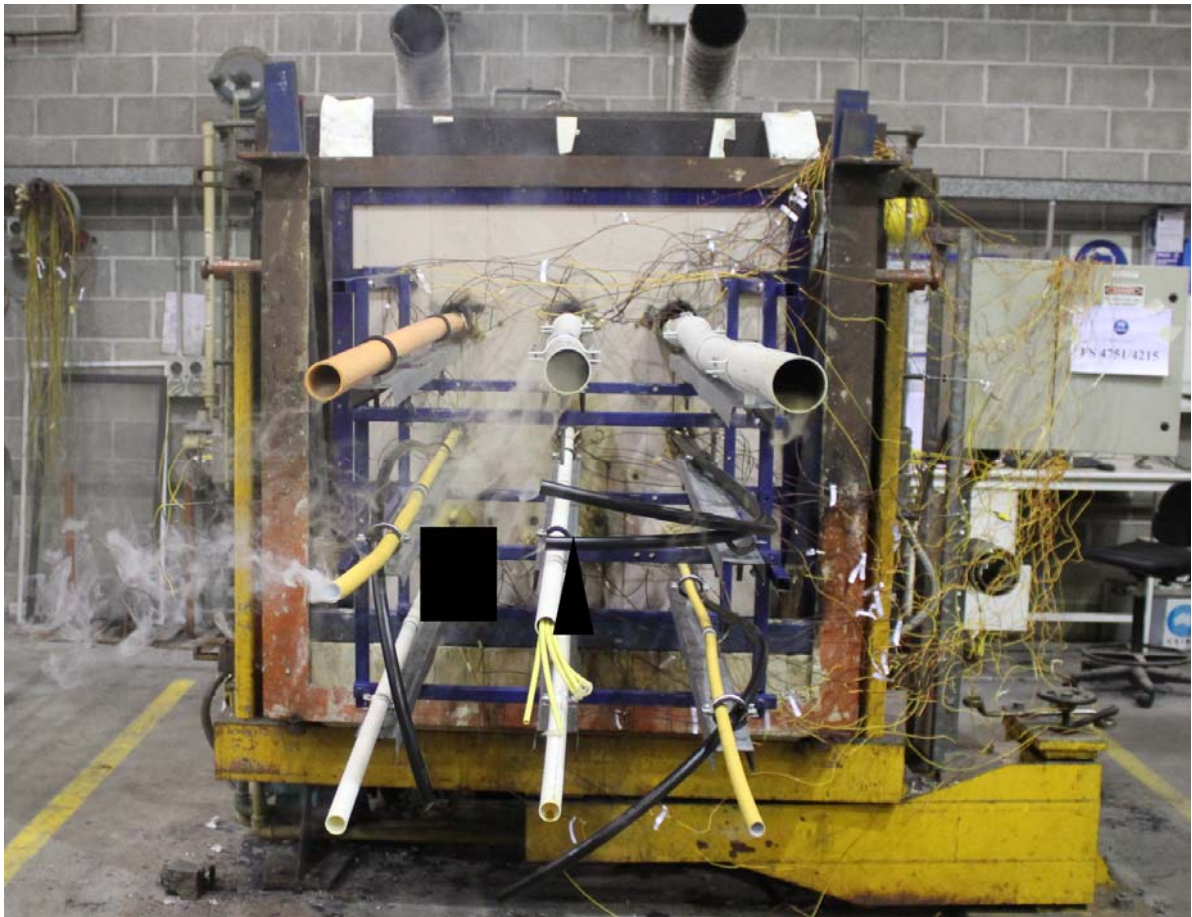
PHOTOGRAPH 7 – SPECIMENS AFTER 180 MINUTES OF TESTING

- 155 minutes - Pipes on Specimen 1, 2, 3 and 4 have continued to flue and emit smoke from collars.
- 167 minutes - Insulation Failure Penetration 6 – maximum temperature rise of 180K is exceeded on the pipe collar.

- 170 minutes - Insulation Failure Penetration 5 – maximum temperature rise of 180K is exceeded on the plasterboard wall 25-mm from the collar. The pipes on Specimen 6 have started to flue. Pipes on Specimen 1, 2, 3 and 4 have continued to flue. Fluid is dripping from the black pipe of Specimen 9.

- 175 minutes - Insulation Failure Penetration 4 – maximum temperature rise of 180K is exceeded on the plasterboard 25-mm from the pipe collar.
- 179 minutes - Insulation Failure Penetration 9 – maximum temperature rise of 180K is exceeded on the plasterboard 25-mm from the pipe collar.
