Fire-resistance test on fire collars protecting a floor/ceiling system penetrated by services

Test Report

Author: Chris Wojcik
Report number: FSP 1906

Sponsored Investigation No. FSP 1906

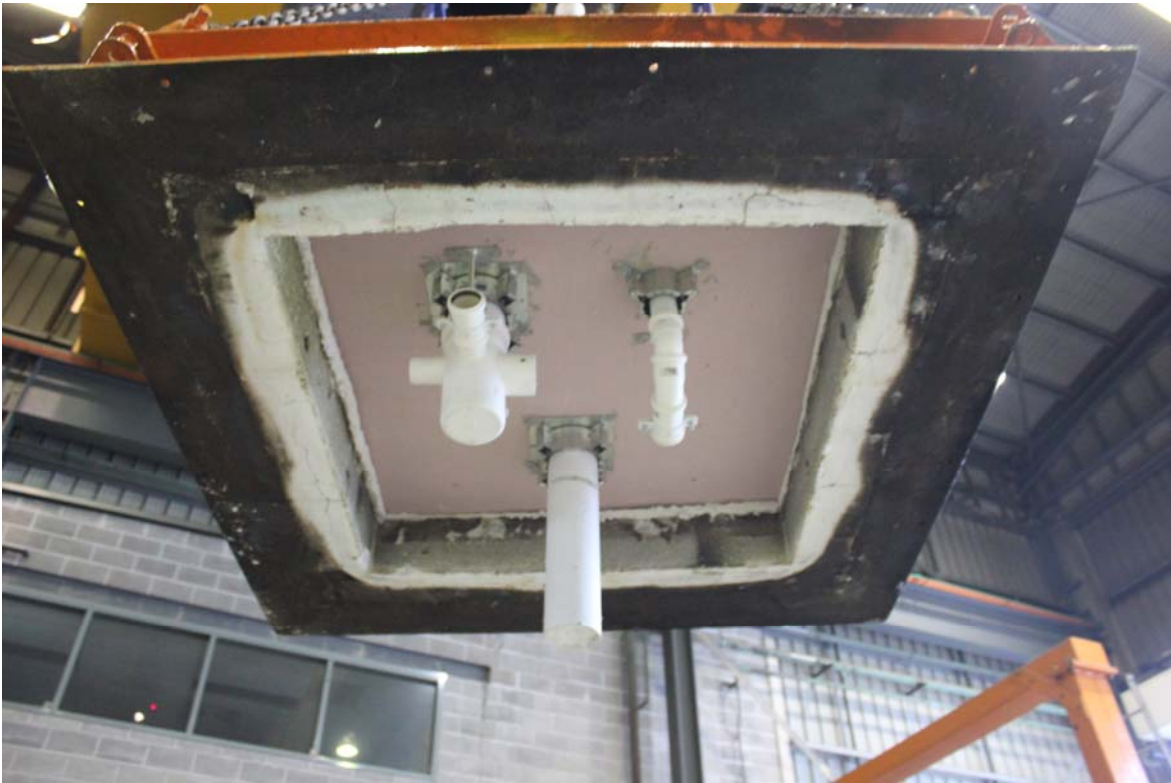
PHOTOGRAPH 1 – EXPOSED FACE OF SPECIMENS PRIOR TO TESTING

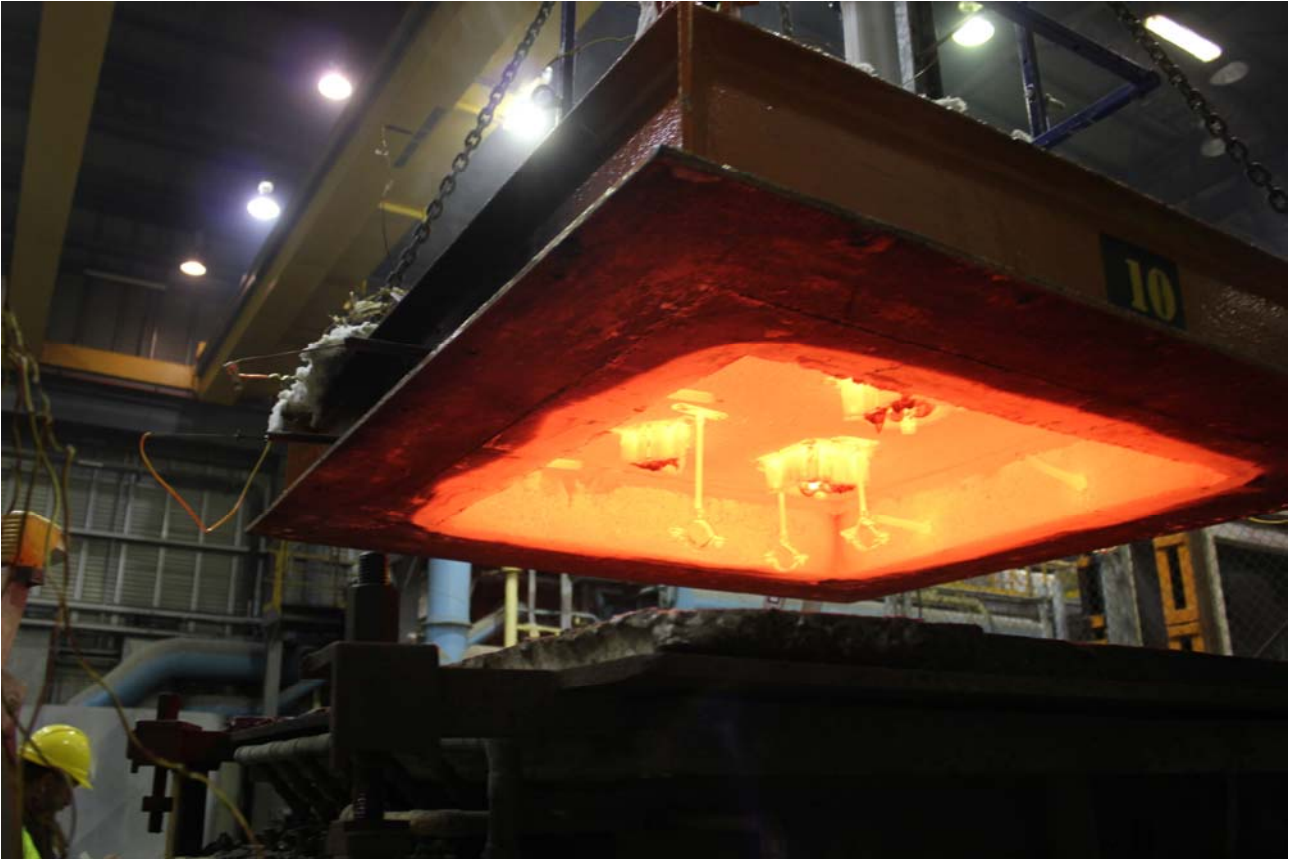
PHOTOGRAPH 5 – EXPOSED FACE OF SPECIMENS AT CONCLUSION OF TESTING
