# Fire-resistance test on fire collars protecting a concrete floor slab penetrated by services

## Test Report

**Author:** Peter Gordon  
**Report number:** FSP 2002  
**Date:** 26 June 2019

## Sponsored Investigation No. FSP 2002

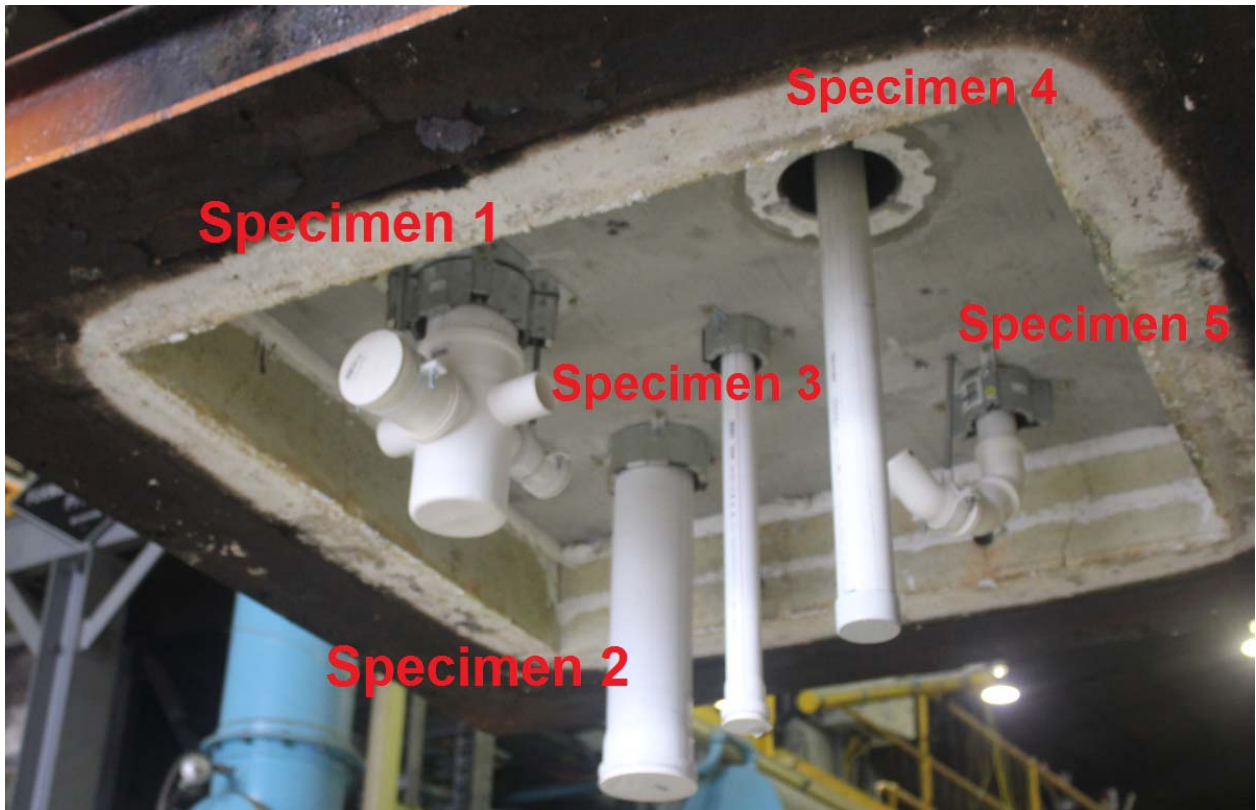
**PHOTOGRAPH 1 – EXPOSED FACE OF SPECIMENS PRIOR TO TESTING**

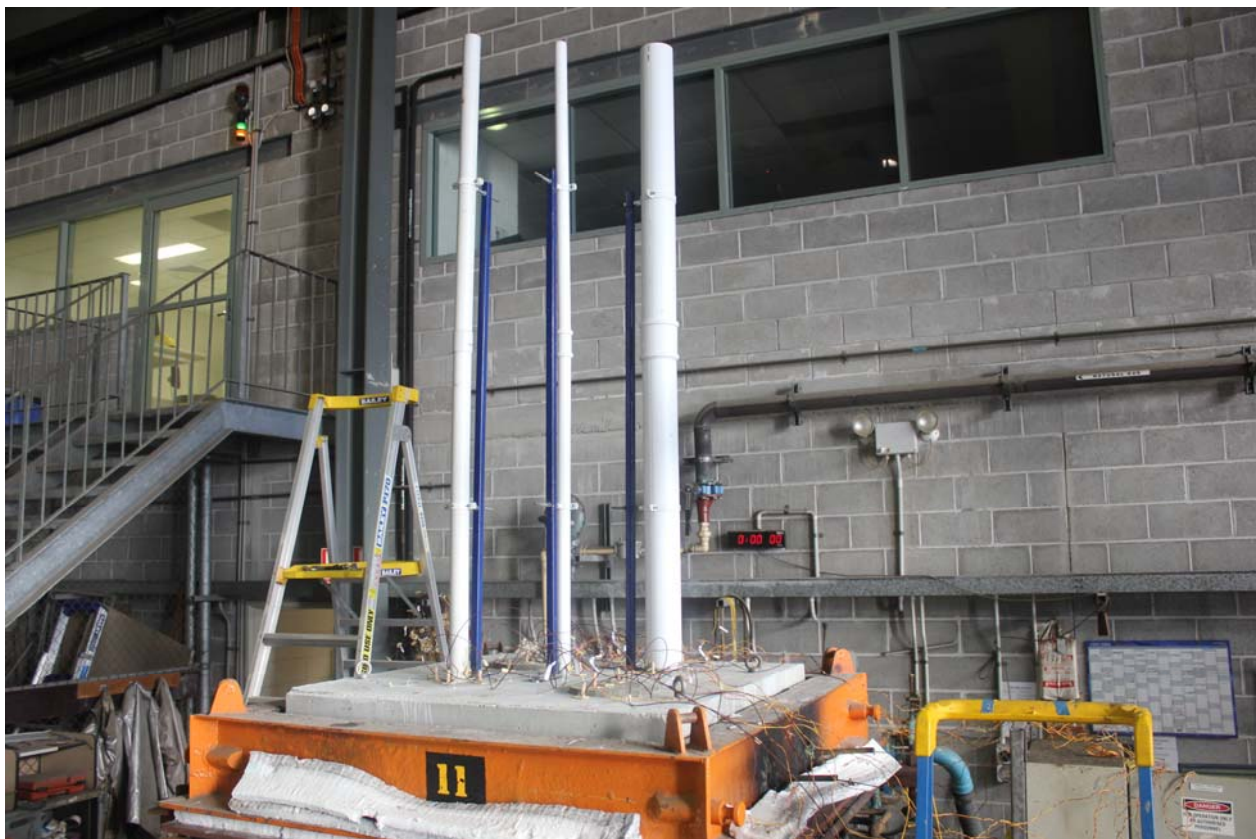
**PHOTOGRAPH 2 – UNEXPOSED FACE OF SPECIMENS PRIOR TO TESTING**

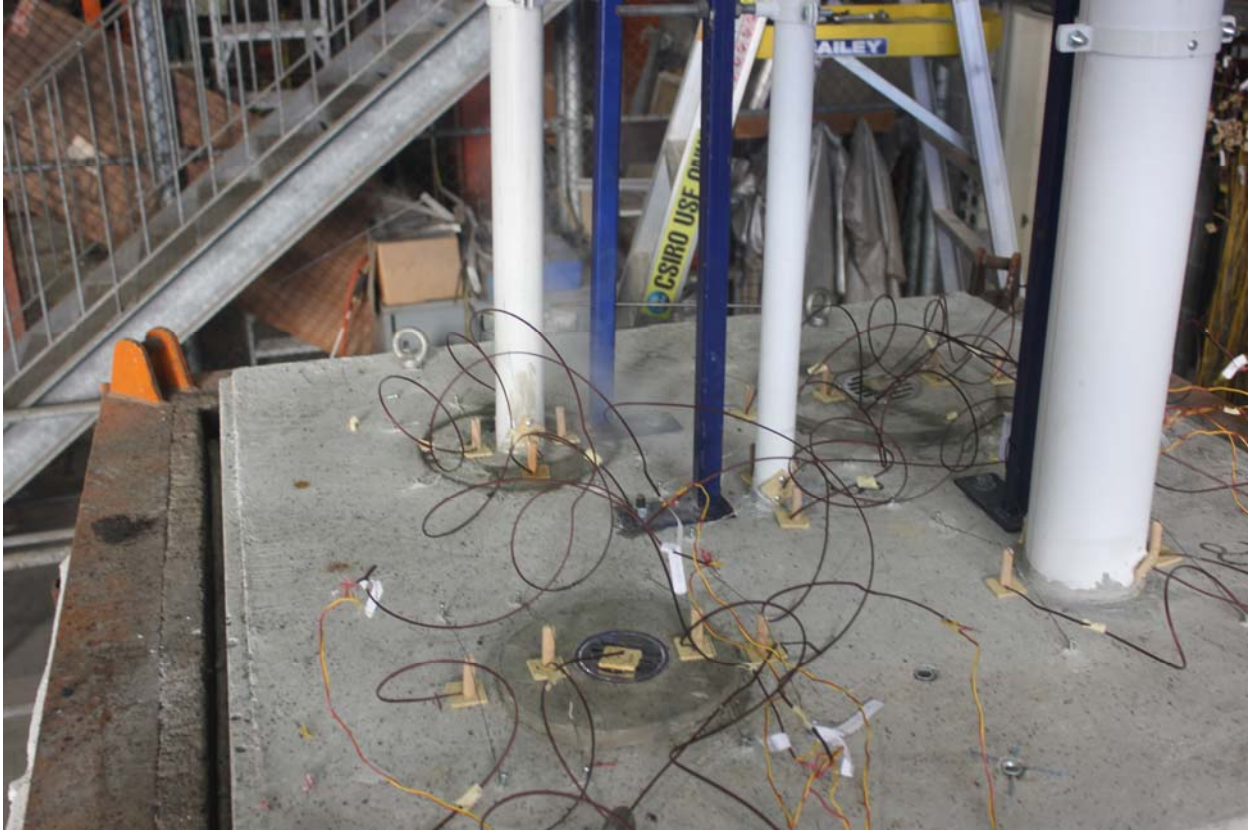
**PHOTOGRAPH 3 – SPECIMENS AFTER 18 MINUTES OF TESTING**

- 18 minutes - Steam is being emitted from the concrete at the base of Specimen 4 with water pooling on the concrete and grout.
- 30 minutes - Steam is being emitted around the base of Specimen 3 and both floor wastes of Specimens 1 and 5. A small amount of smoke is fluing from stack pipe of Specimen 3.

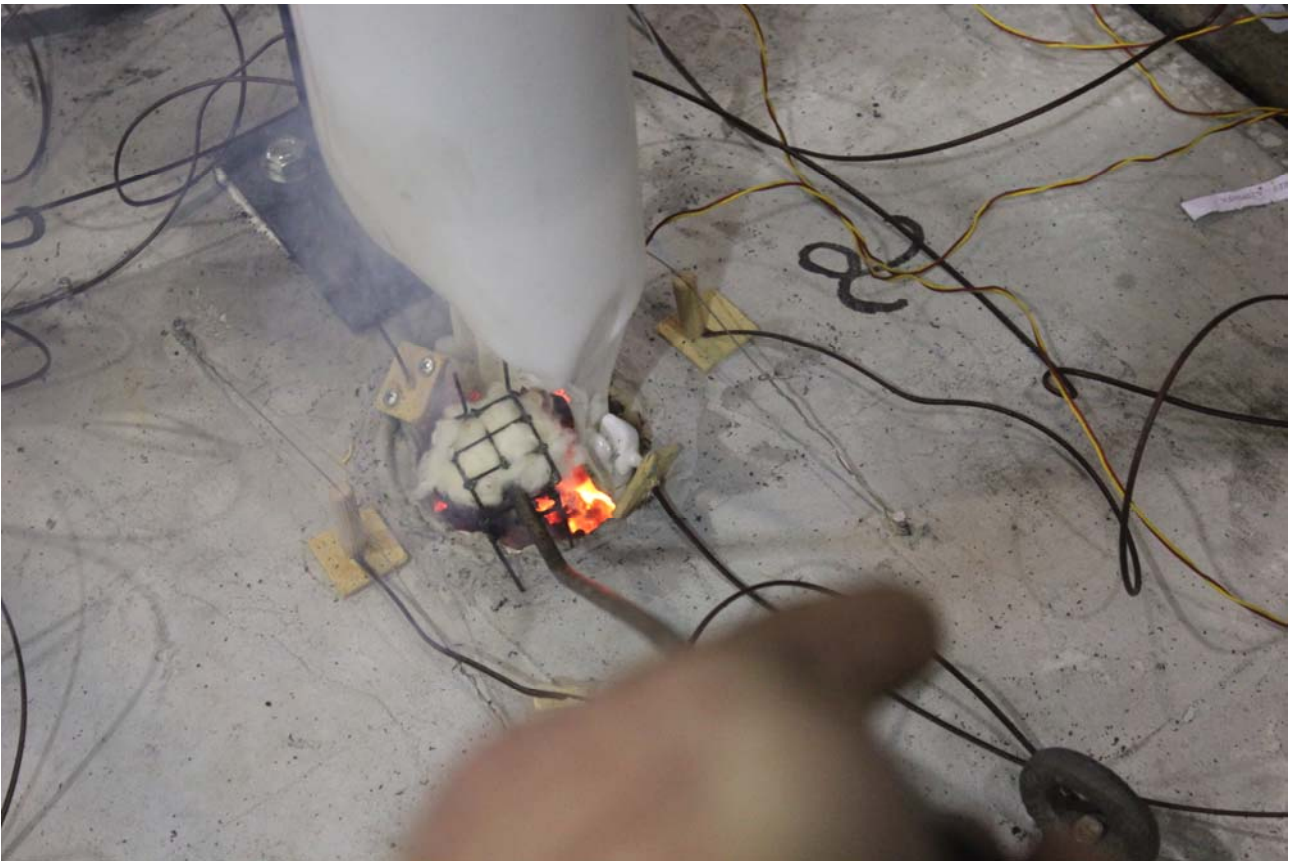
**PHOTOGRAPH 7 – SPECIMEN 2 AFTER 119 MINUTES OF TESTING**

- 106 minutes - Large gaps around the base of Specimen 2 have developed where the pipe has soften and deformed exposing a red glow from the intumescent material inside the collar. Cotton wool pad test applied over the gap, no ignition noted at this time.

- 113 minutes - Molten plastic from the base of Specimen 2 pipe is dripping down onto the intumescent material of the collar below.
- 114 minutes - Insulation failure of Specimen 2 - maximum temperature rise of 180K is exceeded on the pipe 25-mm above the mastic on the unexposed face.

- 119 minutes - Cotton wool pad test applied above the gap at the base of Specimen 2, no ignition noted at this time.
- 149 minutes - Thermocouple wires #16 and #20 located close to the gaps formed from Specimen 2 have been affected by heat and should be disregarded.

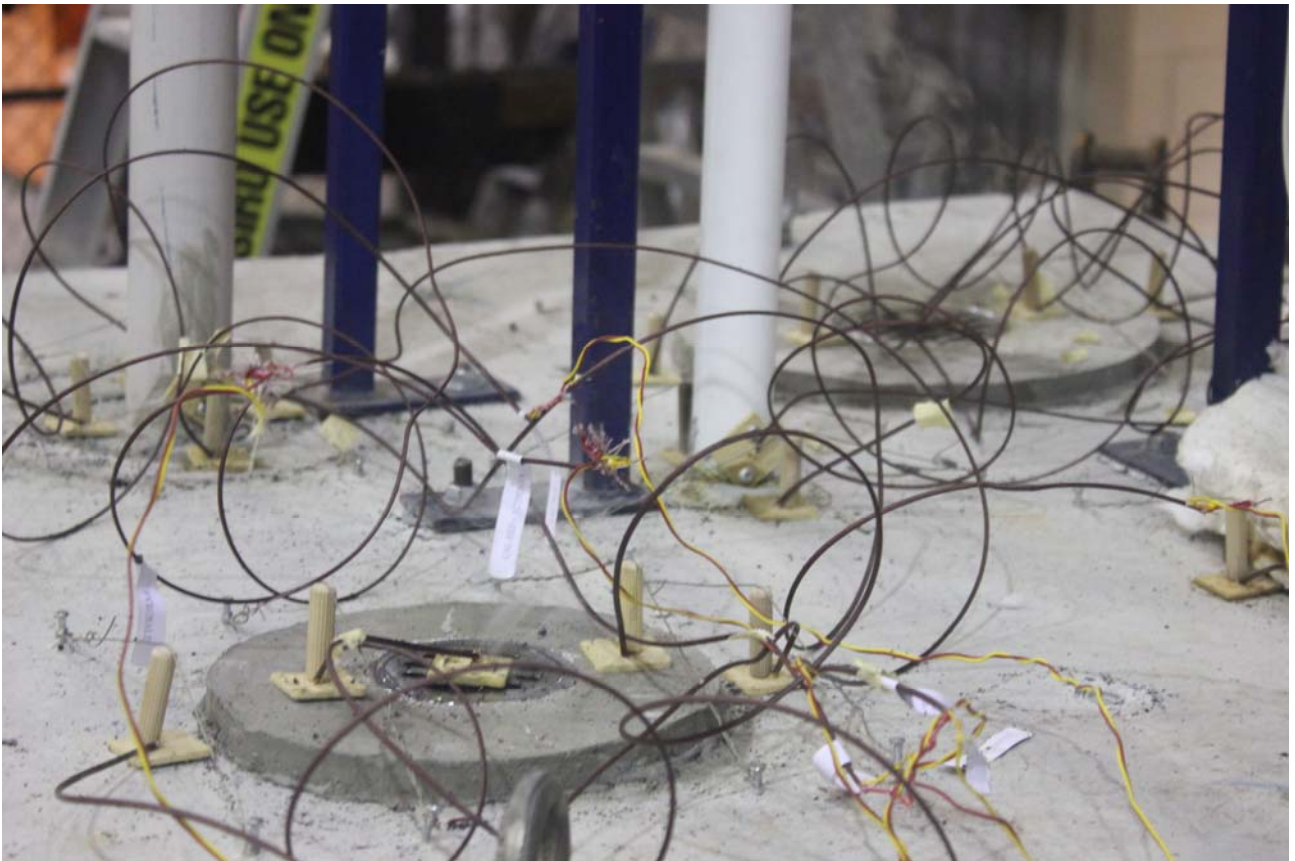
**PHOTOGRAPH 11 – UNEXPOSED FACED OF SPECIMEN AT THE CONCLUSION OF TESTING**

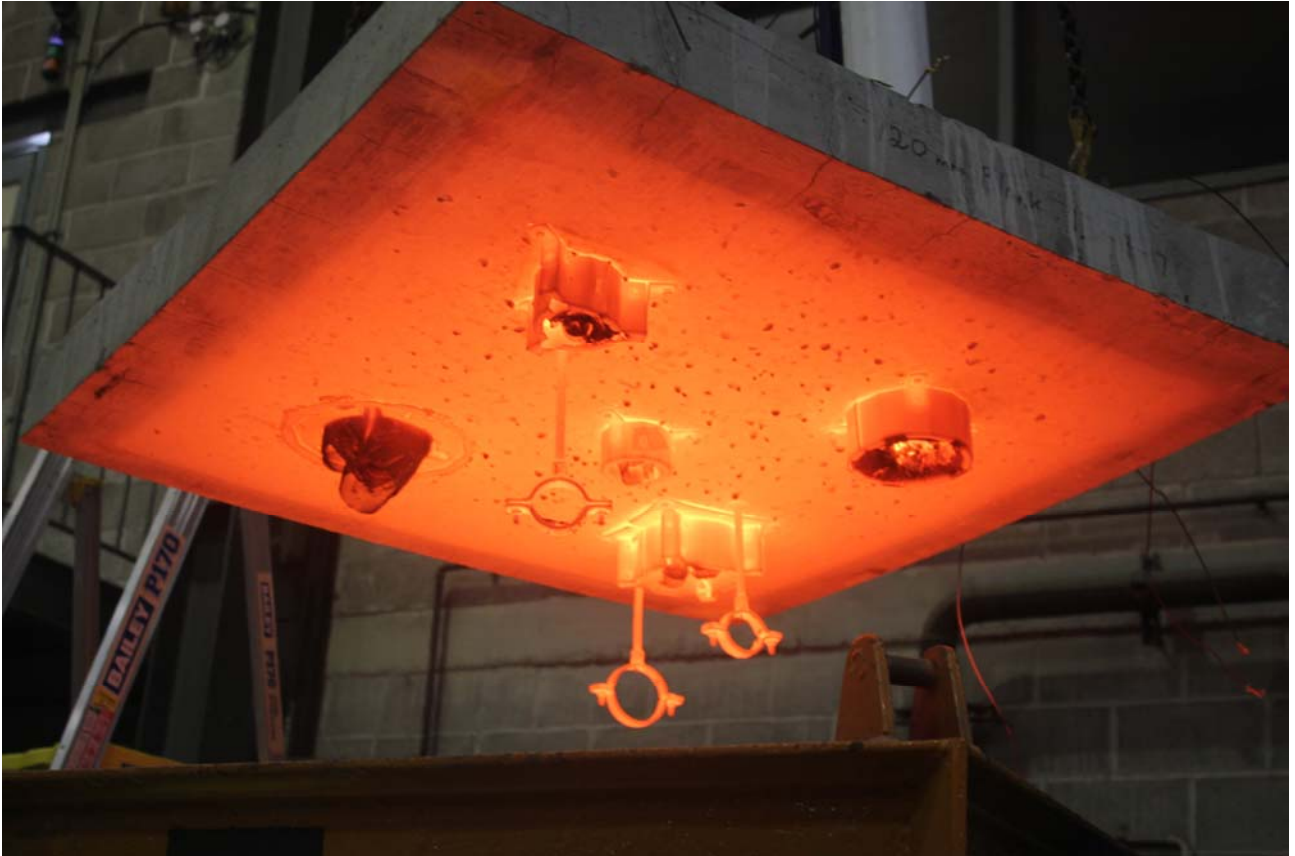
**PHOTOGRAPH 12 – EXPOSED FACE OF SPECIMENS AT THE CONCLUSION OF TESTING**

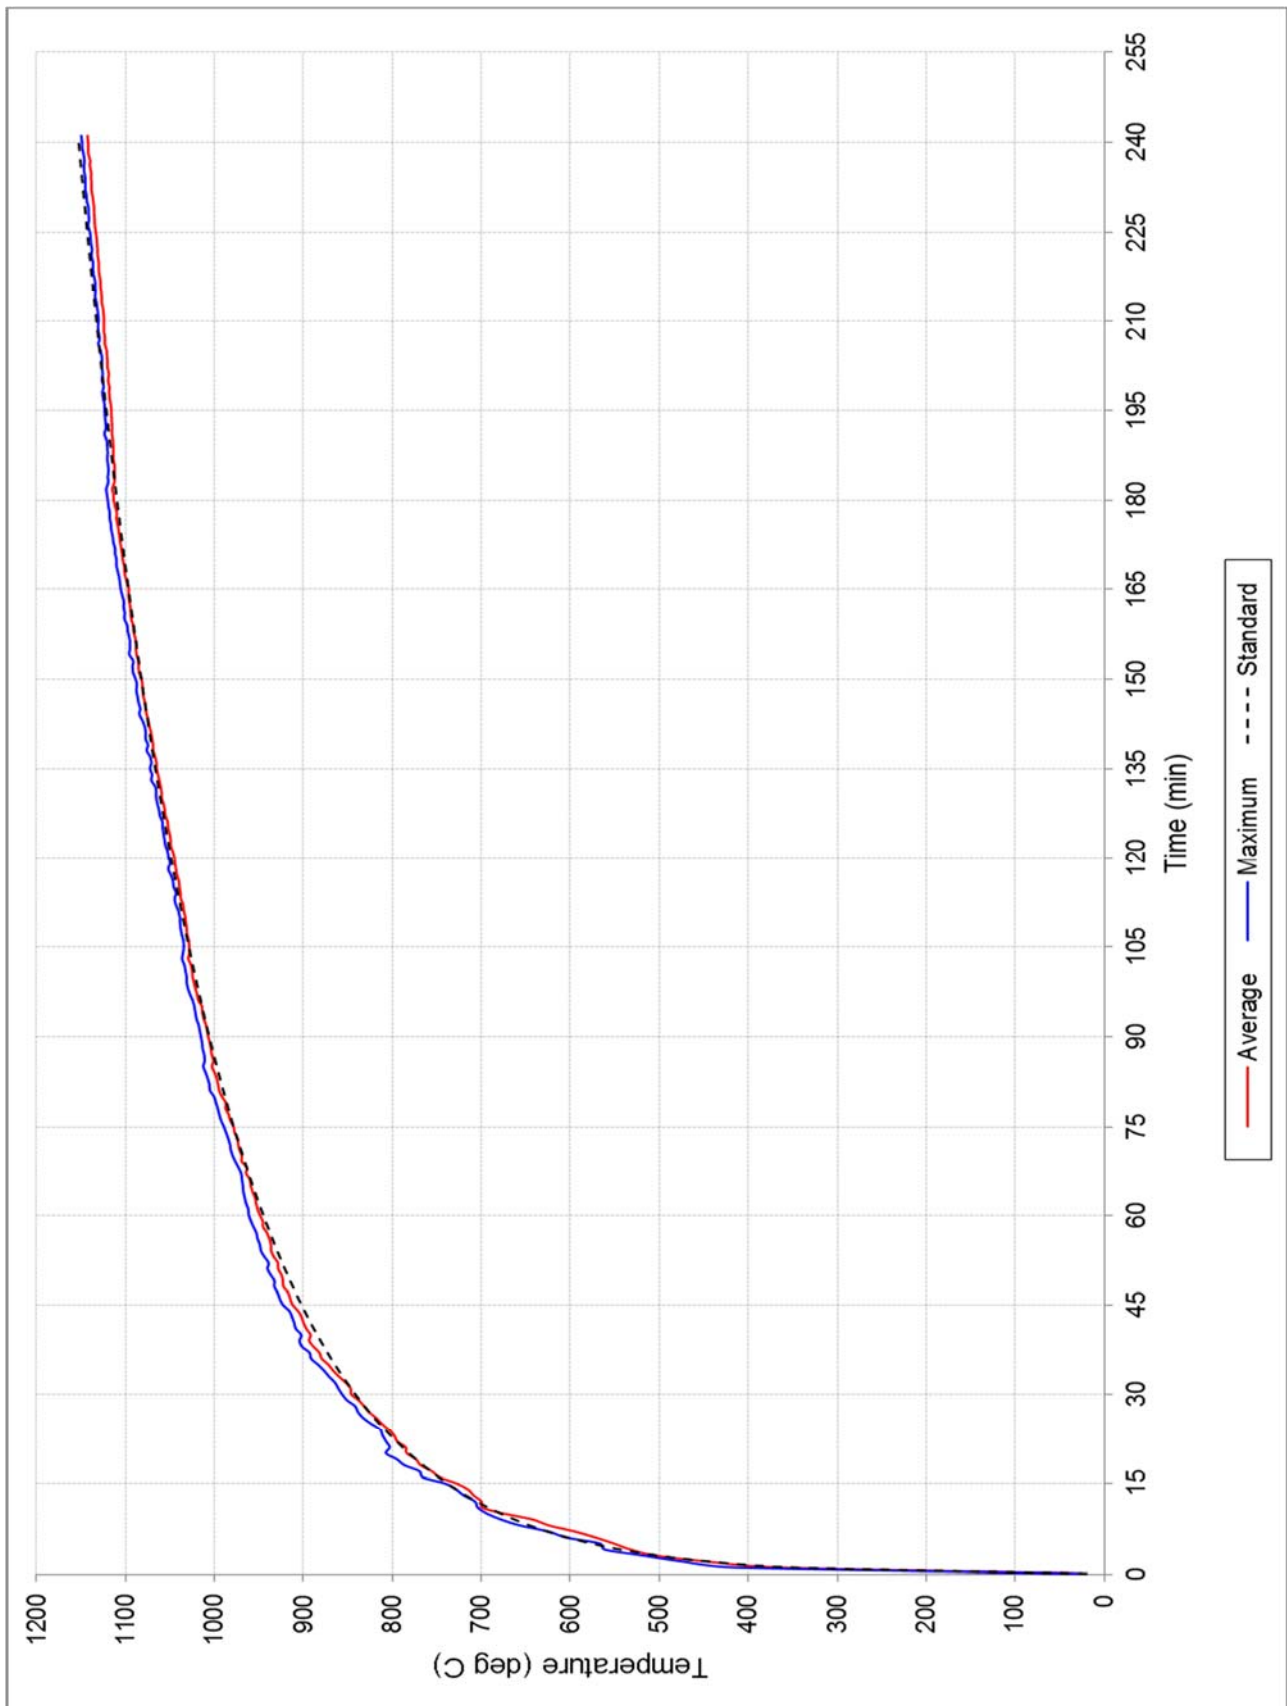
FIGURE 1 – FURNACE TEMPERATURE

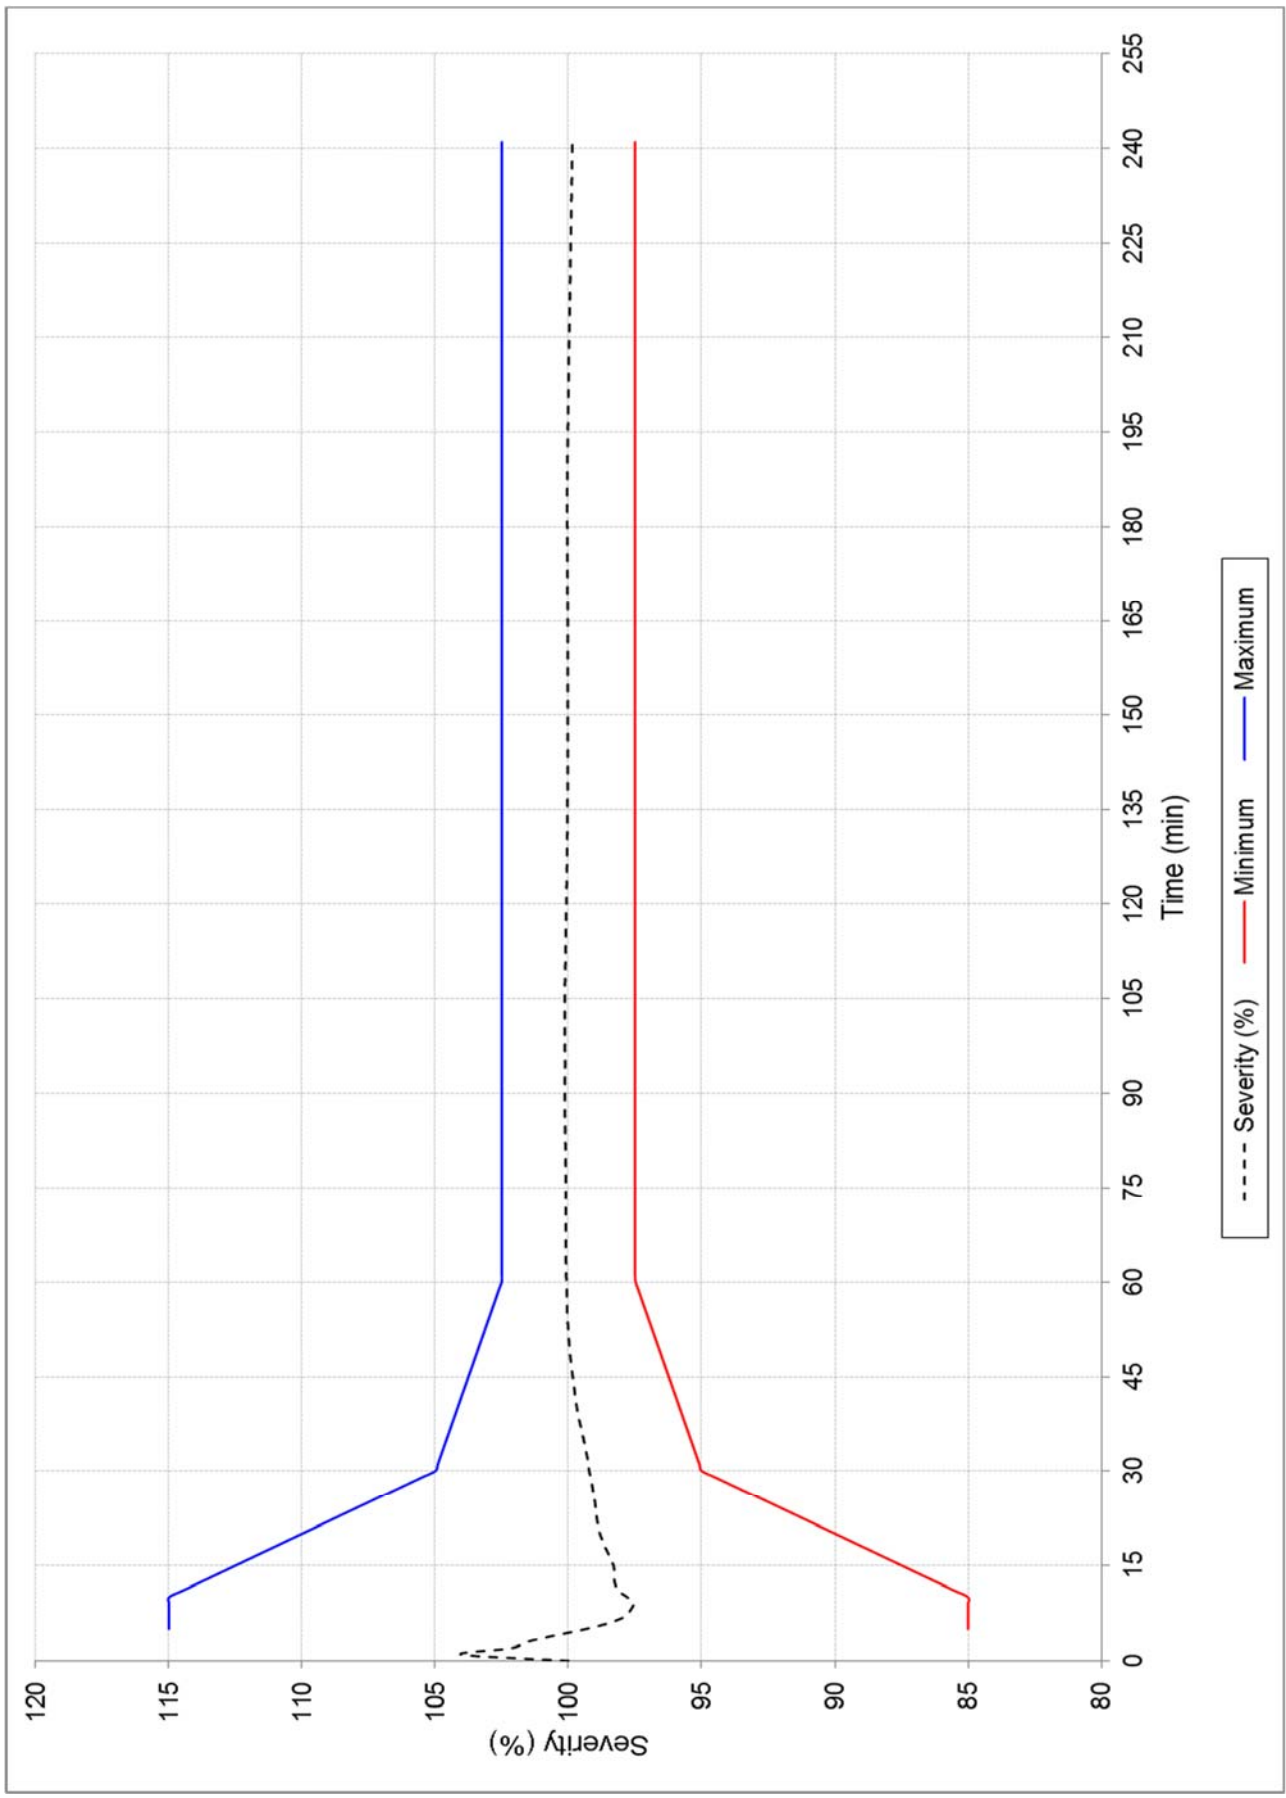
FIGURE 2 – FURNACE SEVERITY

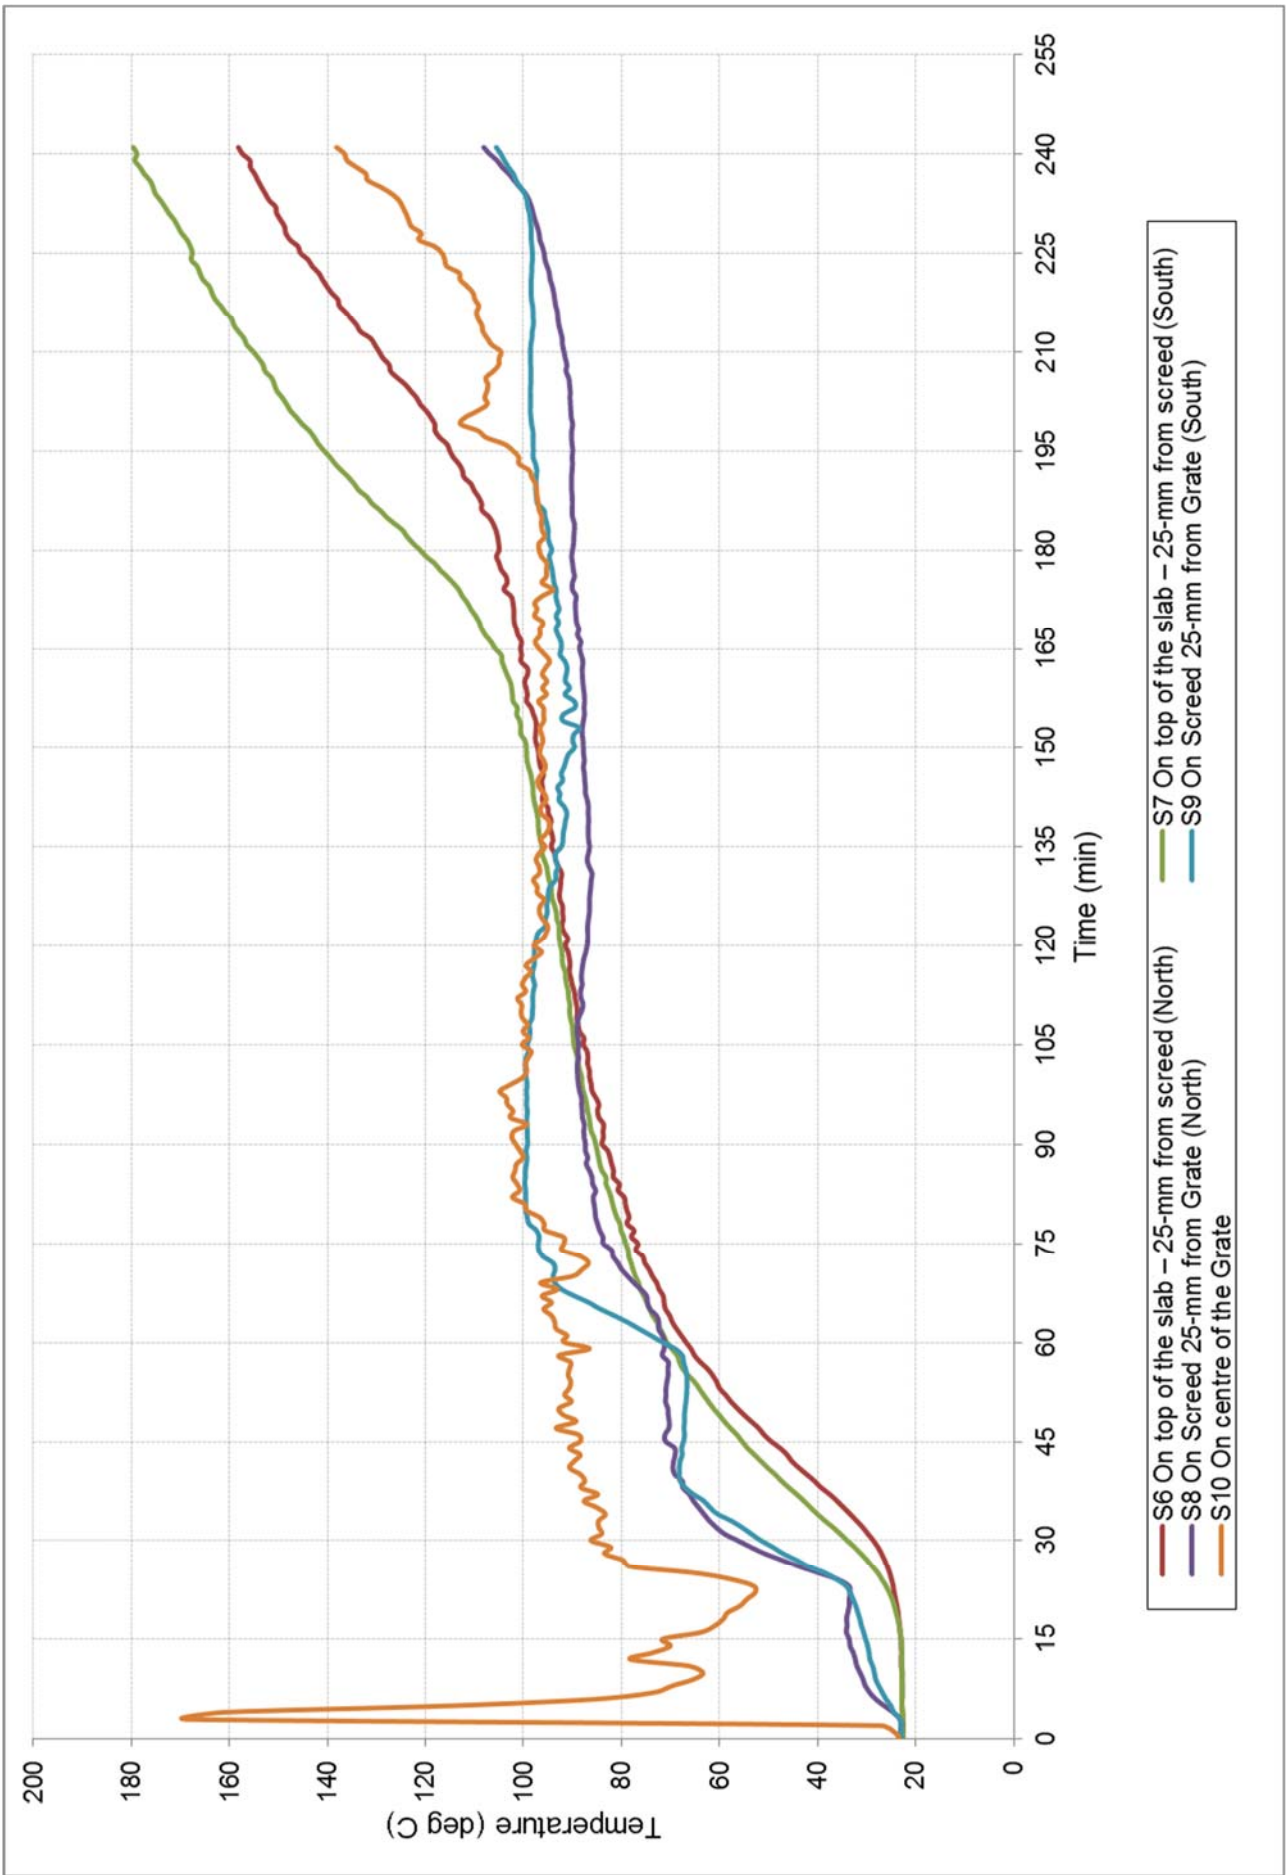
FIGURE 3 – SPECIMEN TEMPERATURE – ASSOCIATED WITH SPECIMEN 1

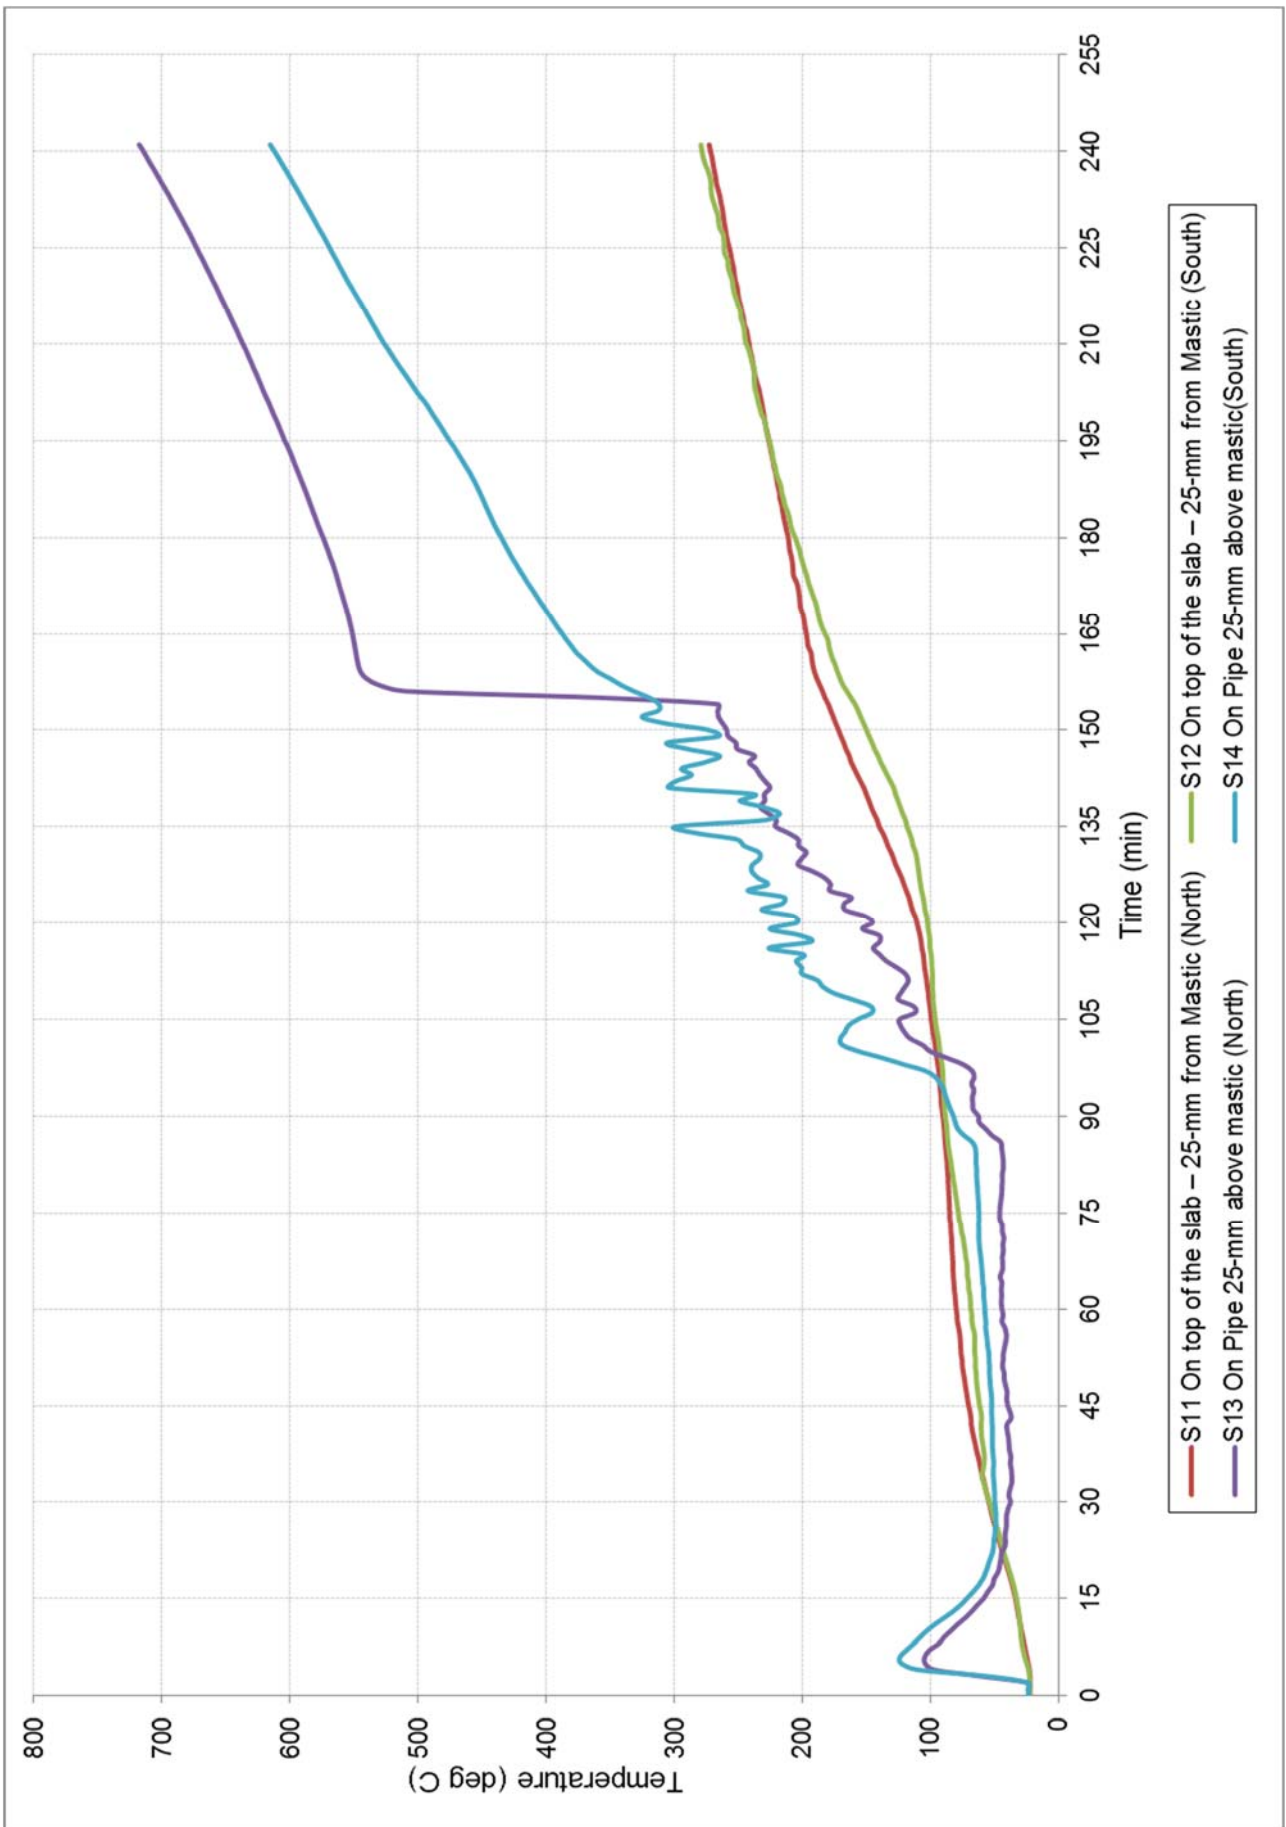
FIGURE 4 – SPECIMEN TEMPERATURE – ASSOCIATED WITH SPECIMEN 2

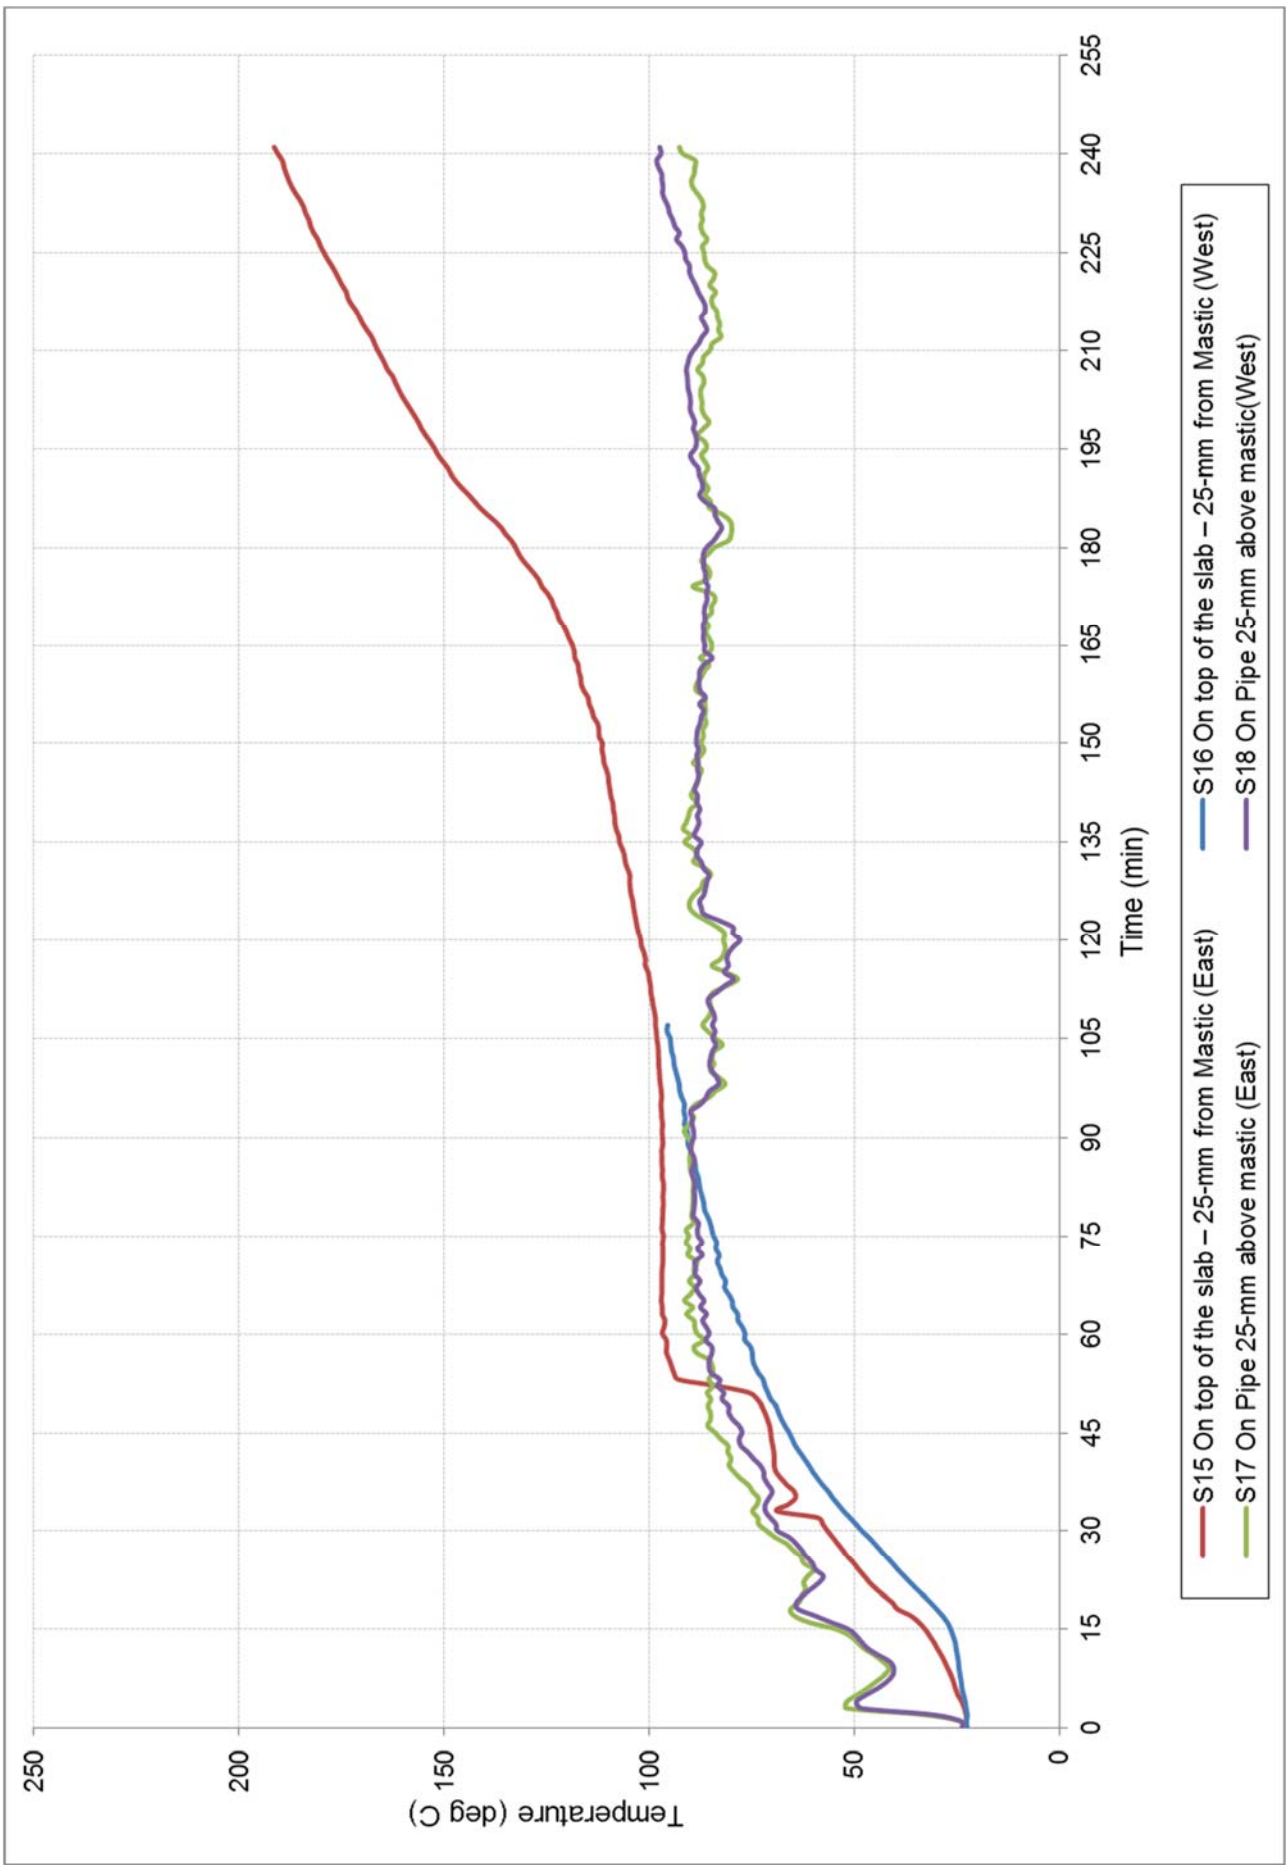
FIGURE 5 – SPECIMEN TEMPERATURE – ASSOCIATED WITH SPECIMEN 3

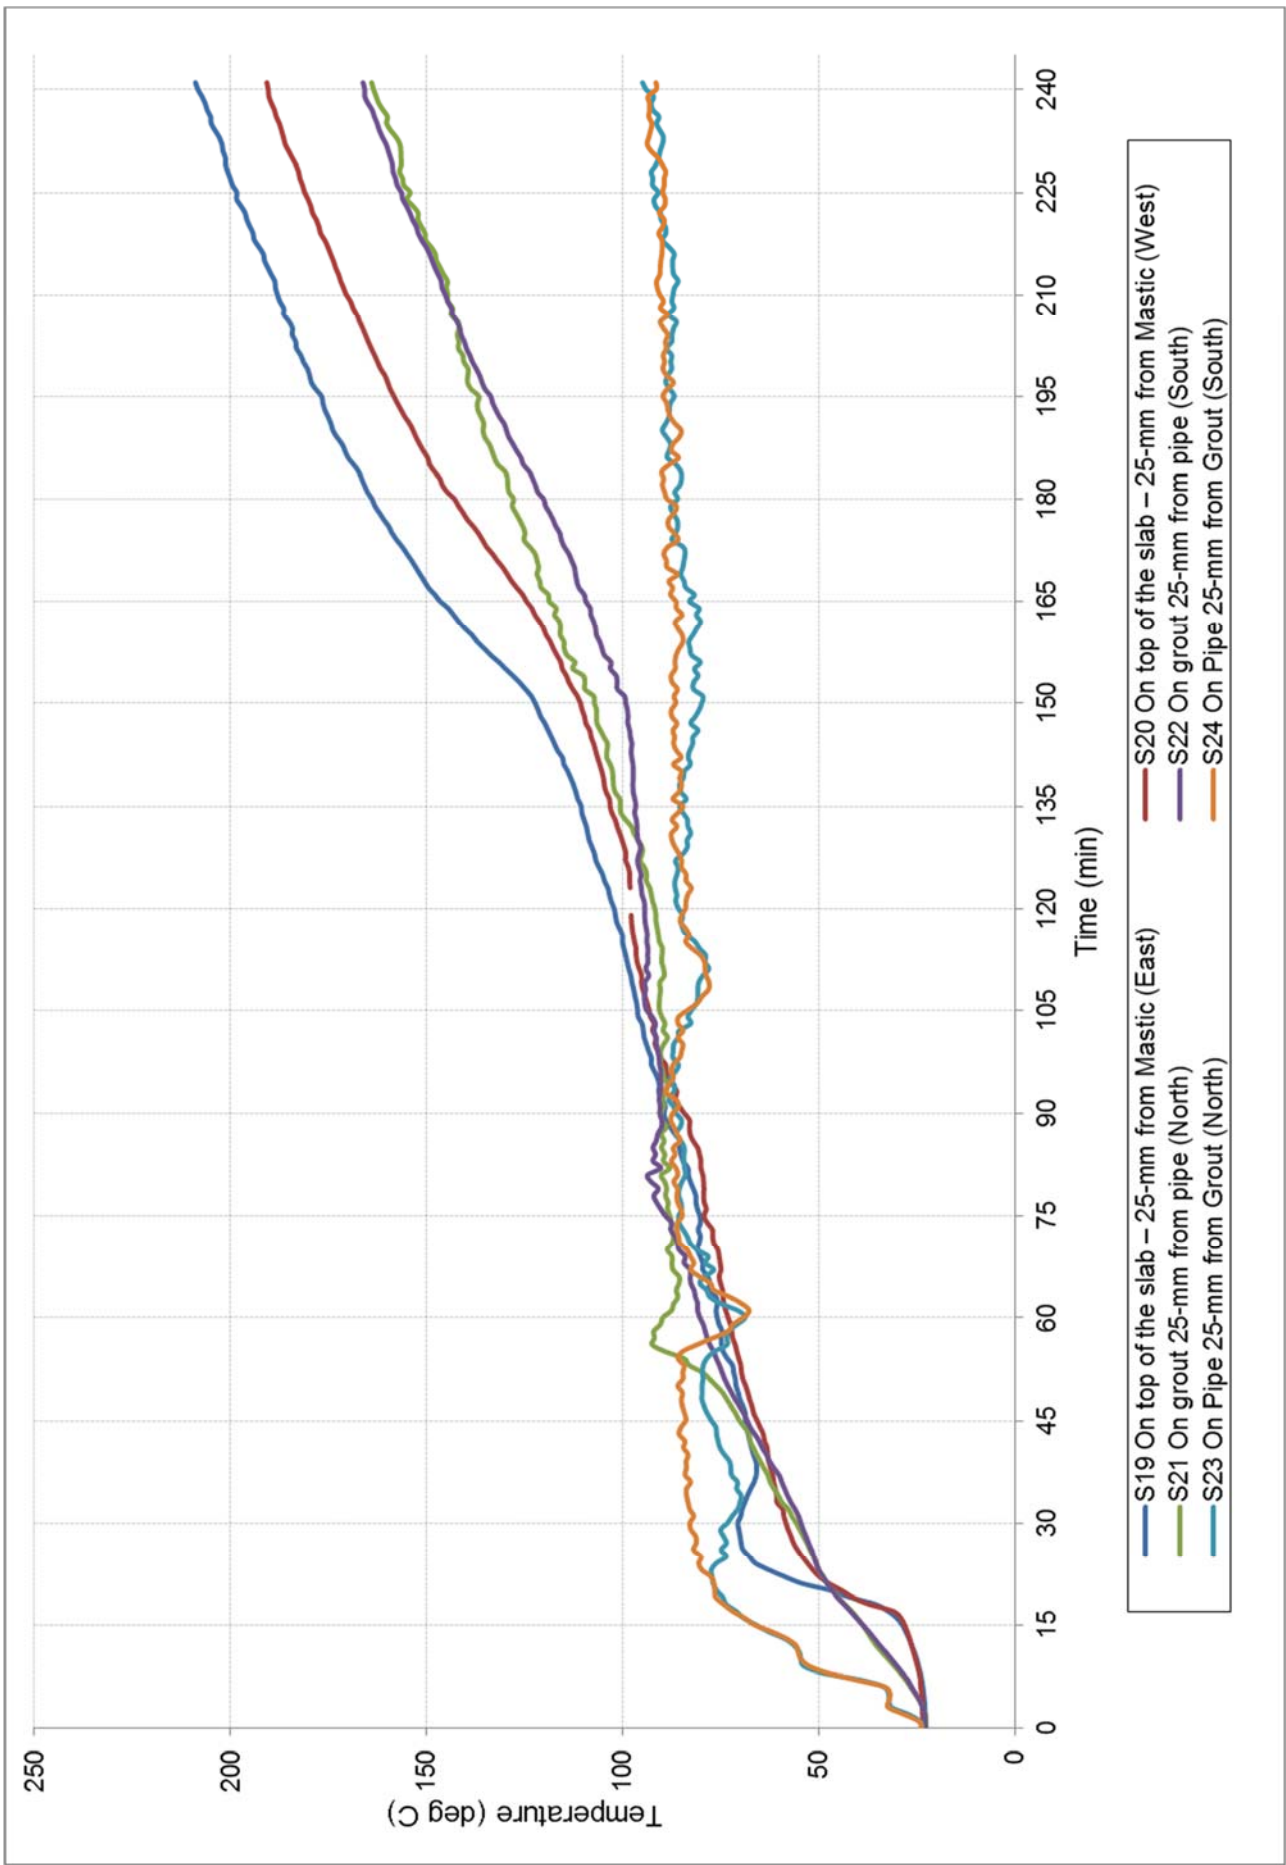
FIGURE 6 – SPECIMEN TEMPERATURE – ASSOCIATED WITH SPECIMEN 4

- 234 minutes - Insulation failure of Specimen 4 - maximum temperature rise of 180K is exceeded on the slab 25-mm from mastic on the unexposed face.
- 236 minutes - Smoke continues to flue from Specimens 1, 3 and 5.
