# Fire-resistance test on fire collars protecting a concrete floor slab penetrated by services

## Test Report

**Author:** Peter Gordon  
**Report number:** FSP 2002  
**Date:** 26 June 2019

## Sponsored Investigation No. FSP 2002

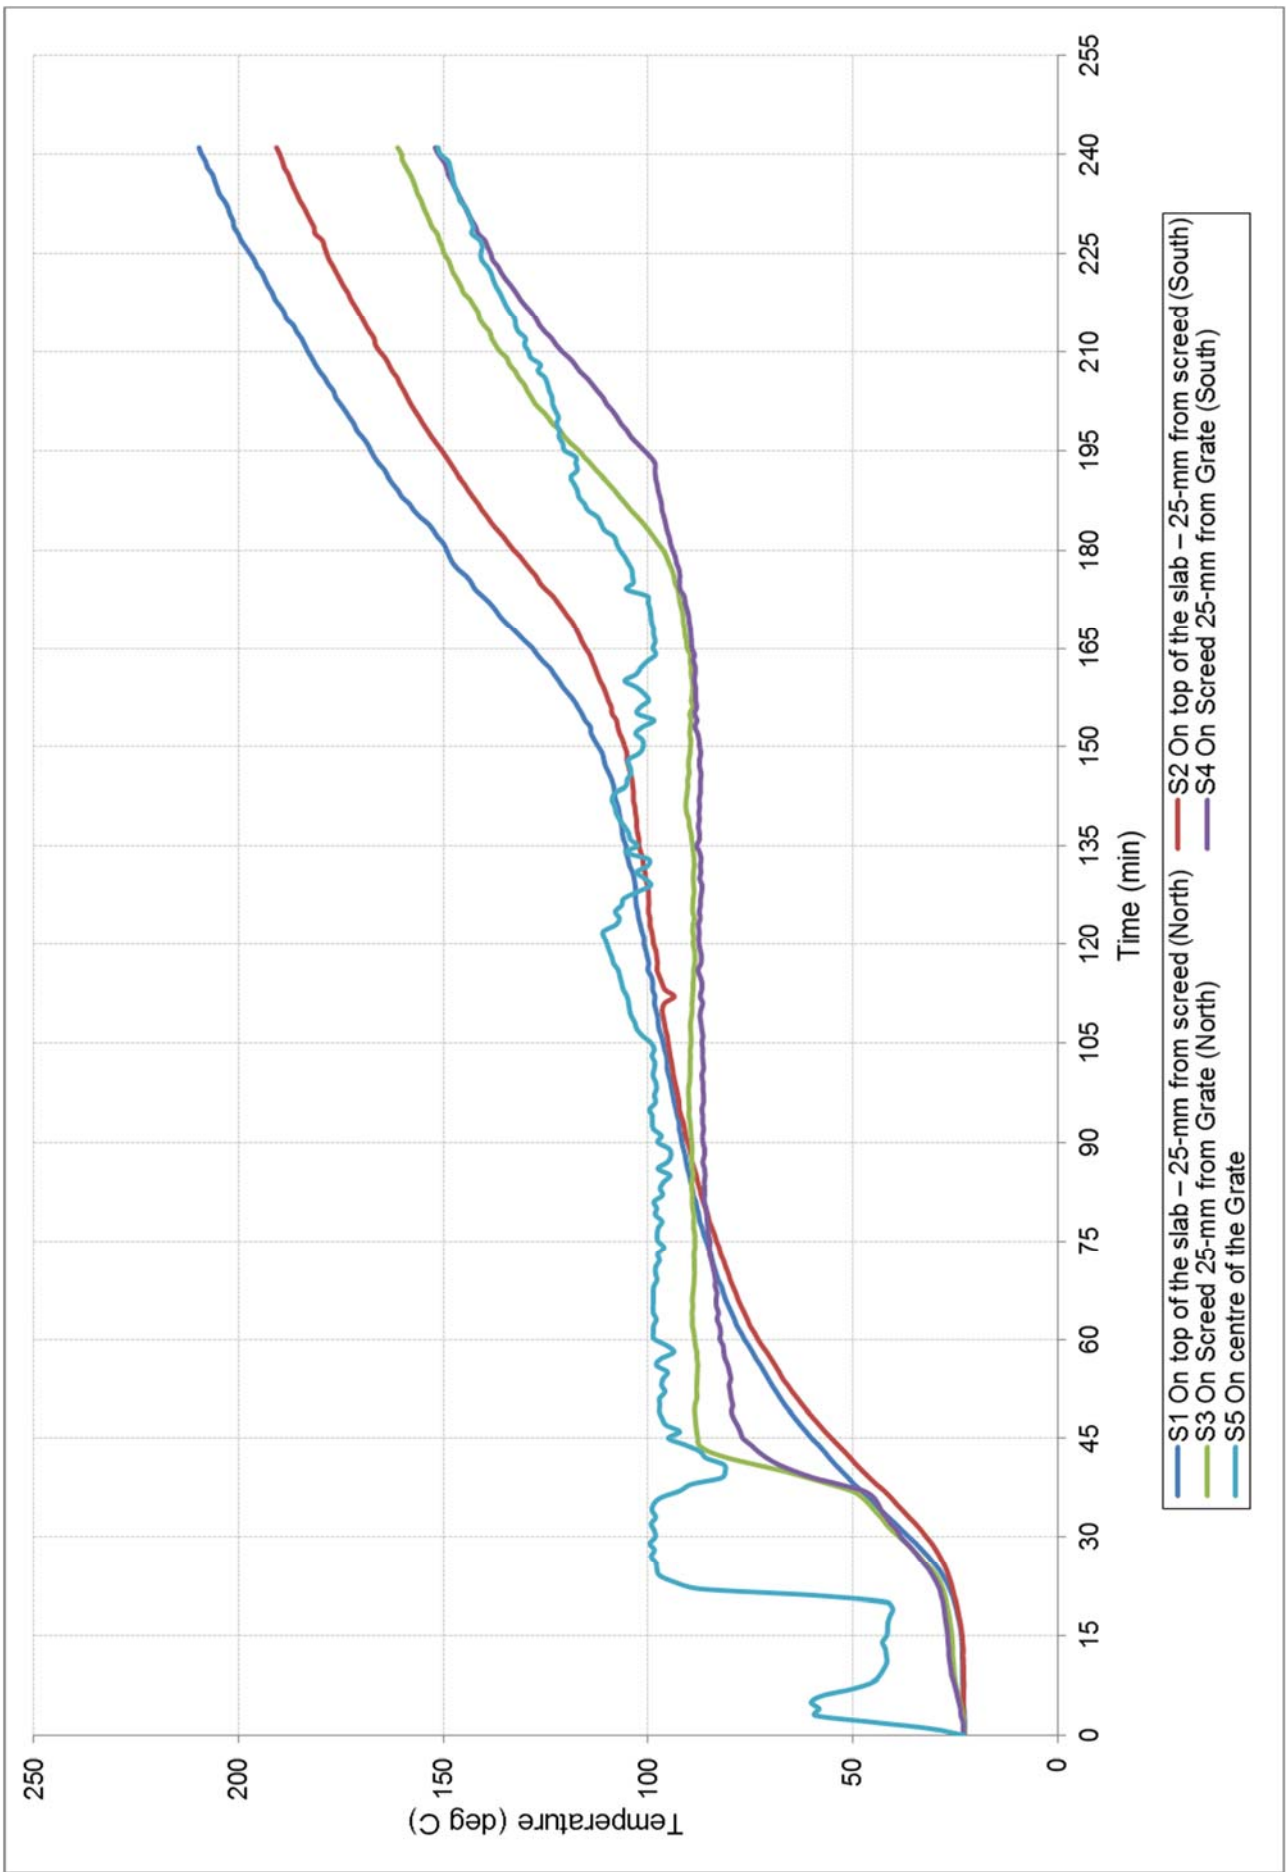
FIGURE 7 – SPECIMEN TEMPERATURE – ASSOCIATED WITH SPECIMEN 5

- 183 minutes - Smoke is fluing from Specimens 1, 3 and 5.
- 233 minutes - Insulation failure of Specimen 5 - maximum temperature rise of 180K is exceeded on the slab 25-mm from mastic on the unexposed face.

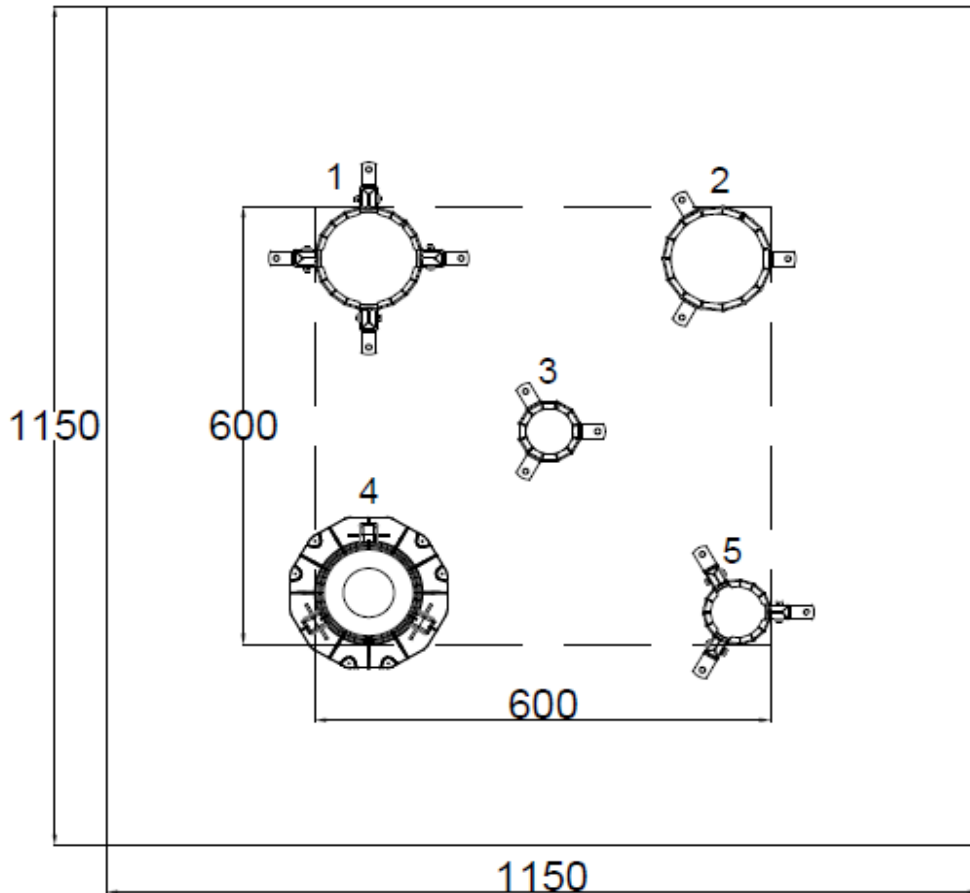
Test Slab S-19-B Layout

Penetration	Collar Code	Pipe Type	Pipe Diameter (mm)	Sealant
1	LP100R-D	Raupiano	110	-
2	110R	Raupiano	110	Firesound
3	50R	Raupiano	40	Firesound
4	H100S-RR	PVC	50	Firesound
5	LP50R	Raupiano	50	Firesound

**DRAWING TITLED "TEST SLAB S-19-B LAYOUT", DATED 19 MARCH 2019, PROVIDED BY SNAP FIRE SYSTEMS PTY LTD**

Drawing titled "Test Slab S-19-B Layout", dated 19 March 2019 provided by Snap Fire Systems Pty Ltd.

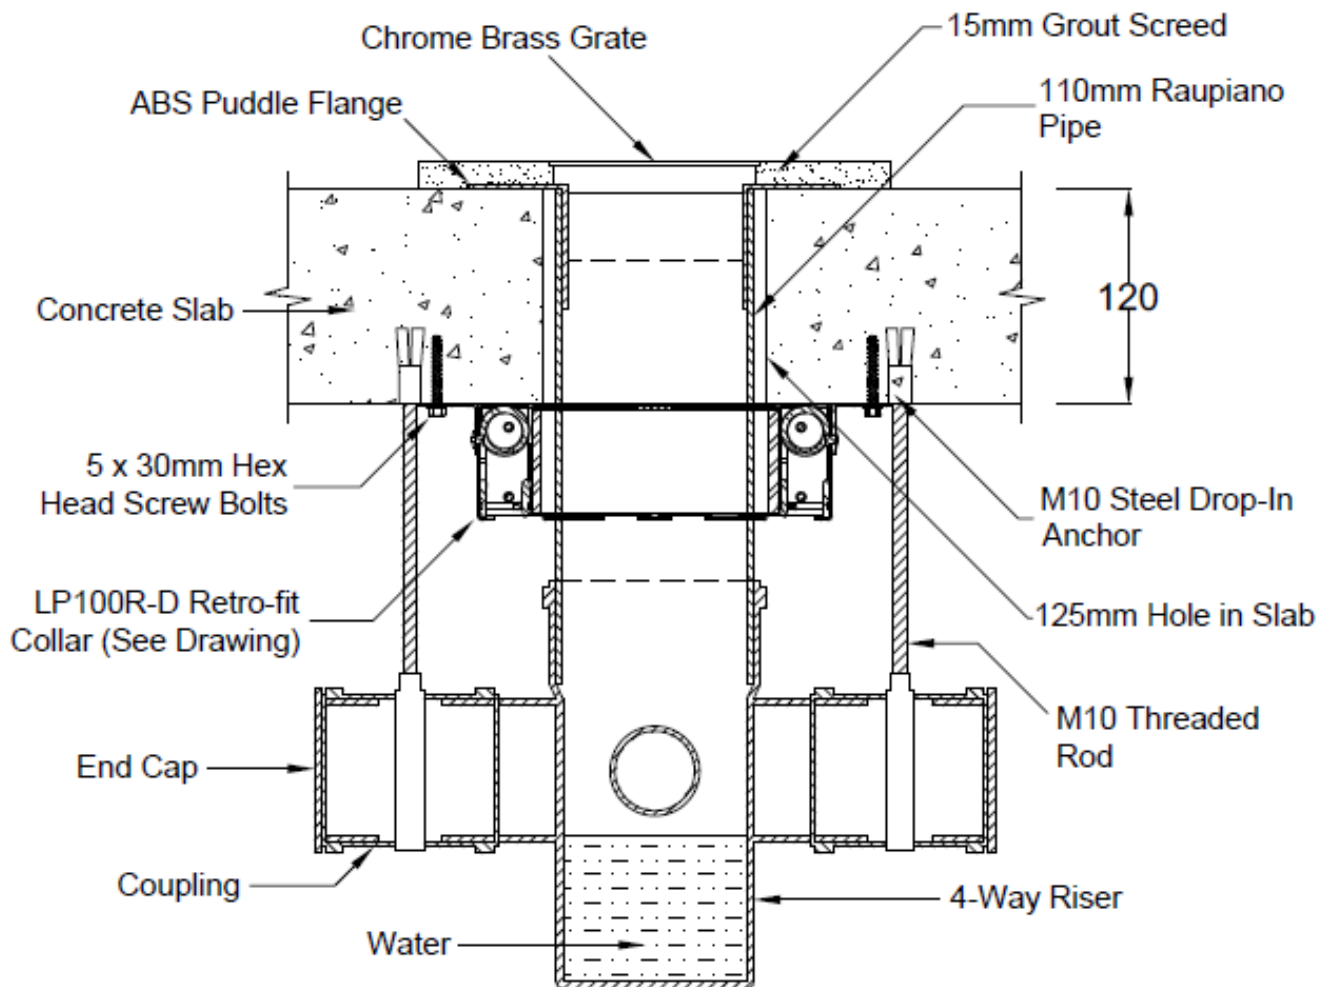
110 Raupiano Floorwaste & LP100R-D

DRAWING "SPECIMEN #1, 110 RAUPIANO FLOORWASTE & LP100R-D", DATED 3 APRIL 2019, PROVIDED BY SNAP FIRE SYSTEMS PTY LTD

Specimen 1 – SNAP LP100R-D Retrofit fire collar protecting a nominal 110-mm polypropylene (Raupiano Plus) floor waste incorporating a 4-way riser.

The SNAP Retrofit LP100R-D fire collar comprised a 0.95-mm steel casing with a 122-mm inner diameter and a 260-mm diameter base flange. The 65-mm high collar casing incorporated a closing mechanism that comprised of a soft Intumesh intumescent strip and wire mesh lined within the internal circumference of the collar. The Intumescent strip was 5-mm thick x 59-mm wide x 418-mm long. Folded over the intumescent strip was a layer of 316 stainless steel mesh 415-mm long x 120-mm wide with a mesh wire diameter of 0.15-mm, as shown in drawing numbered LP100R-D-T dated 10 January 2017, by Snap Fire Systems Pty Ltd. The Snap collar was surface mounted around the pipe on the exposed face (underside) of the slab and fixed through 4 mounting brackets using 5-mm x 30-mm concrete screw bolts.

The penetrating service comprised a 109.5-mm outside diameter polypropylene pipe with a wall thickness of 3.02-mm fitted through the collar's sleeve. A 125-mm diameter opening was cut into the slab and the collar fixed centrally over the hole. The floor waste system was fitted with a chrome brass grate and ABS Puddle Flange. A 15-mm thick grout screed was laid on top of the concrete slab and finished flush with the floor grate. On the exposed side of the slab, a 4-way riser was connected to the penetrating pipe, supported by two M10 threaded rods and steel drop-in anchors to the concrete slab. On the exposed face, the 4-way riser was capped using a polypropylene end cap(s). The floor waste gully was charged with water to the level shown in drawing titled "Specimen #1, 110 Raupiano Floorwaste & LP100R-D", dated 3 April 2019, provided by Snap Fire Systems Pty Ltd.

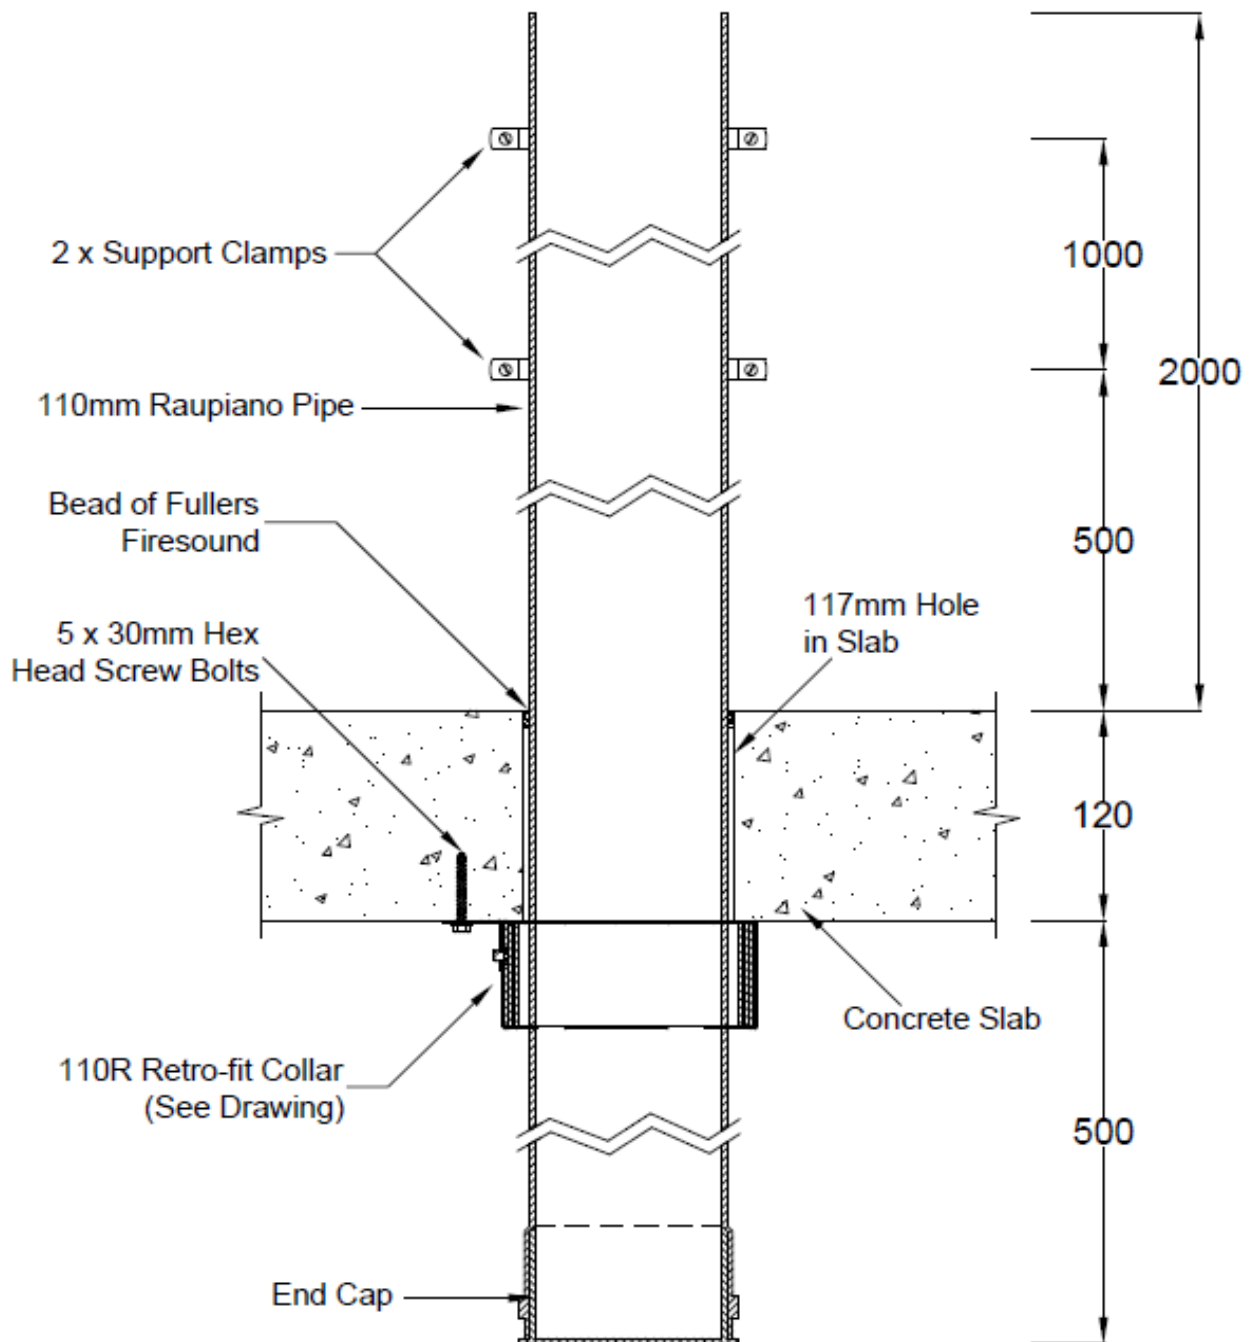
110 Raupiano Stack & 110R

DRAWING TITLED "SPECIMEN # 2, 110 RAUPIANO STACK & 110R", DATED 3 APRIL 2019, PROVIDED BY NAP FIRE SYSTEMS PTY LTD

Specimen 2 – SNAP 110R Retrofit fire collar protecting a nominal 110-mm polypropylene (Raupiano Plus) stack pipe.

The SNAP Retrofit 110R fire collar comprised a 0.75-mm steel casing with a 122-mm inner diameter and a 206-mm diameter base flange. The 62-mm high collar casing incorporated a closing mechanism that was comprised of three soft Intumesh intumescent wraps and wire mesh lined within the internal circumference of the collar. Intumescent A was 2.5-mm thick x 58-mm wide x 424-mm long, Intumescent B was 2.5-mm thick x 58-mm wide x 407-mm long and Intumescent C was 2.5-mm thick x 58-mm wide x 389-mm long. Between intumescent strips A and B was a layer of 304 stainless steel mesh measuring 415-mm long x 58-mm wide and between intumescent strips B and C was a layer of 316 stainless steel mesh measuring 398-mm long x 58-mm wide. Both had wire mesh diameters of 0.15-mm, as shown in drawing titled “SNAP 110 Retro”, dated 16 January 2019, by Snap Fire Systems Pty Ltd. The Snap collar was surface mounted around the pipe on the exposed face (underside) of the slab and fixed through 4 mounting brackets using 5-mm x 30-mm concrete screw bolts.

The annular gap between the pipe and concrete slab on the unexposed face was protected with a bead of Fullers Firesound sealant.

The penetrating service comprised a 109.5-mm outside diameter polypropylene pipe with a wall thickness of 3.02-mm fitted through the collar’s sleeve. A 117-mm diameter opening was cut into the slab and the collar fixed centrally over the hole as shown in drawing titled “Specimen # 2, 110 Raupiano Stack & 110R”, dated 3 April 2019, provided by Snap Fire Systems Pty Ltd. The pipe projected vertically, approximately 2000-mm above from the unexposed face of the concrete floor and approximately 500-mm into the furnace chamber. The pipe was supported at nominally 500-mm and 1500-mm from the unexposed face of the slab. The pipe was open at the unexposed end and closed with a polypropylene end cap on the exposed end.

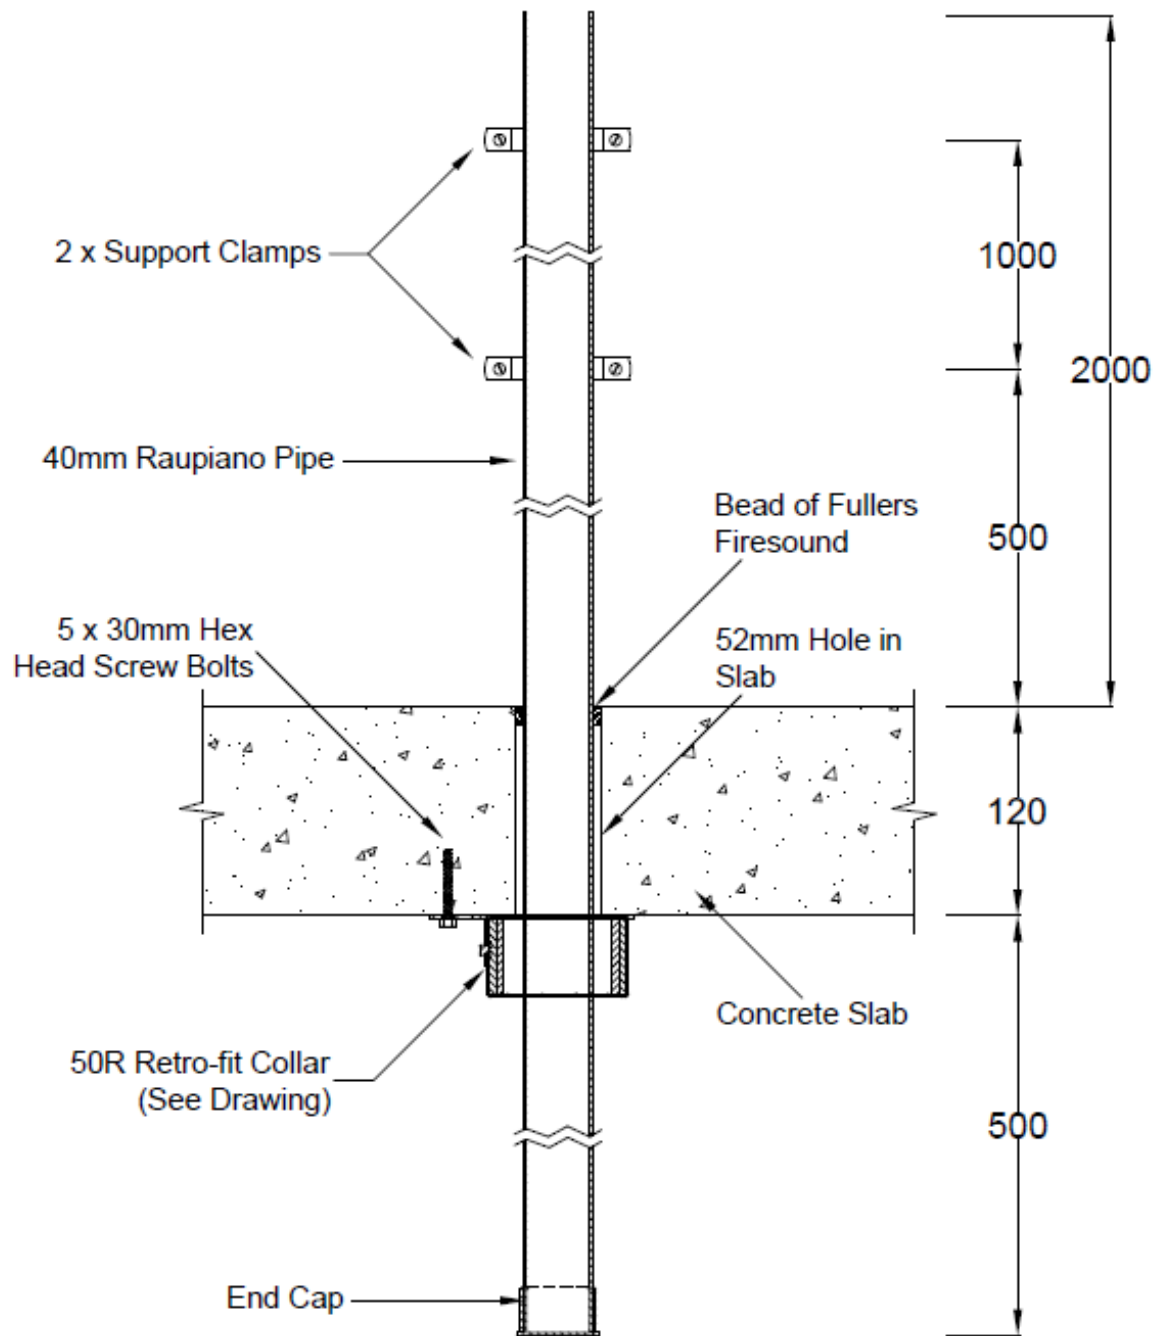
40 Raupiano Stack & 50R

DRAWING TITLED "SPECIMEN # 3, 40 RAUPIANO STACK & 50R", DATED 3 APRIL 2019, PROVIDED BY SNAP FIRE SYSTEMS PTY LTD

Specimen 3 – SNAP 50R Retrofit collar protecting a nominal 40-mm polypropylene (Raupiano) stack pipe.

The SNAP Retrofit 50R fire collar comprised a 0.75-mm steel casing with a 62-mm inner diameter and a 147-mm diameter base flange. The 47-mm high collar casing incorporated a closing mechanism which comprised two soft Intumesh intumescent wraps lined within the internal circumference of the collar. Intumescent A was 4-mm thick x 43-mm wide x 220-mm long and Intumescent B was 4-mm thick x 43-mm wide x 200-mm long. Between the strips was a layer of 316 grade stainless steel mesh measuring 210-mm long x 42-mm wide with a wire mesh diameter of 0.15-mm, as shown in drawing titled “SNAP 50 Retro”, dated 18 January 2019, by Snap Fire Systems Pty Ltd. The Snap collar was surface mounted around the pipe on the exposed face (underside) of the floor and fixed through 4 mounting brackets using 5-mm x 30-mm concrete screw bolts.

The annular gap between the pipe and concrete slab on the unexposed face was protected with a bead of Fullers Firesound sealant.

The penetrating service comprised a 40.14-mm outside diameter polypropylene pipe with a wall thickness of 1.98-mm fitted through the collar’s sleeve. A 52-mm diameter opening was cut into slab and the collar fixed centrally over the hole as shown in drawing titled “Specimen # 3, 40 Raupiano Stack & 50R”, dated 3 April 2019, provided by Snap Fire Systems Pty Ltd. The pipe projected vertically 2000-mm above the concrete slab and 500-mm into the furnace chamber. The pipe was supported at nominally 500-mm and 1500-mm from the unexposed face of the slab. The pipe was open at the unexposed end and closed with a polypropylene end cap on the exposed end.

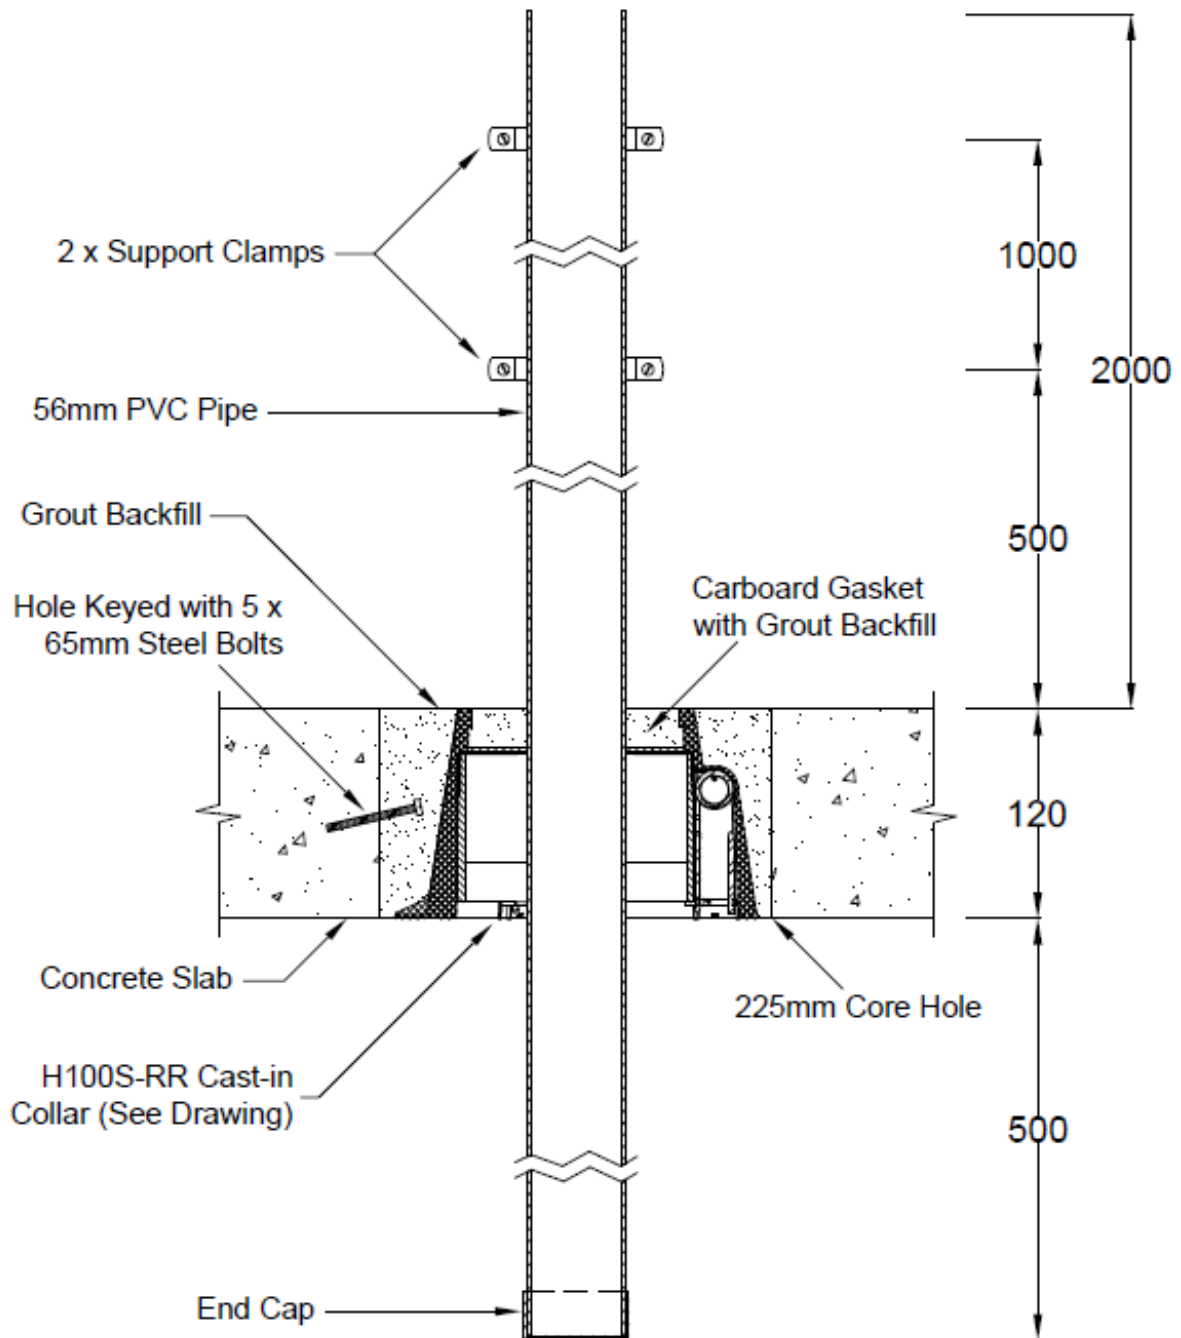
50 PVC Stack & H100S-RR

DRAWING TITLED "SPECIMEN #4, 50 PVC STACK & H100S-RR", DATED 21 MARCH 2019, PROVIDED BY SNAP FIRE SYSTEMS PTY LTD

#### Specimen 4 – SNAP H100S-RR Cast-in collar protecting a nominal 50-mm polyvinyl chloride (PVC-U) stack pipe.

The SNAP Cast-in H100S-RR fire collar comprised a 1.6-mm thick polypropylene casing with a 126.5-mm inner diameter and a 213-mm diameter base flange. The 250-mm high collar casing incorporated a 412-mm x 85-mm x 4-mm thick Intumesh intumescent material and a rubber ring seal. The closing mechanism comprised three galvanised steel springs bound with nylon fuse links and a 460-mm x 85-mm 316 stainless steel mesh as shown in drawing numbered H100S-RR-T dated 29 September 2017, by Snap Fire Systems Pty Ltd.

The penetrating service comprised a 55.8-mm outside diameter PVC pipe with a wall thickness of 2.21-mm through the collar's sleeve. A 225-mm diameter opening was cut into the slab and 5 x 65-mm steel bolts were secured into the slab, the collar was placed centrally over the opening and backfilled with cement between the collar and the slab with grout over a cardboard gasket between the collar and pipe as shown in drawing titled "Specimen #4, 50 PVC Stack & H100S-RR", dated 21 March 2019, provided by Snap Fire Systems Pty Ltd. The pipe projected vertically, approximately 2000-mm above from the unexposed face of the concrete slab and approximately 500-mm into the furnace chamber. The pipe was supported at nominally 500-mm and 1500-mm from the unexposed face of the slab. The pipe was open at the unexposed end and closed with a PVC end cap on the exposed end.

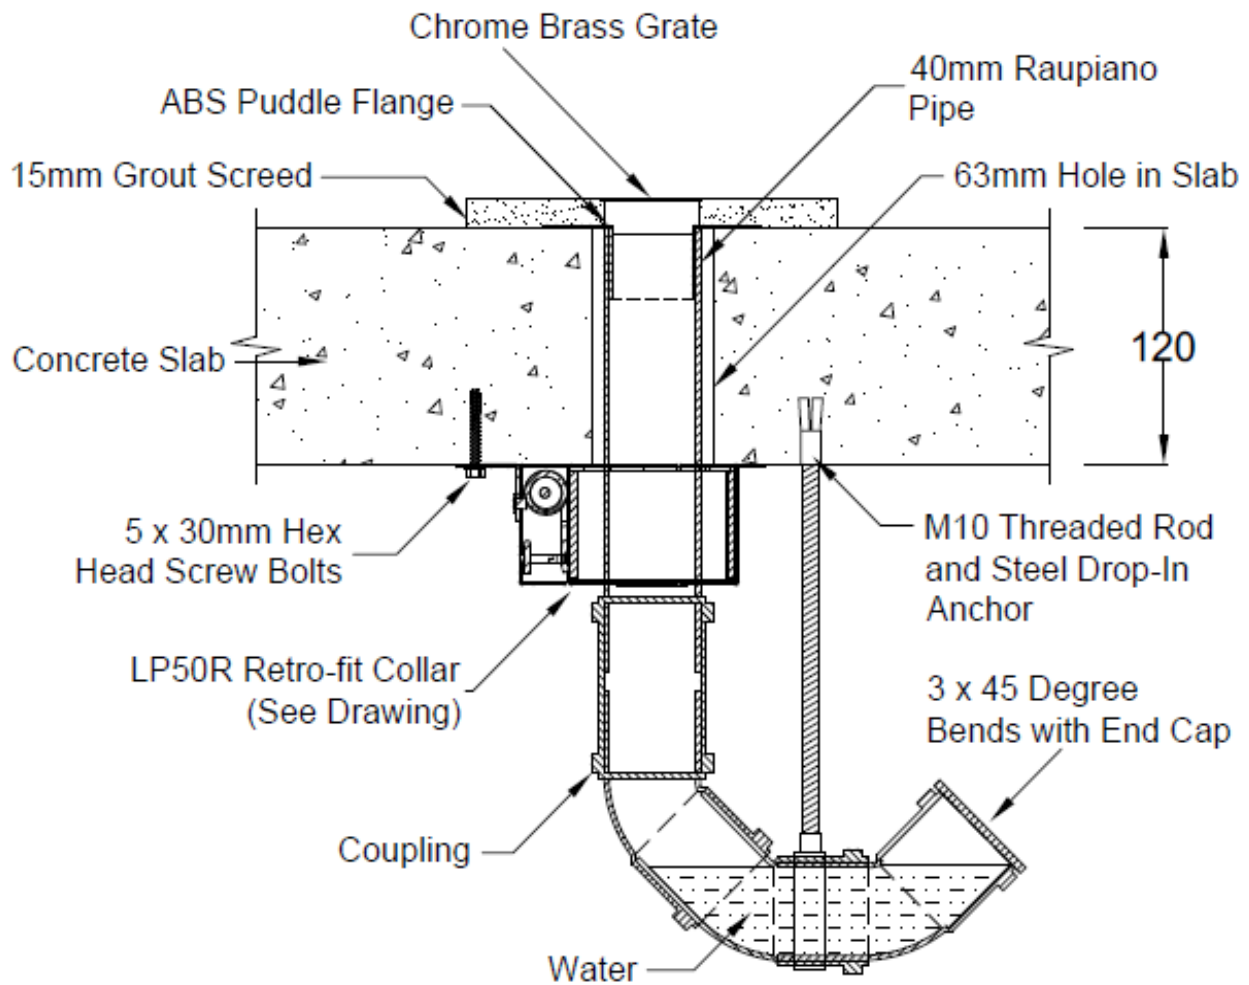
40 Raupiano Floorwaste & LP50R

DRAWING TITLED "SPECIMEN #5, 40 RAUPIANO FLOORWASTE & LP50R", DATED 3 APRIL 2019, PROVIDED BY SNAP FIRE SYSTEMS PTY LTD

#### Specimen 5 – SNAP LP50R Retrofit fire collar protecting a nominal 40-mm Polypropylene (Raupiano Plus) floor waste incorporating a p-trap.

The SNAP retrofit LP50R fire collar comprised a 0.75-mm steel case with a 69-mm inner diameter and a 203-mm diameter base flange. The 62-mm high collar casing incorporated a 255-mm x 58-mm x 4-mm thick Intumesh intumescent material. The closing mechanism incorporated three 316 stainless steel springs, with nylon fuse links and a 260-mm x 58-mm stainless steel mesh as shown in drawing numbered LP50R-T dated 6 October 2017, by SNAP Fire Systems Pty Ltd. The Snap collar was surface mounted around the pipe on the underside of the slab and fixed through 3 mounting brackets using 5-mm x 30-mm concrete screw bolts.

The penetrating service comprised a 50.3-mm outside diameter polypropylene pipe with a wall thickness of 2.35-mm through the collar's sleeve. The floor waste system was fitted with a chrome brass grate and ABS Puddle Flange. A 15-mm thick grout screed was laid on top of the concrete slab and finished flush with the floor grate. On the exposed side of the slab, a waste trap incorporating a p-trap was connected to the penetrating pipe, supported by supported by an M10 threaded rod and steel drop-in anchor to the concrete slab. On the exposed face, the gully trap was capped using a polypropylene end cap. The floor waste gully was charged with water to the level shown in drawing titled "Specimen #5, 40 Raupiano Floor waste & LP50R", dated 3 April 2019, provided by Snap Fire Systems Pty Ltd.

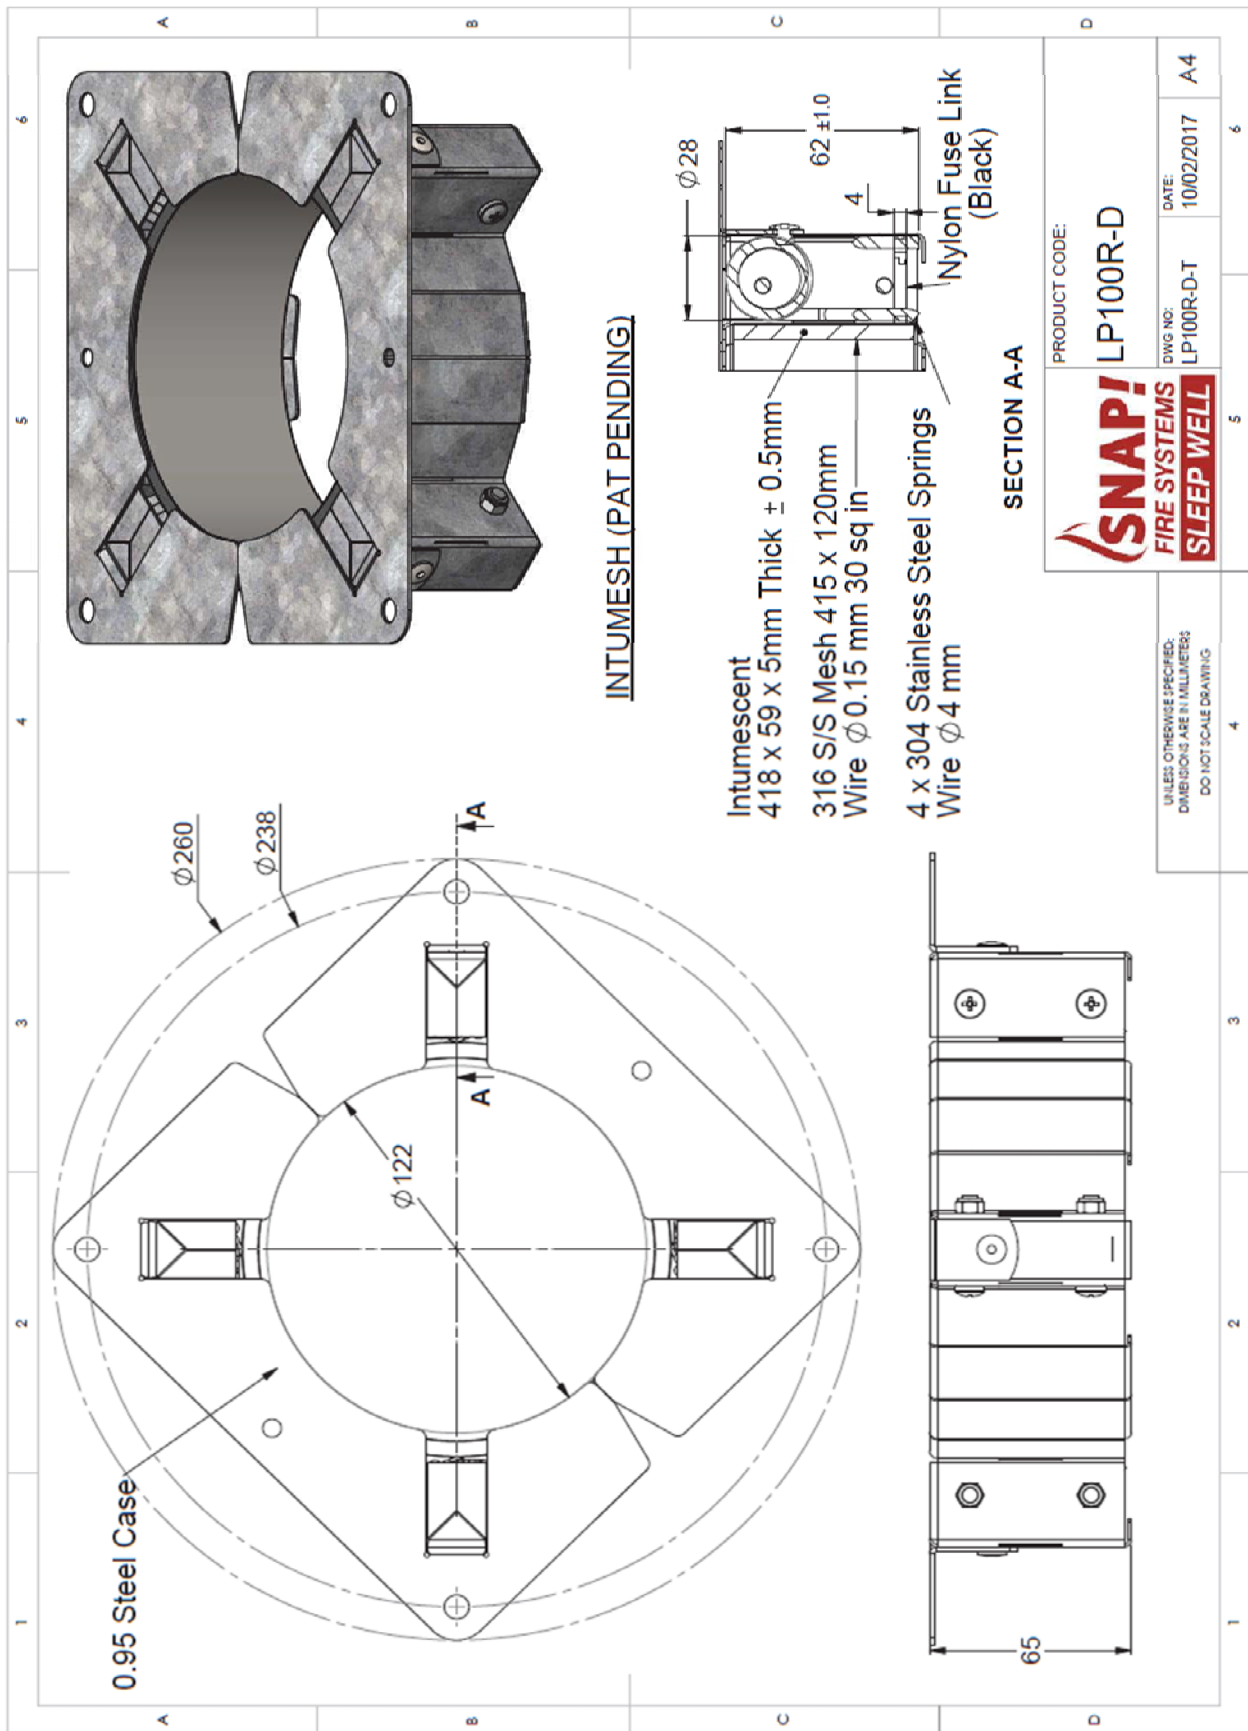
DRAWING NUMBERED LP100R-D-T DATED 10 FEBRUARY 2017, BY SNAP FIRE SYSTEMS PTY LTD.

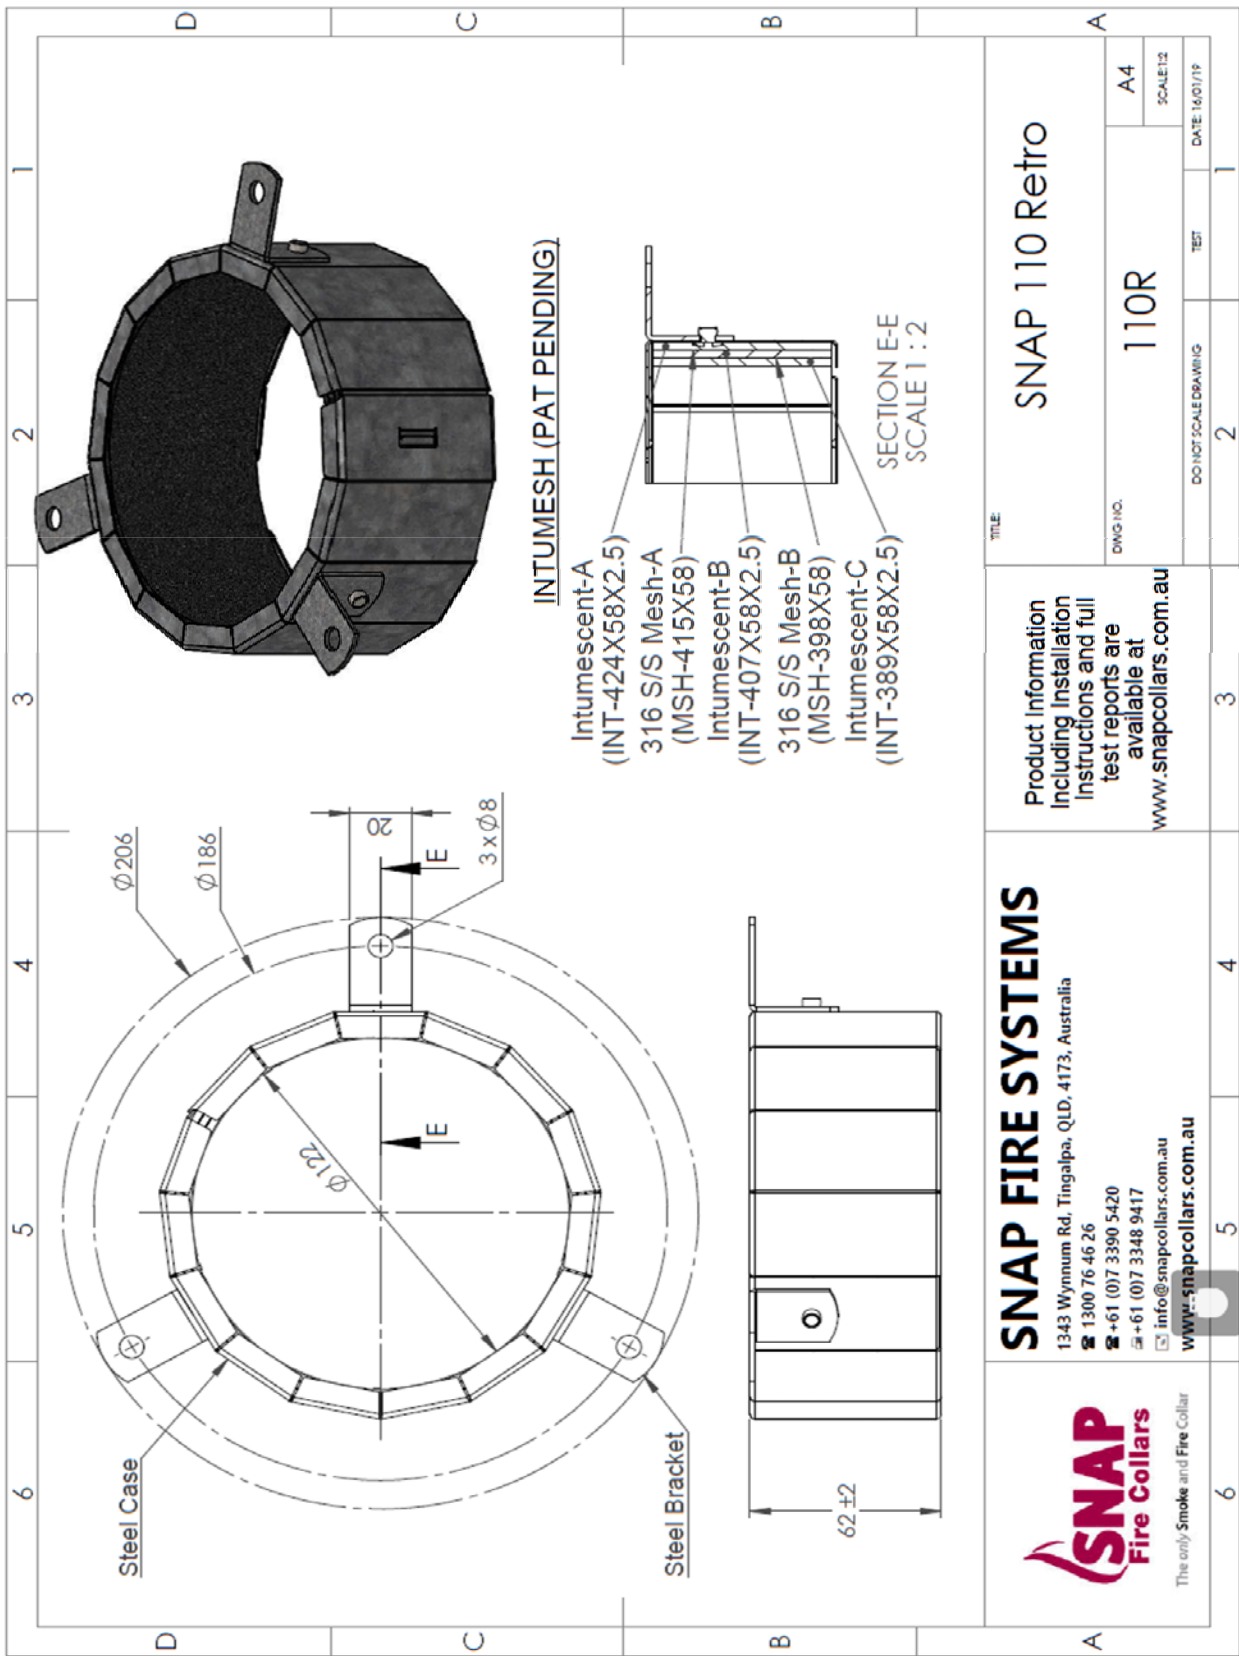
DRAWING TITLED "SNAP 110 RETRO", DATED 16 JANUARY 2019, BY SNAP FIRE SYSTEMS PTY LTD.

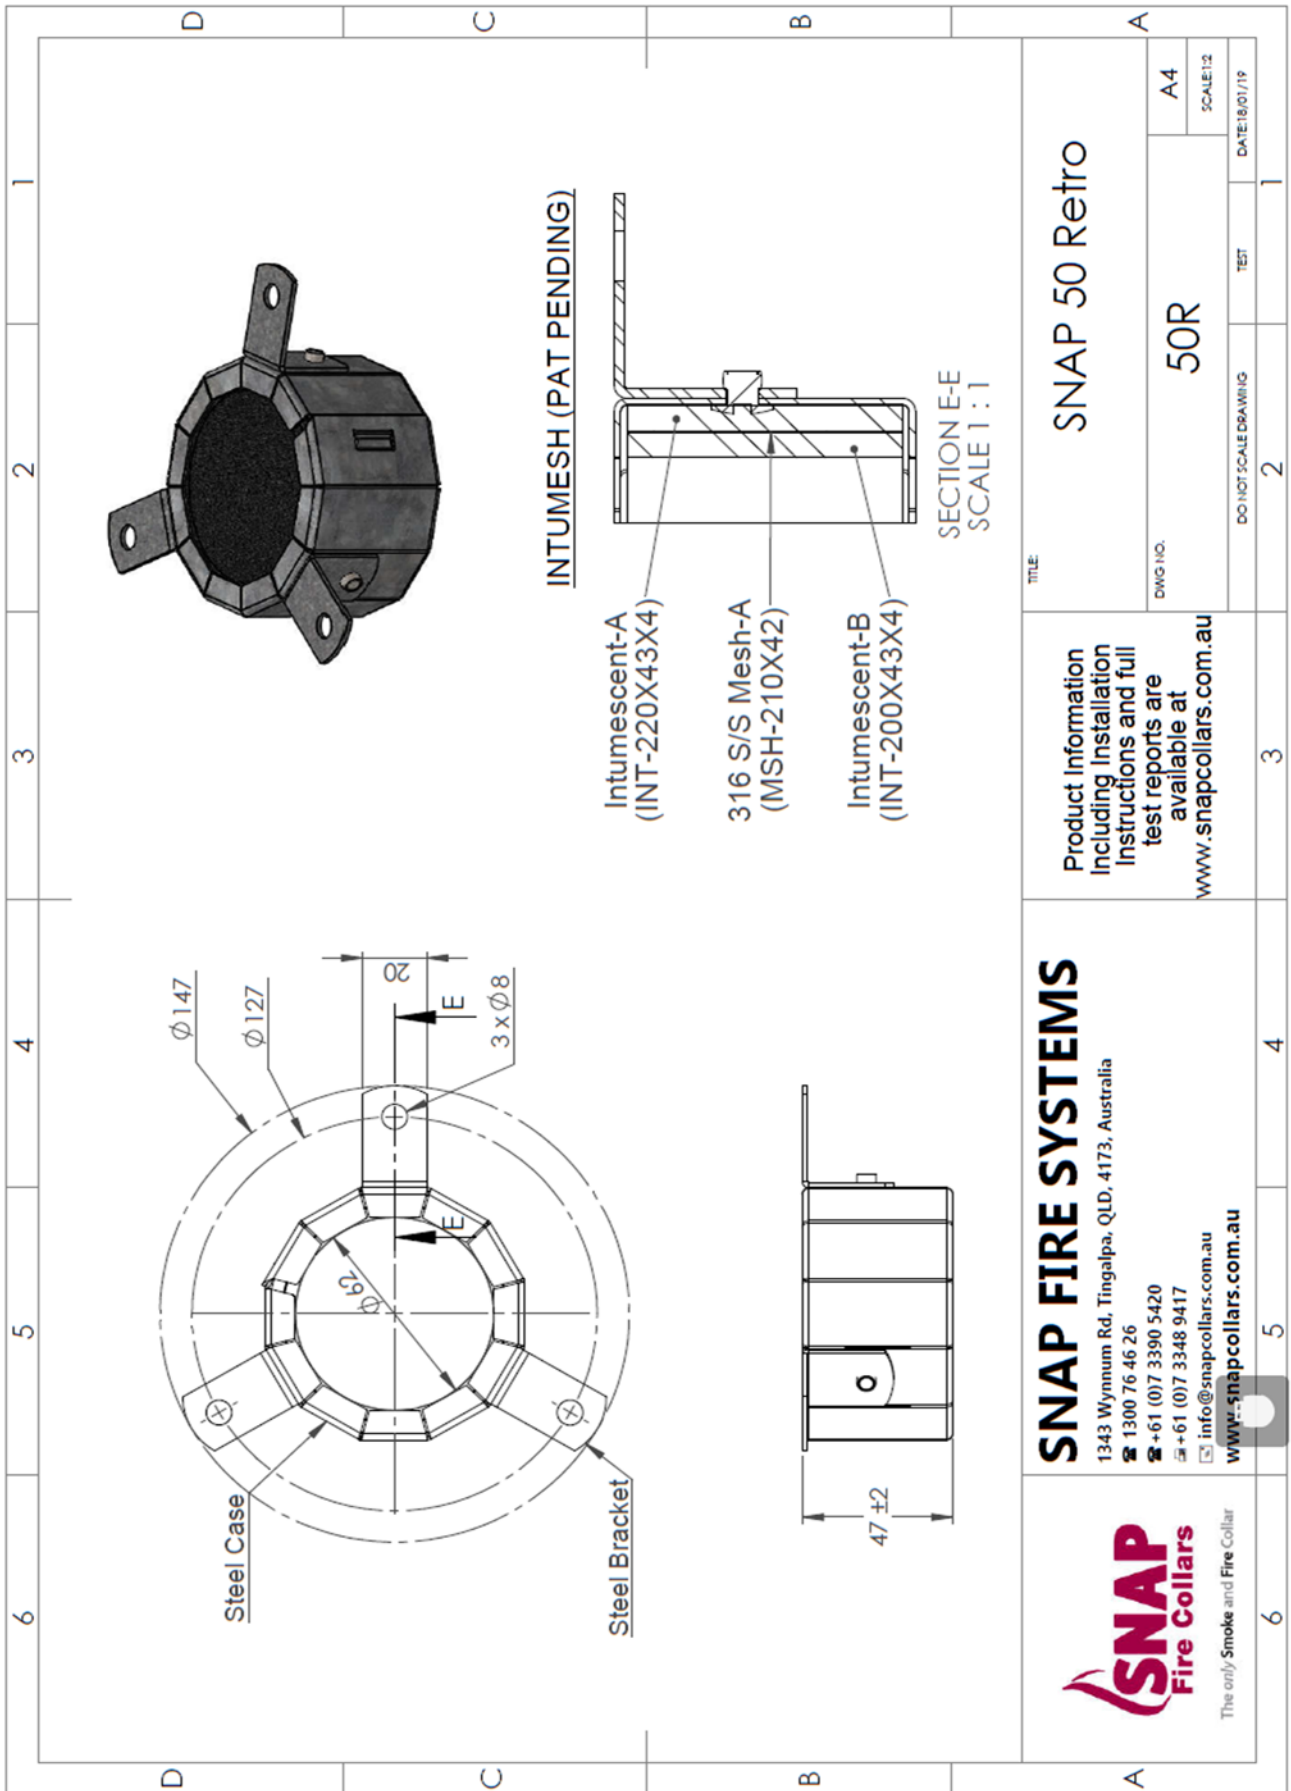
DRAWING TITLED "SNAP 50 RETRO", DATED 18 JANUARY 2019, BY SNAP FIRE SYSTEMS PTY LTD.

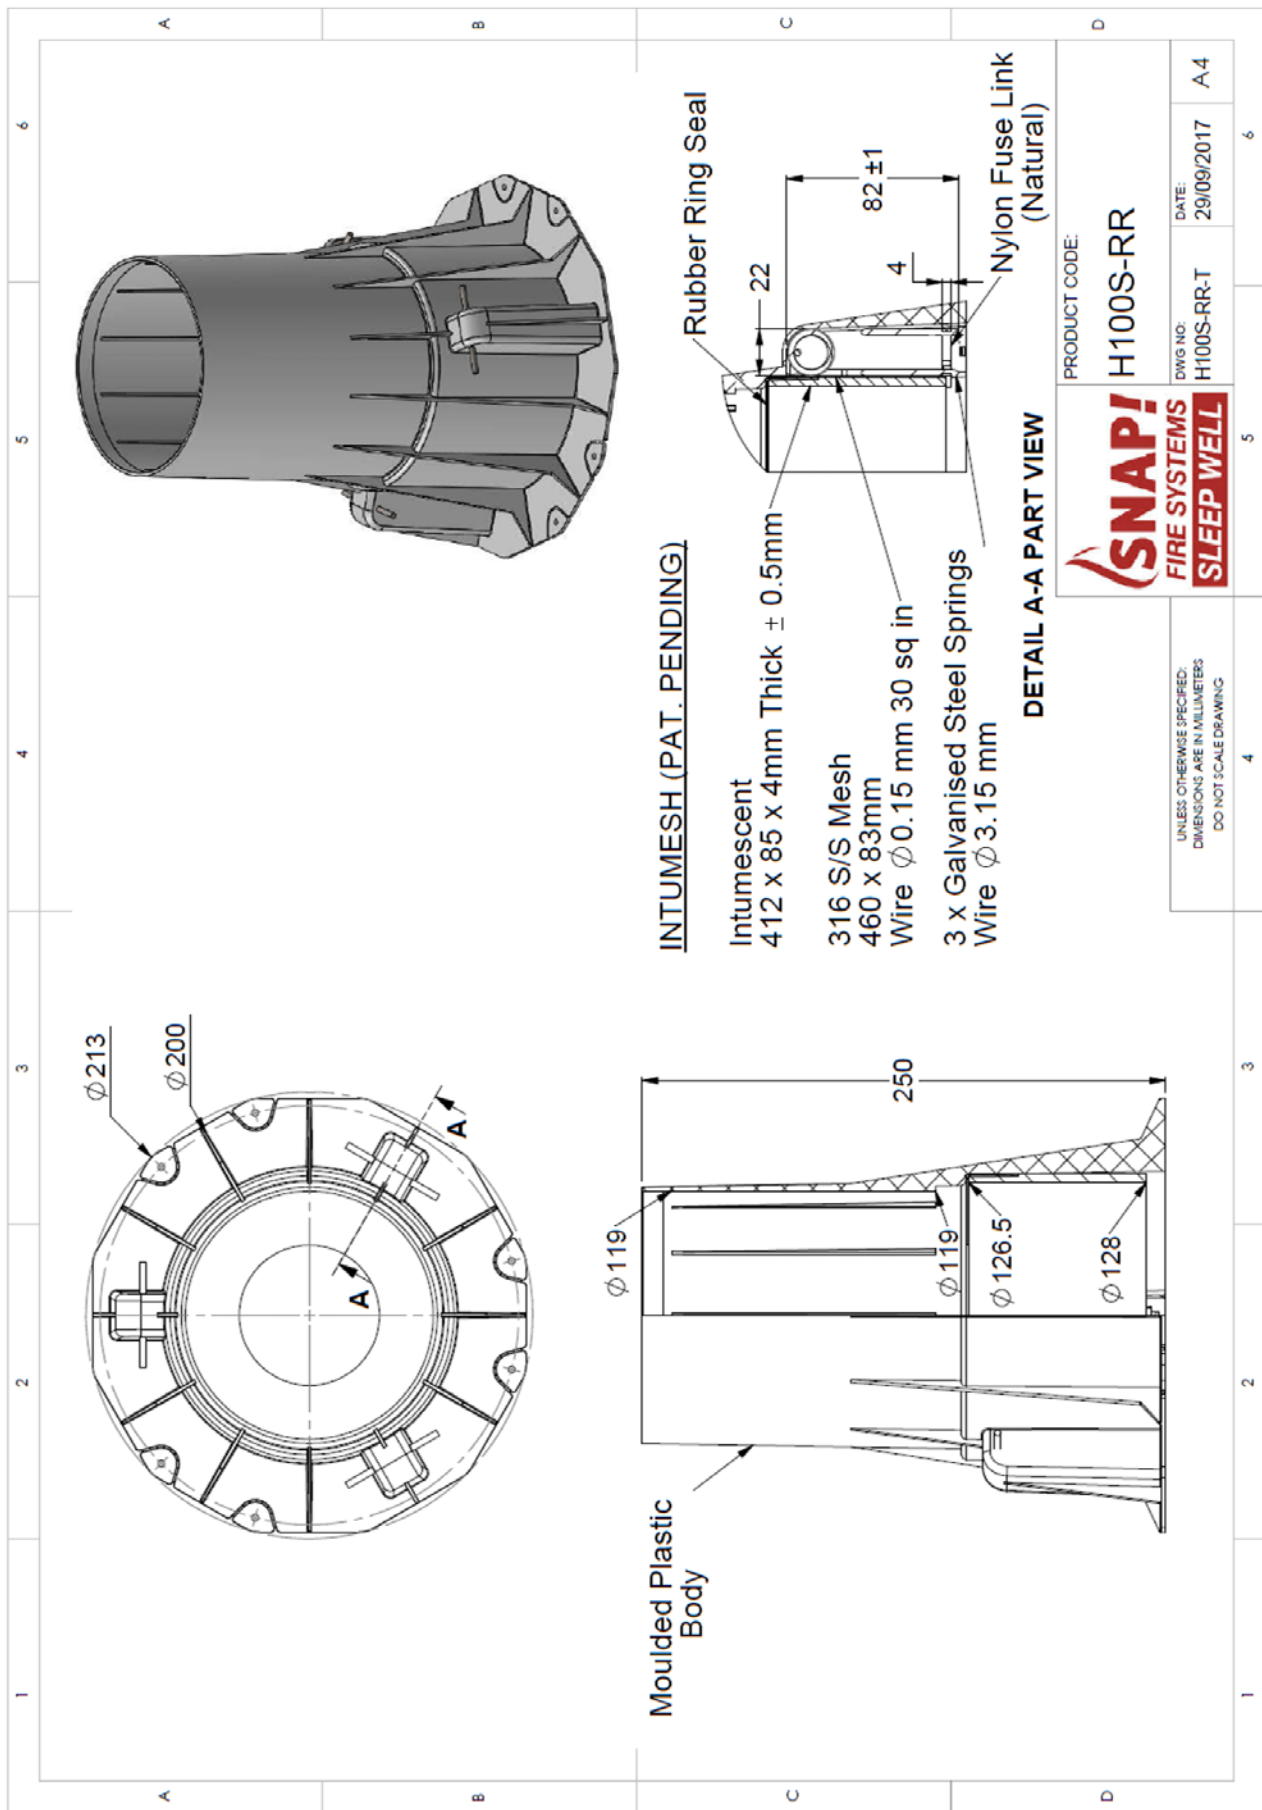
DRAWING NUMBER H100S-RR-T, DATED 29 SEPTEMBER 2017, BY SNAP FIRE SYSTEMS PTY LTD.
