# Fire-resistance test on fire collars protecting a concrete floor slab penetrated by services

## Test Report

**Author:** Peter Gordon  
**Report number:** FSP 2002  
**Date:** 26 June 2019

## Sponsored Investigation No. FSP 2002

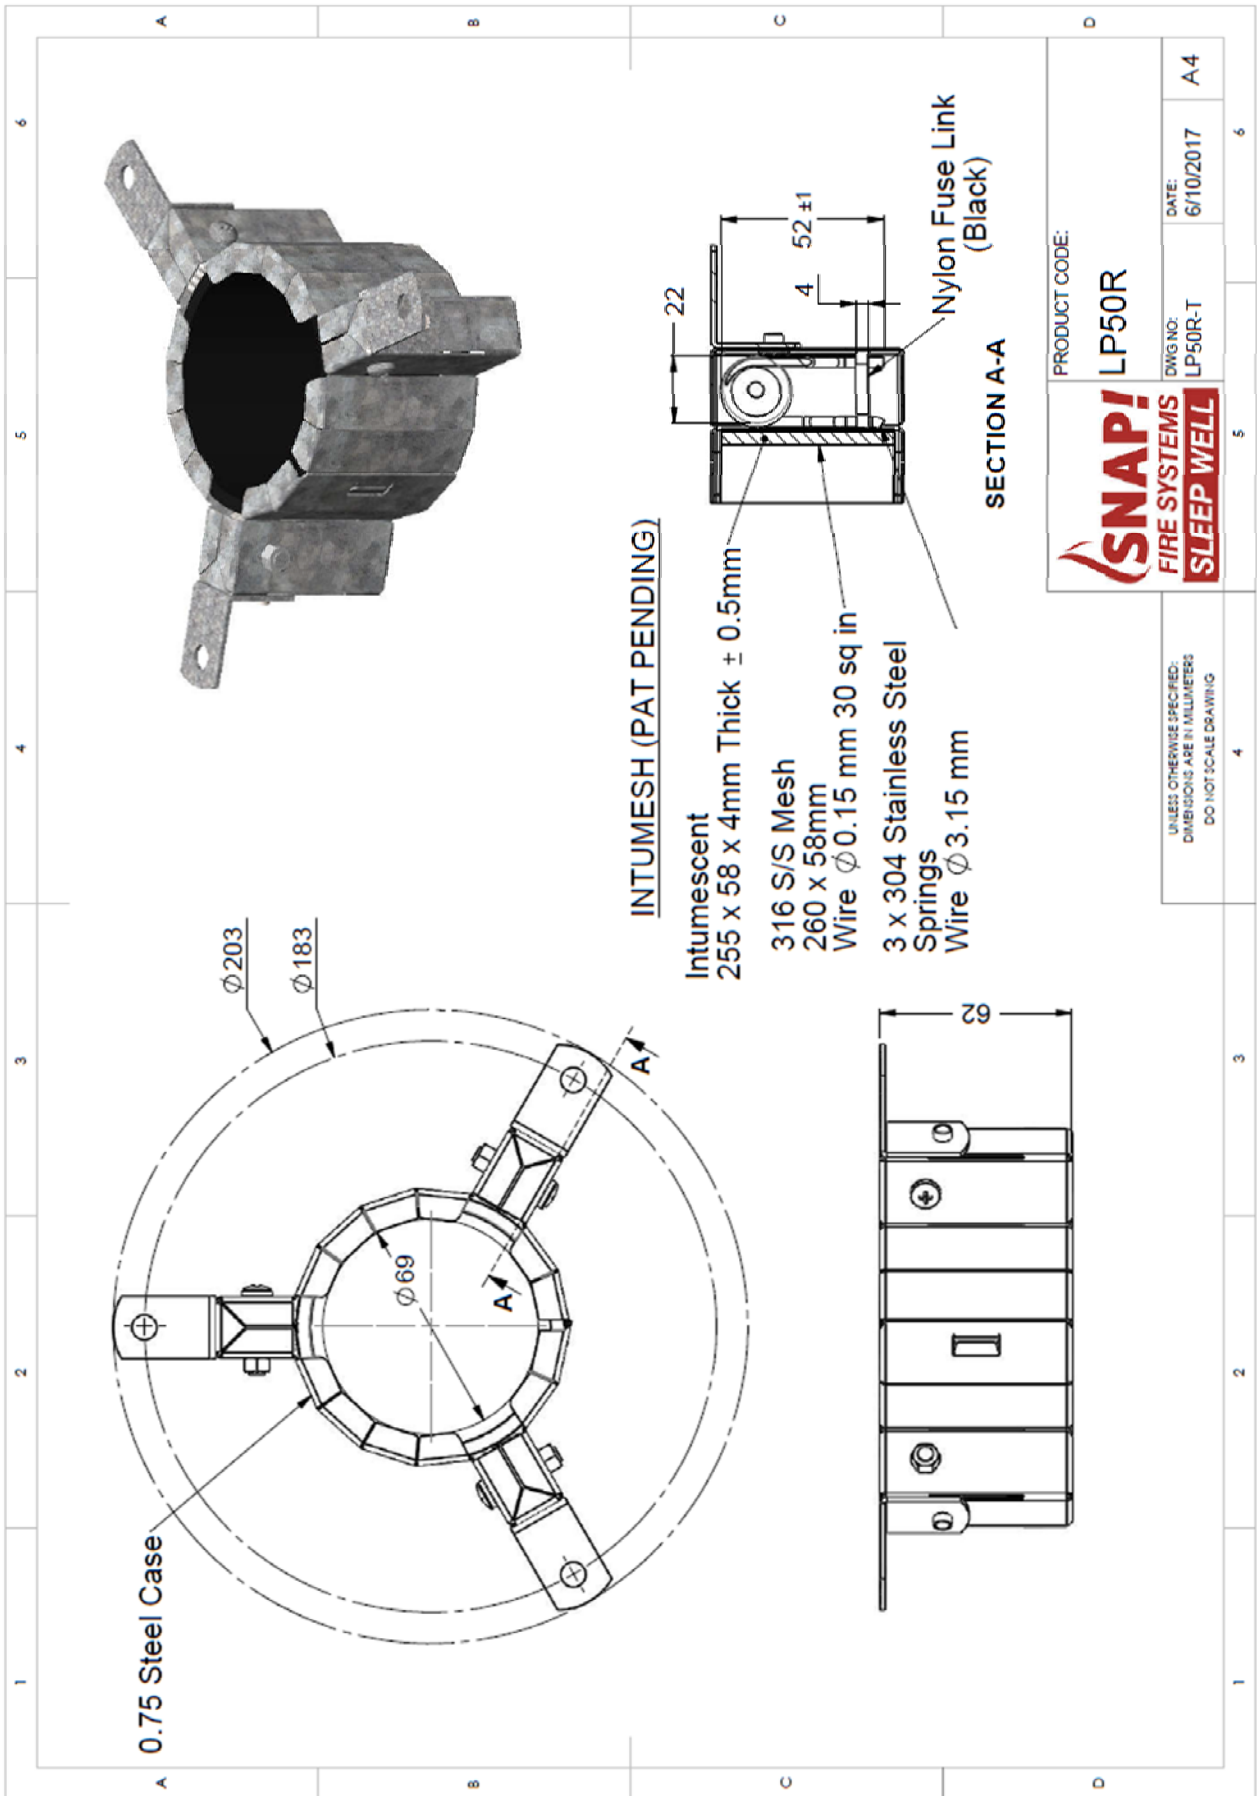
DRAWING NUMBERED LP50R-T DATED 6 OCTOBER 2017 2015, BY SNAP FIRE SYSTEMS PTY LTD.

The SNAP retrofit LP50R fire collar comprised a 0.75-mm steel case with a 69-mm inner diameter and a 203-mm diameter base flange. The 62-mm high collar casing incorporated a 255-mm x 58-mm x 4-mm thick Intumesh intumescent material. The closing mechanism incorporated three 316 stainless steel springs, with nylon fuse links and a 260-mm x 58-mm stainless steel mesh as shown in drawing numbered LP50R-T dated 6 October 2017, by SNAP Fire Systems Pty Ltd. The Snap collar was surface mounted around the pipe on the underside of the slab and fixed through 3 mounting brackets using 5-mm x 30-mm concrete screw bolts.
