# Fire-resistance test on fire collars protecting a concrete floor slab penetrated by services

## Test Report

**Author:** Peter Gordon  
**Report number:** FSP 2008  
**Date:** 22 August 2019

## Sponsored Investigation No. FSP 2008

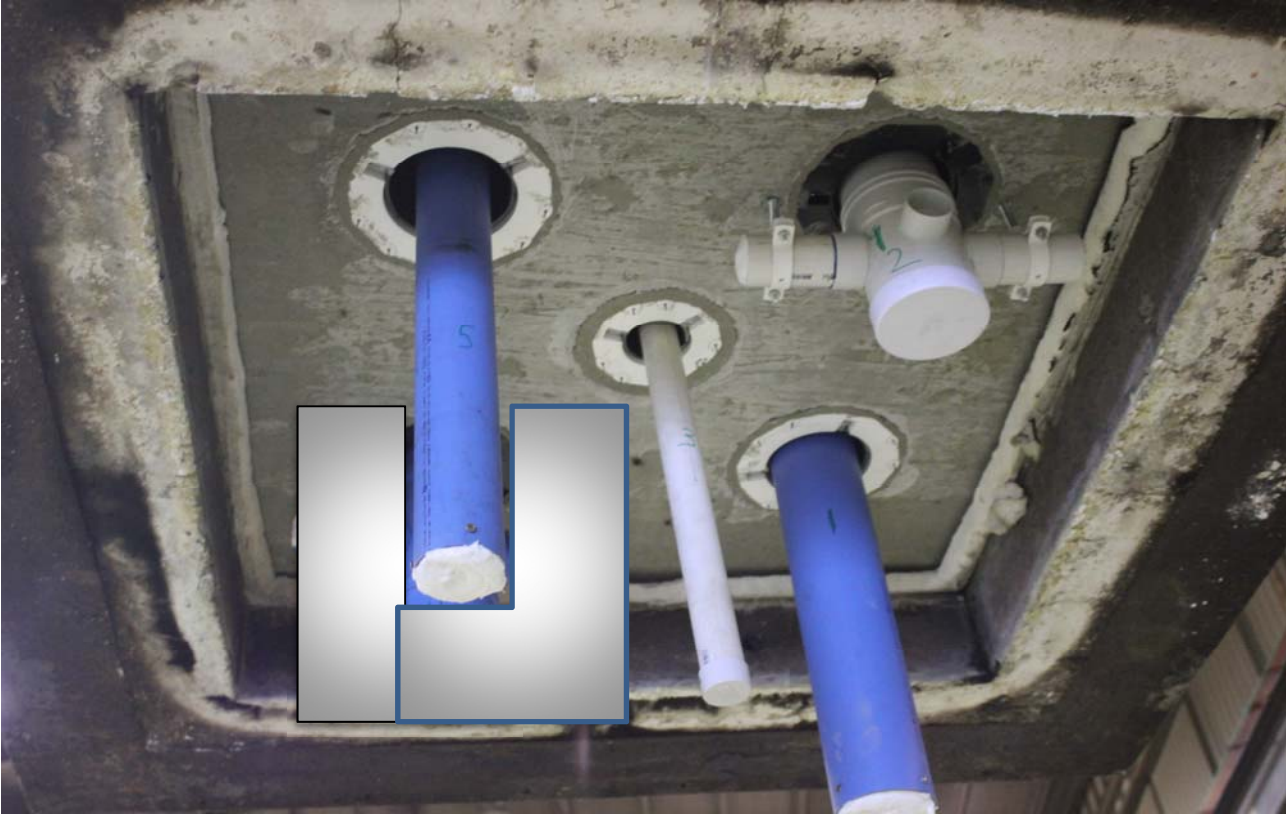
PHOTOGRAPH 1 – EXPOSED FACE OF SPECIMENS PRIOR TO TESTING

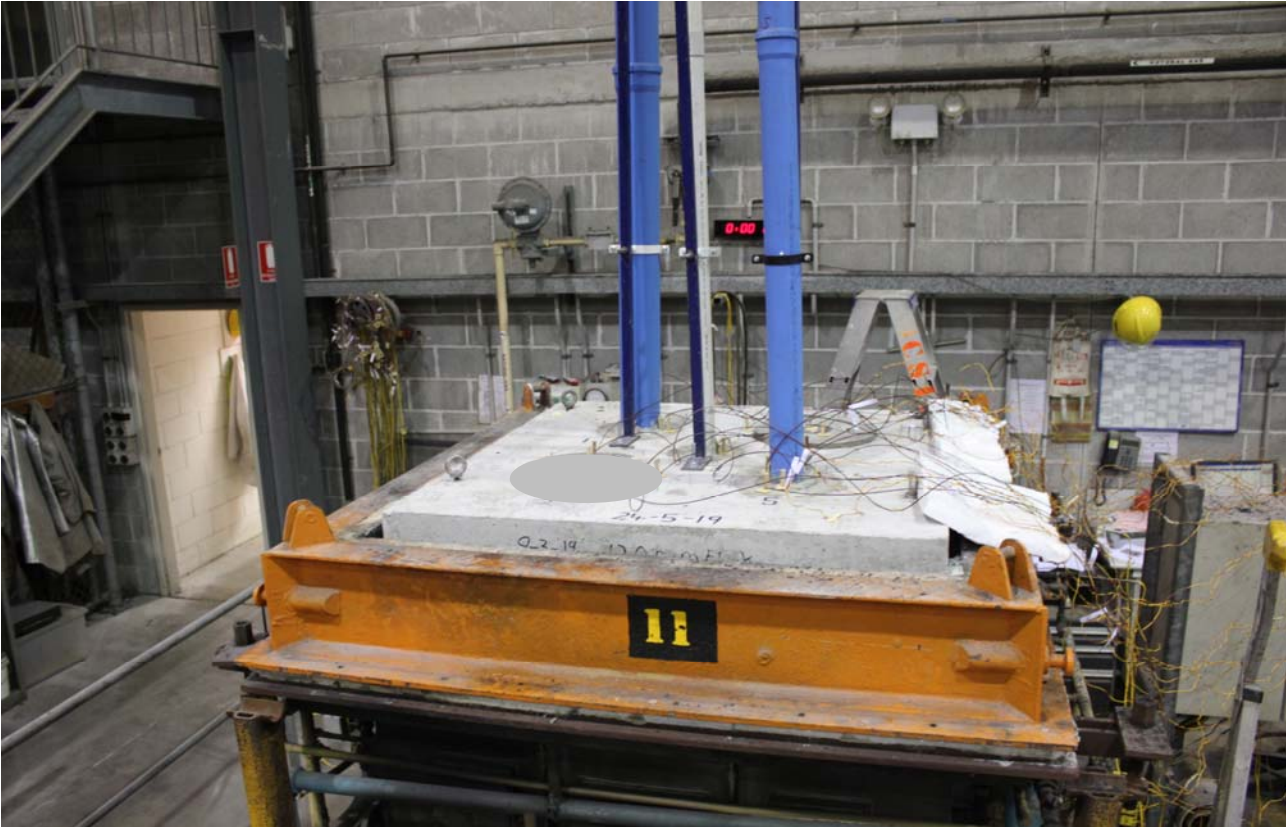
PHOTOGRAPH 2 – UNEXPOSED FACE OF SPECIMENS PRIOR TO TESTING

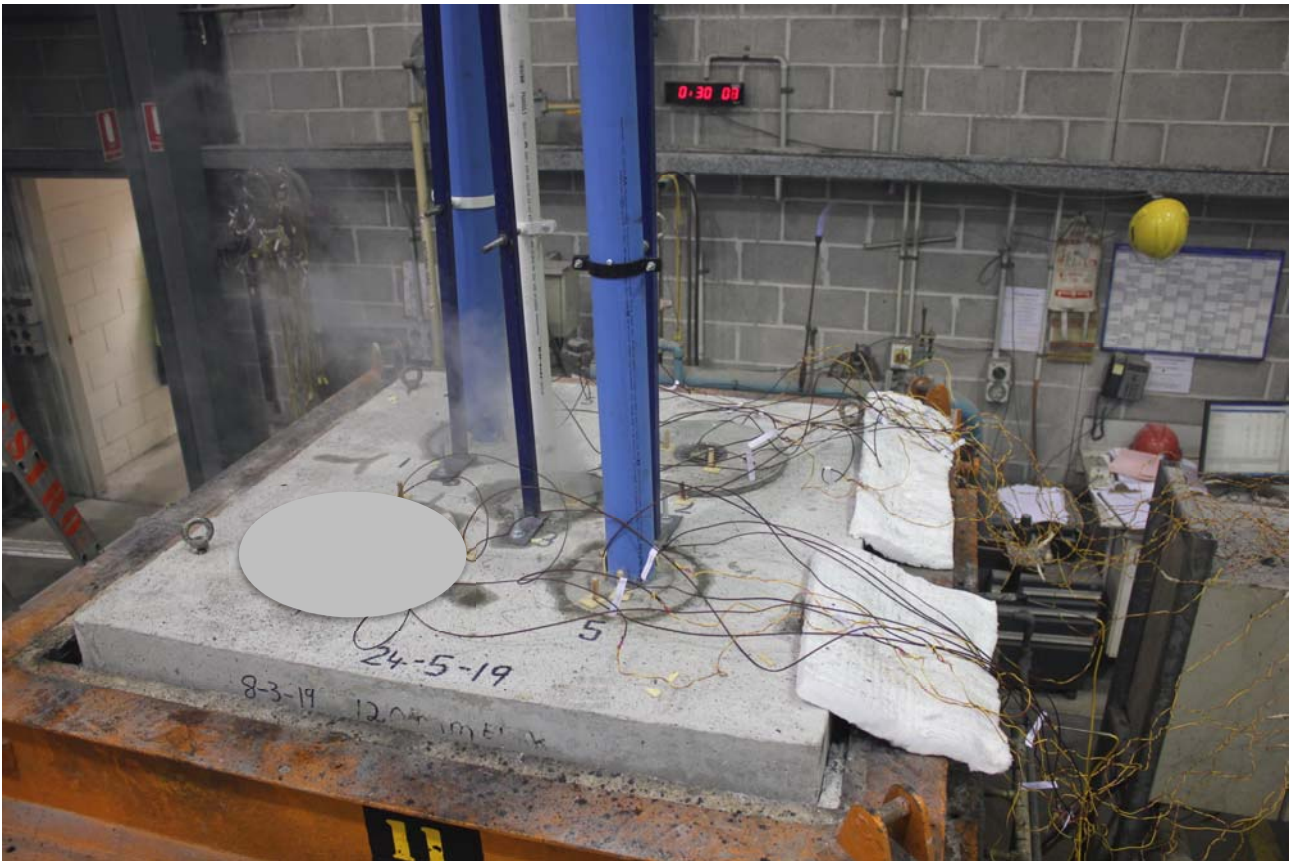
**PHOTOGRAPH 3 – SPECIMENS AFTER 30 MINUTES OF TESTING**

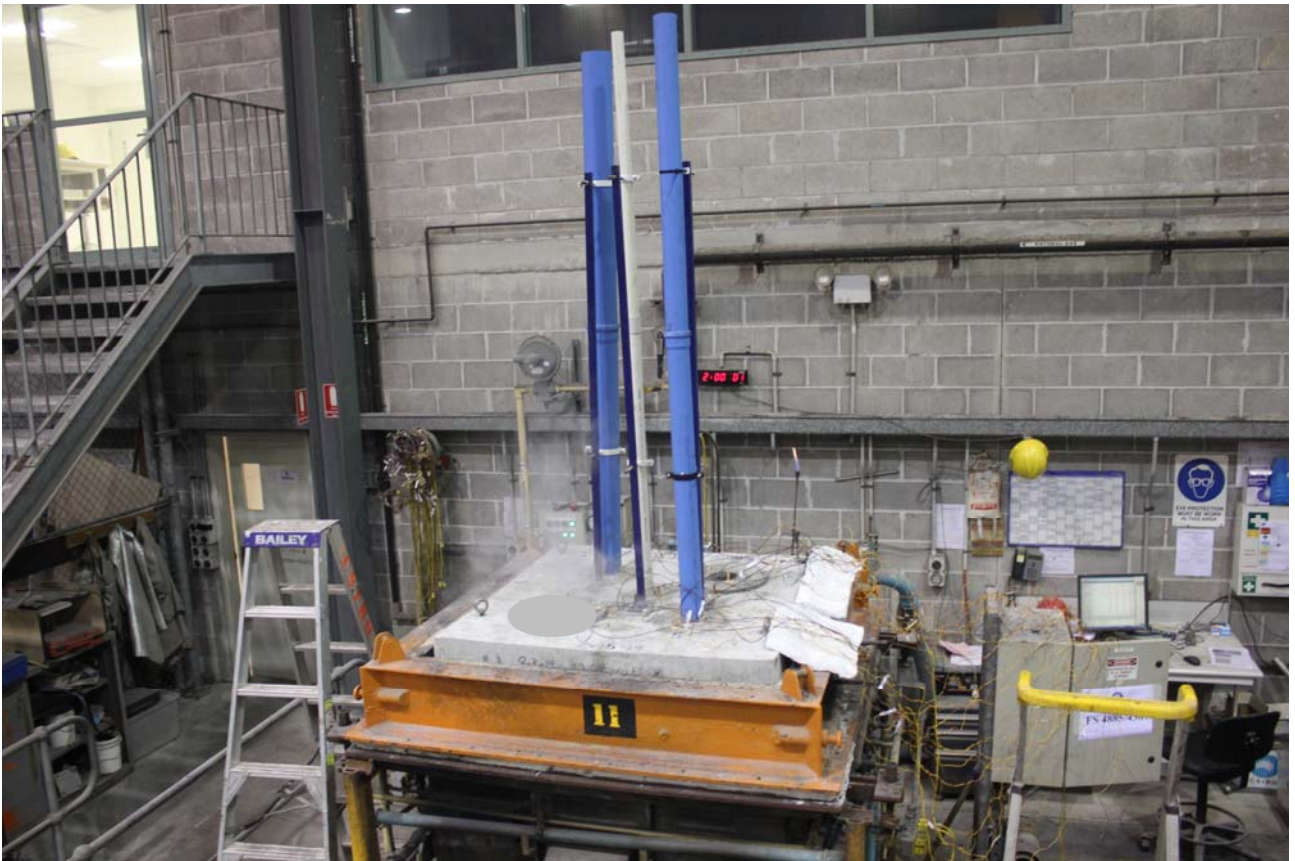
**PHOTOGRAPH 7 – SPECIMENS AFTER 120 MINUTES OF TESTING**

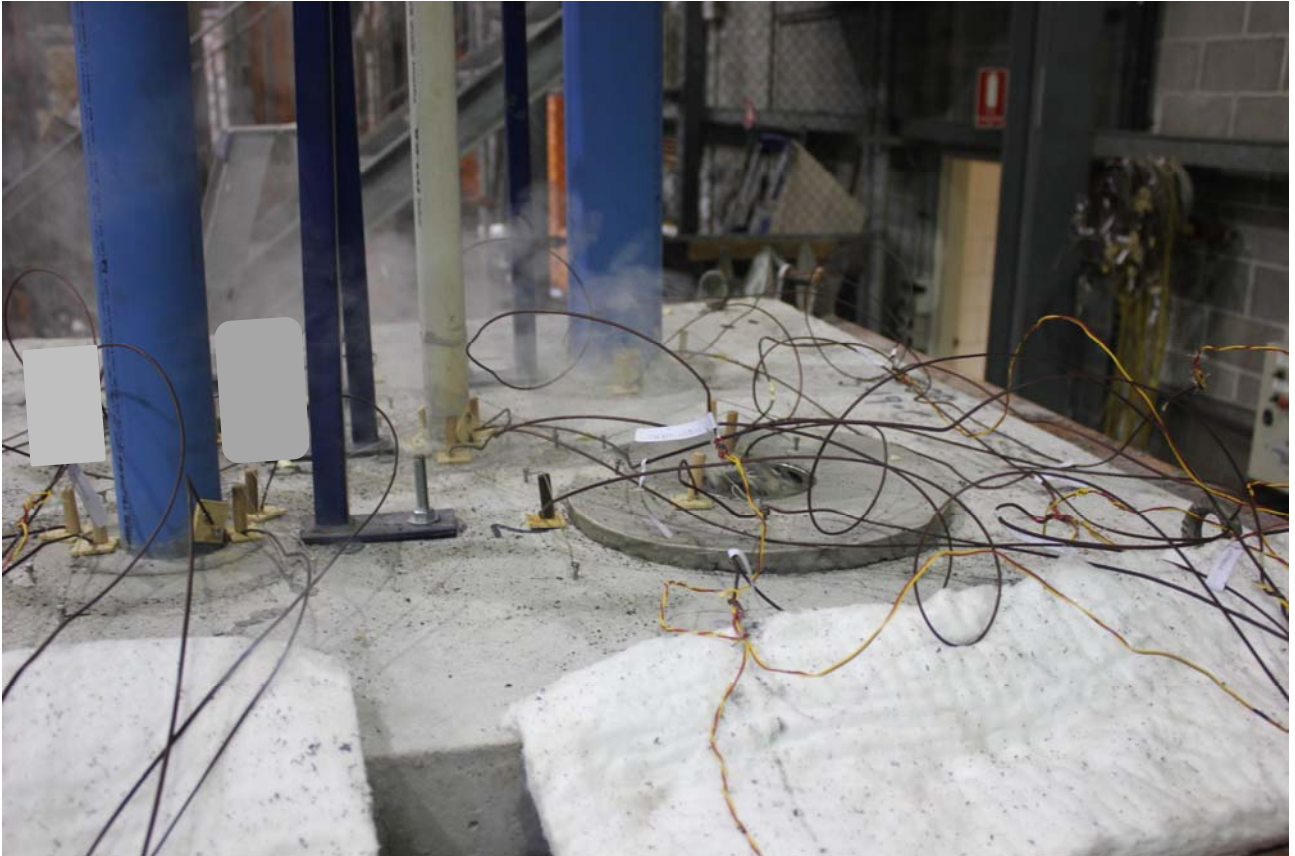
**PHOTOGRAPH 8 – SPECIMENS AFTER 150 MINUTES OF TESTING**

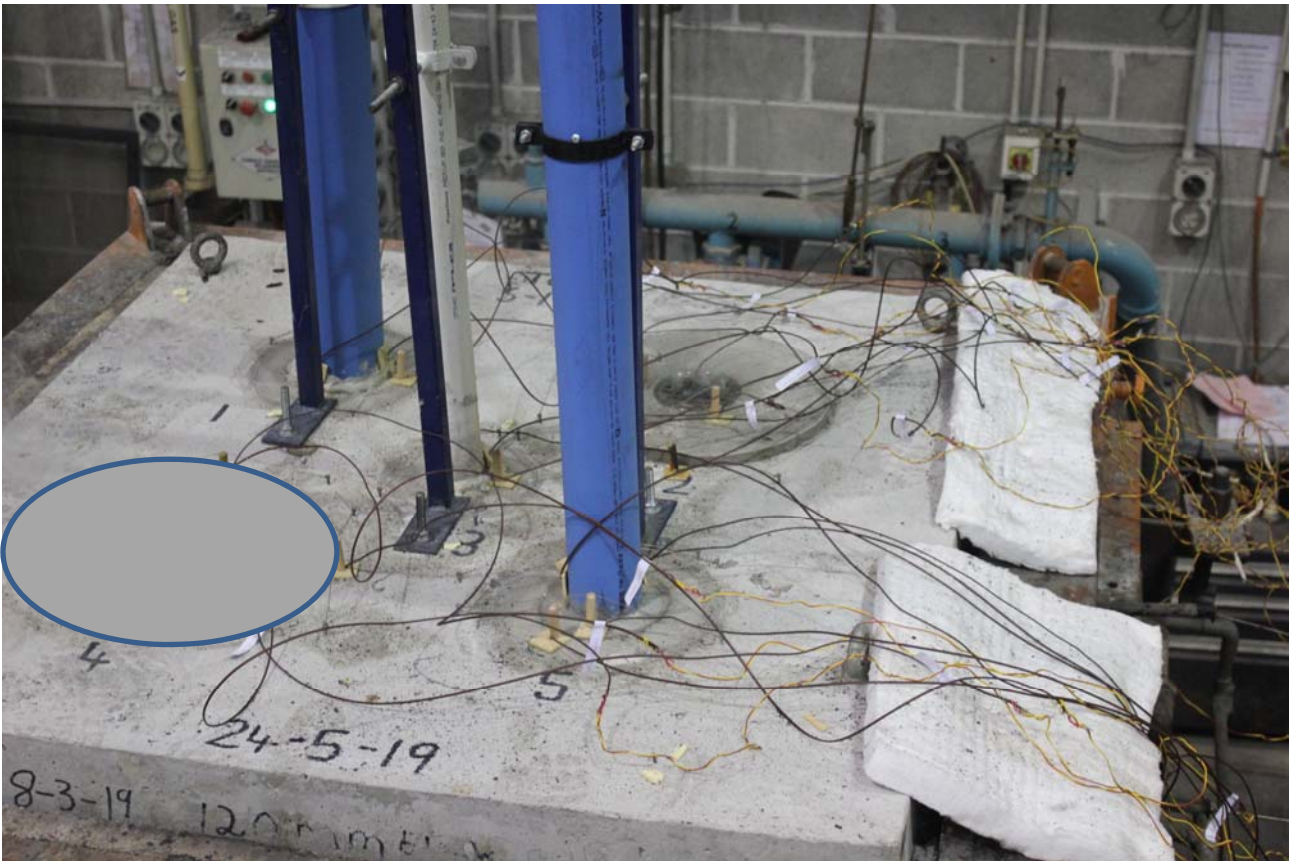
**PHOTOGRAPH 9 – SPECIMENS AFTER 180 MINUTES OF TESTING**

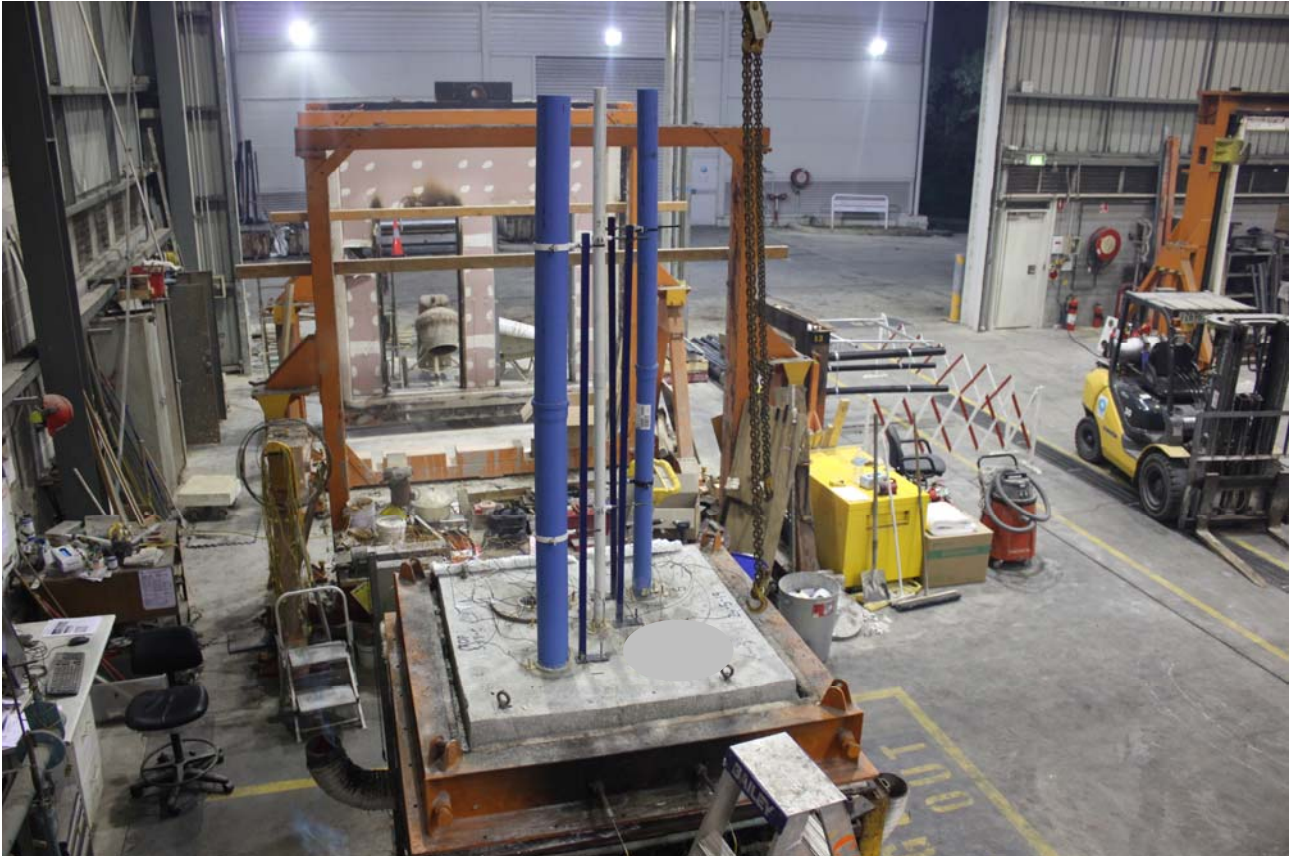
**PHOTOGRAPH 10 – SPECIMENS AFTER 240 MINUTES OF TESTING**

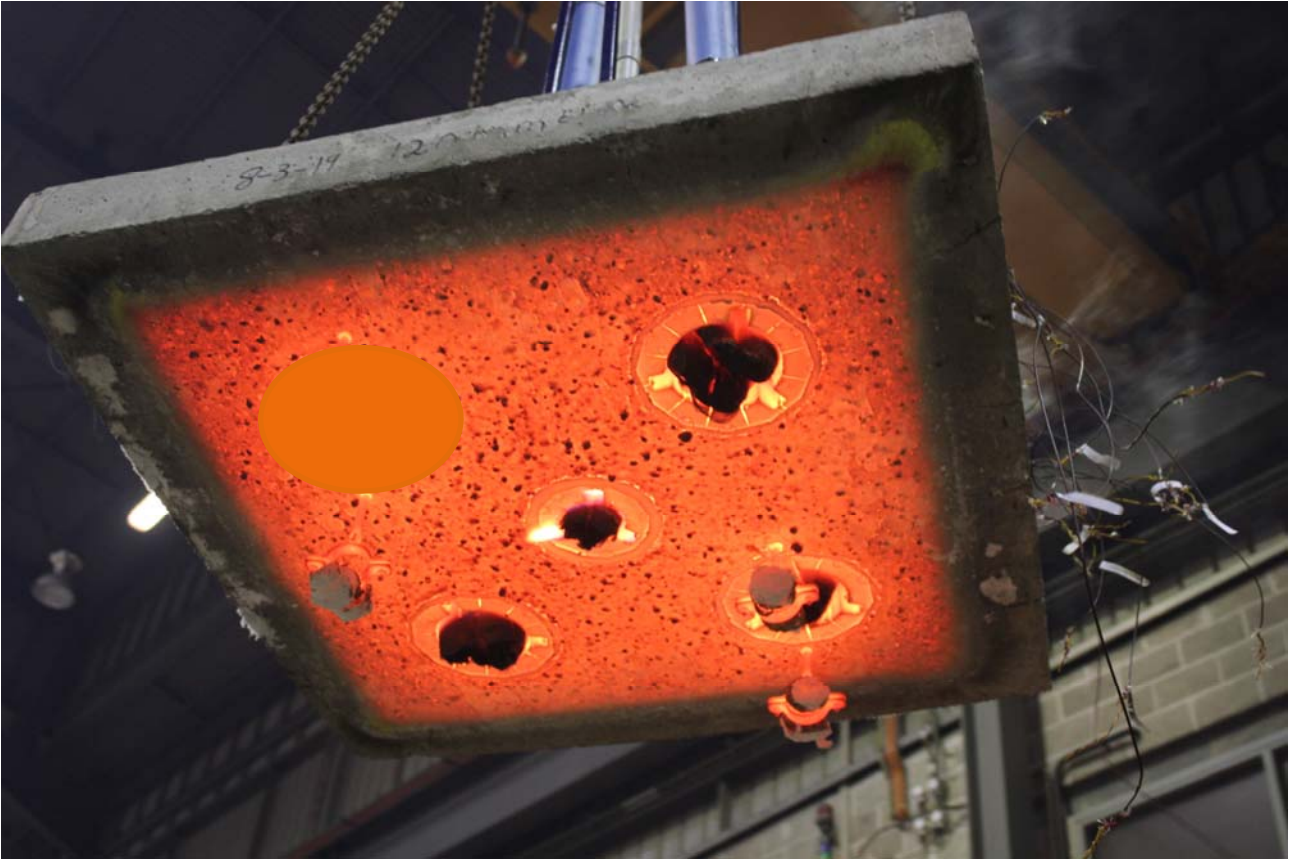
**PHOTOGRAPH 11 – EXPOSED FACE OF SPECIMENS AT THE CONCLUSION OF TESTING**
