Fire-resistance test on fire collars protecting a concrete floor slab penetrated by services

Test Report

Author: Peter Gordon
Report number: FSP 2028
Date: 22 August 2019

Sponsored Investigation No. FSP 2028

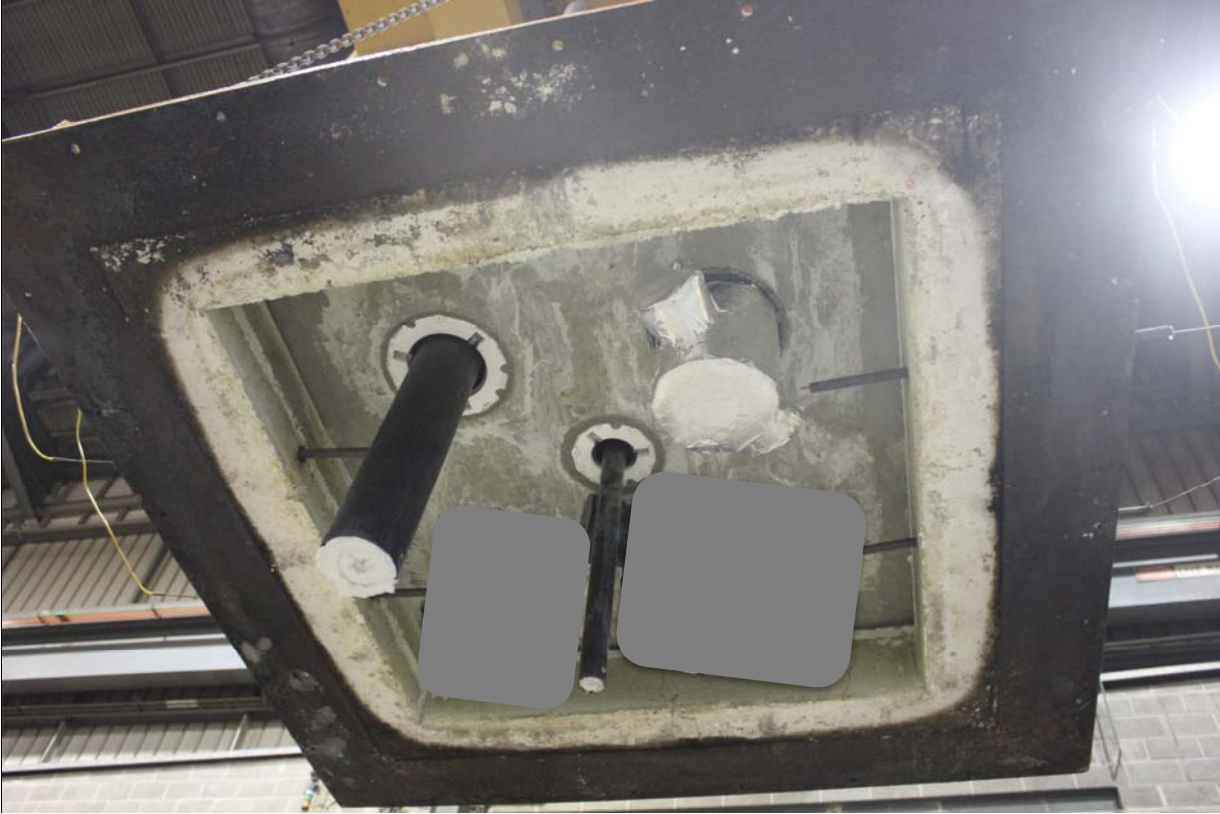
PHOTOGRAPH 1 – EXPOSED FACE OF SPECIMENS PRIOR TO TESTING

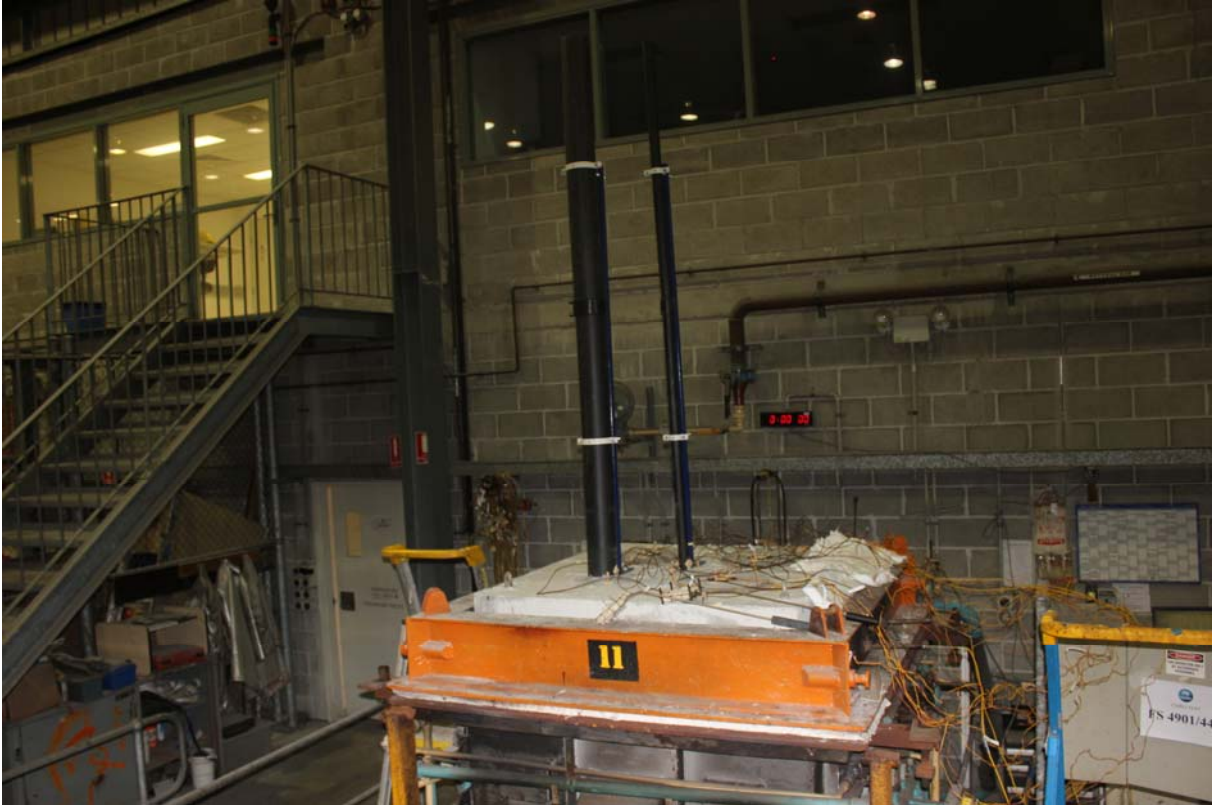
PHOTOGRAPH 2 – UNEXPOSED FACE OF SPECIMENS PRIOR TO TESTING

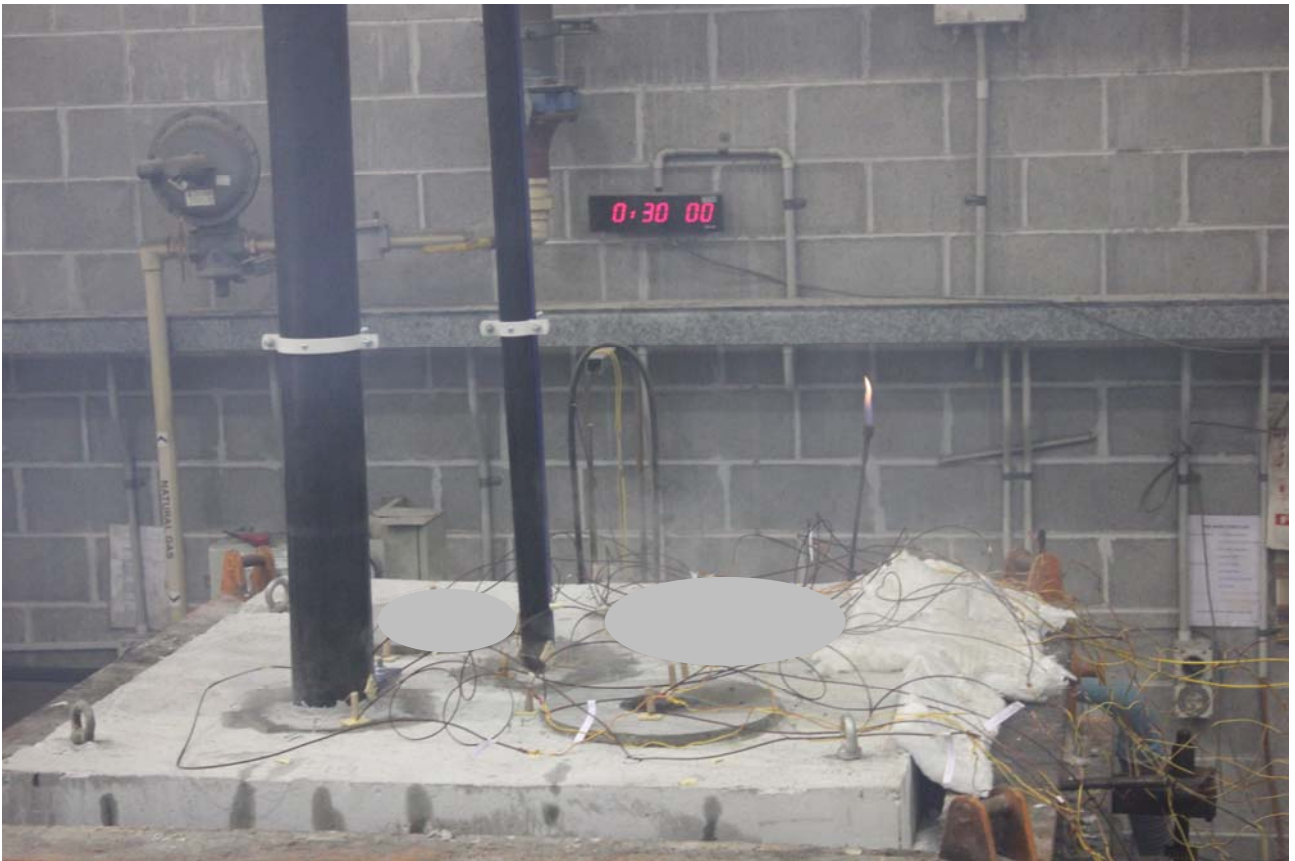
PHOTOGRAPH 3 – SPECIMENS AFTER 30 MINUTES OF TESTING

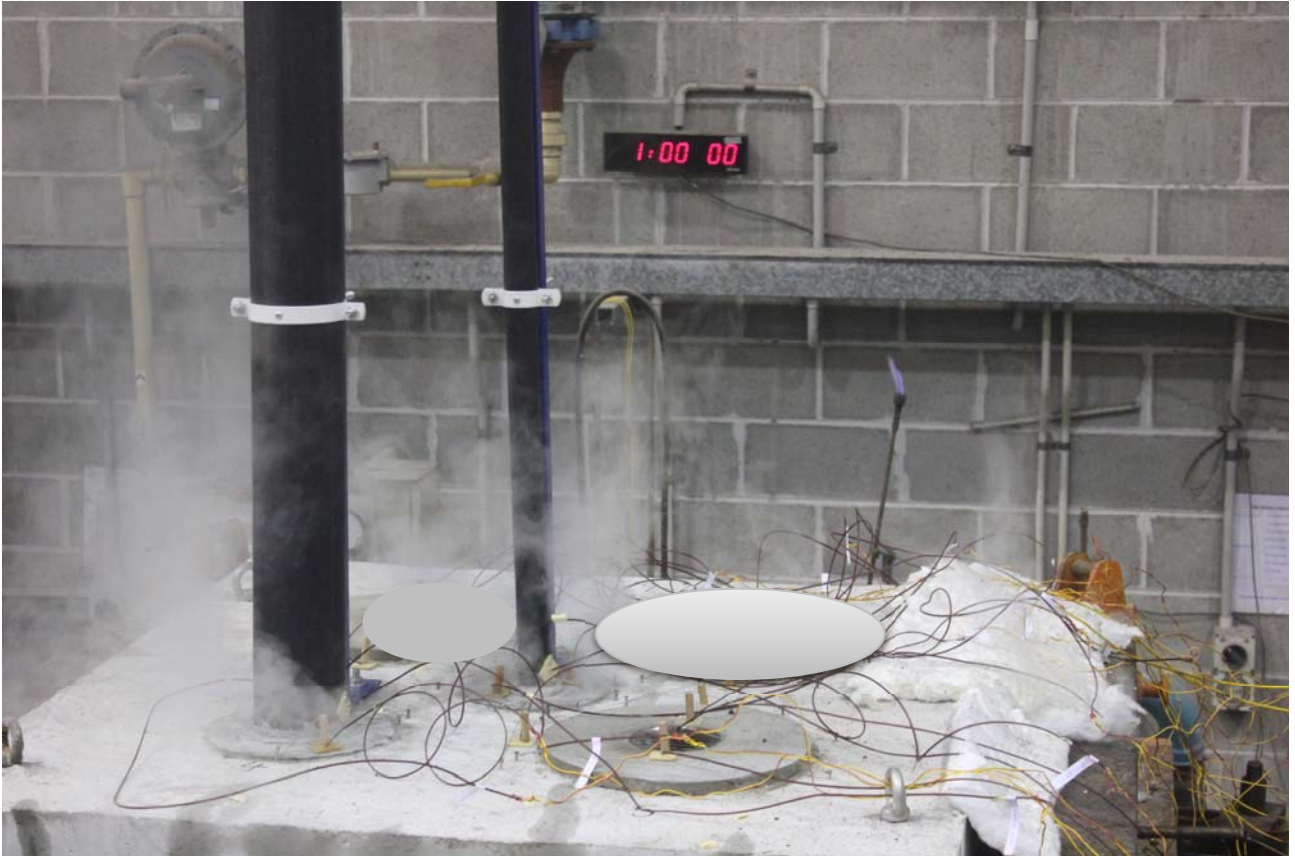
PHOTOGRAPH 4 – SPECIMENS AFTER 60 MINUTES OF TESTING

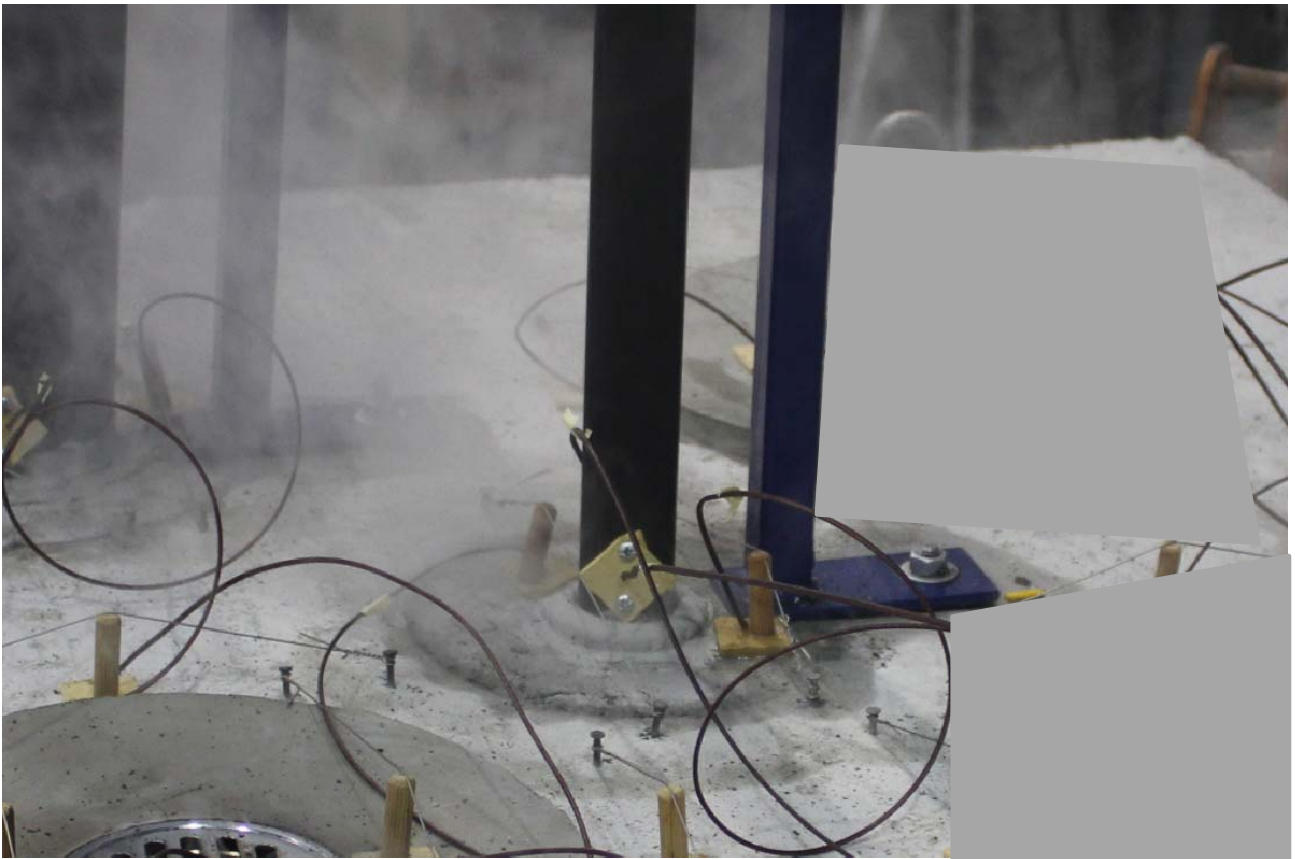
PHOTOGRAPH 5 – SPECIMEN 3 AFTER 62 MINUTES OF TESTING

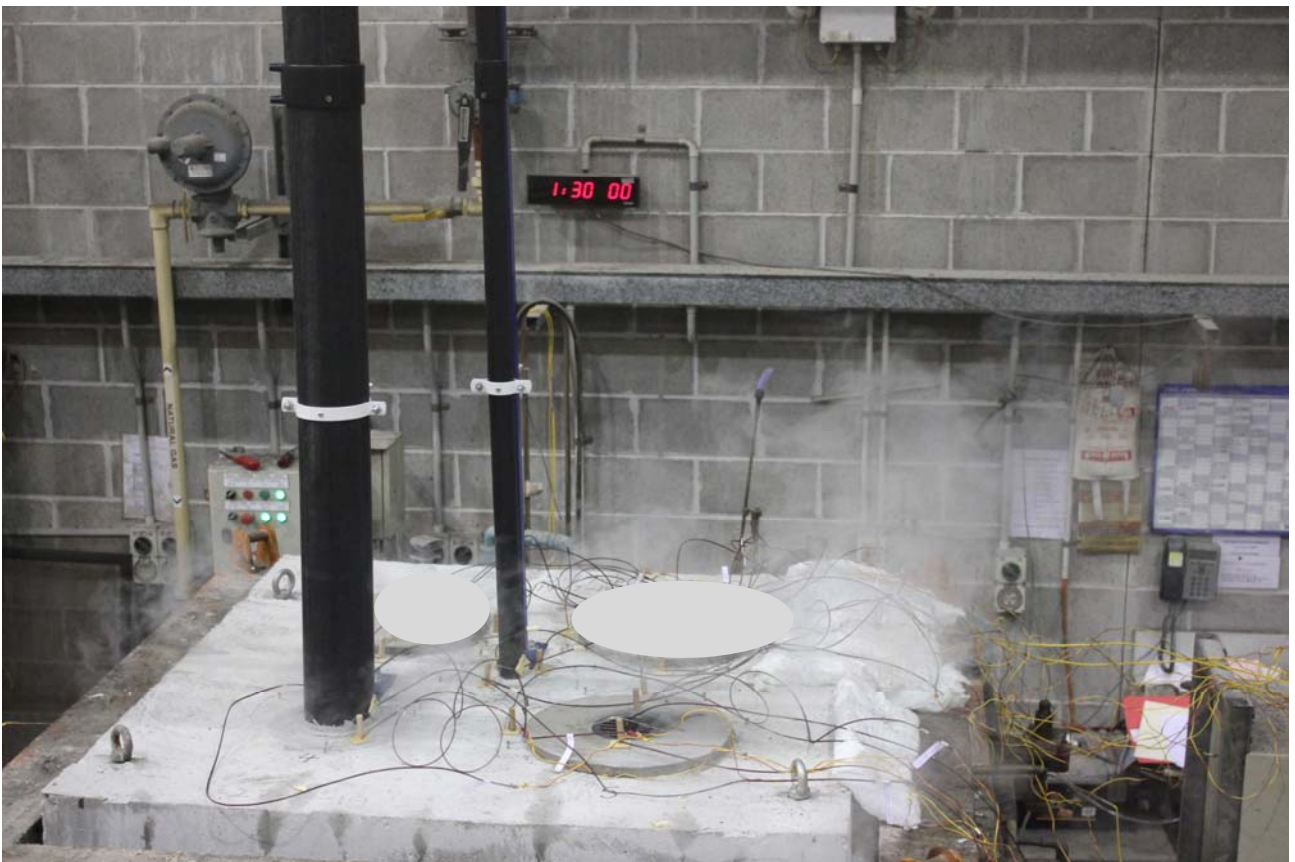
PHOTOGRAPH 6 – SPECIMENS AFTER 90 MINUTES OF TESTING

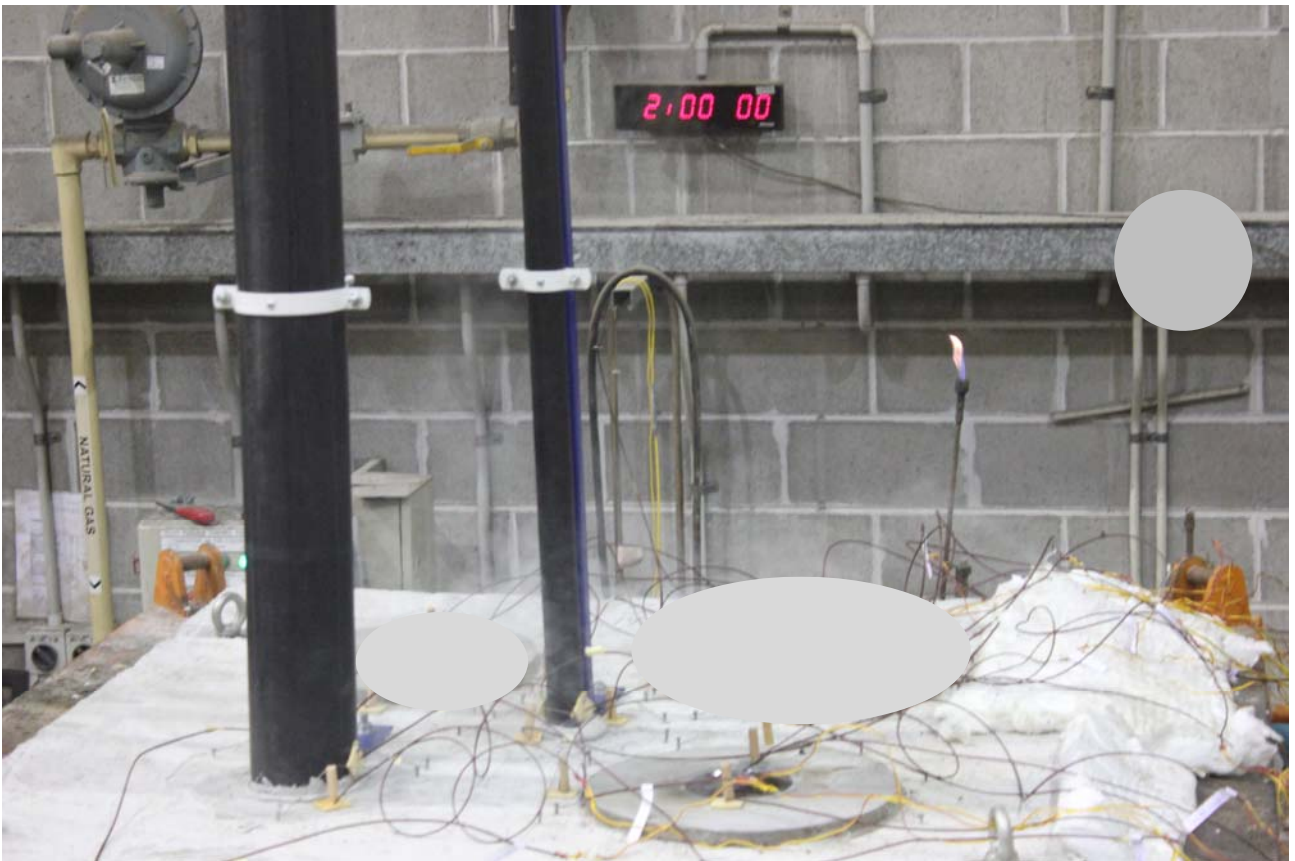
PHOTOGRAPH 7 – SPECIMENS AFTER 120 MINUTES OF TESTING

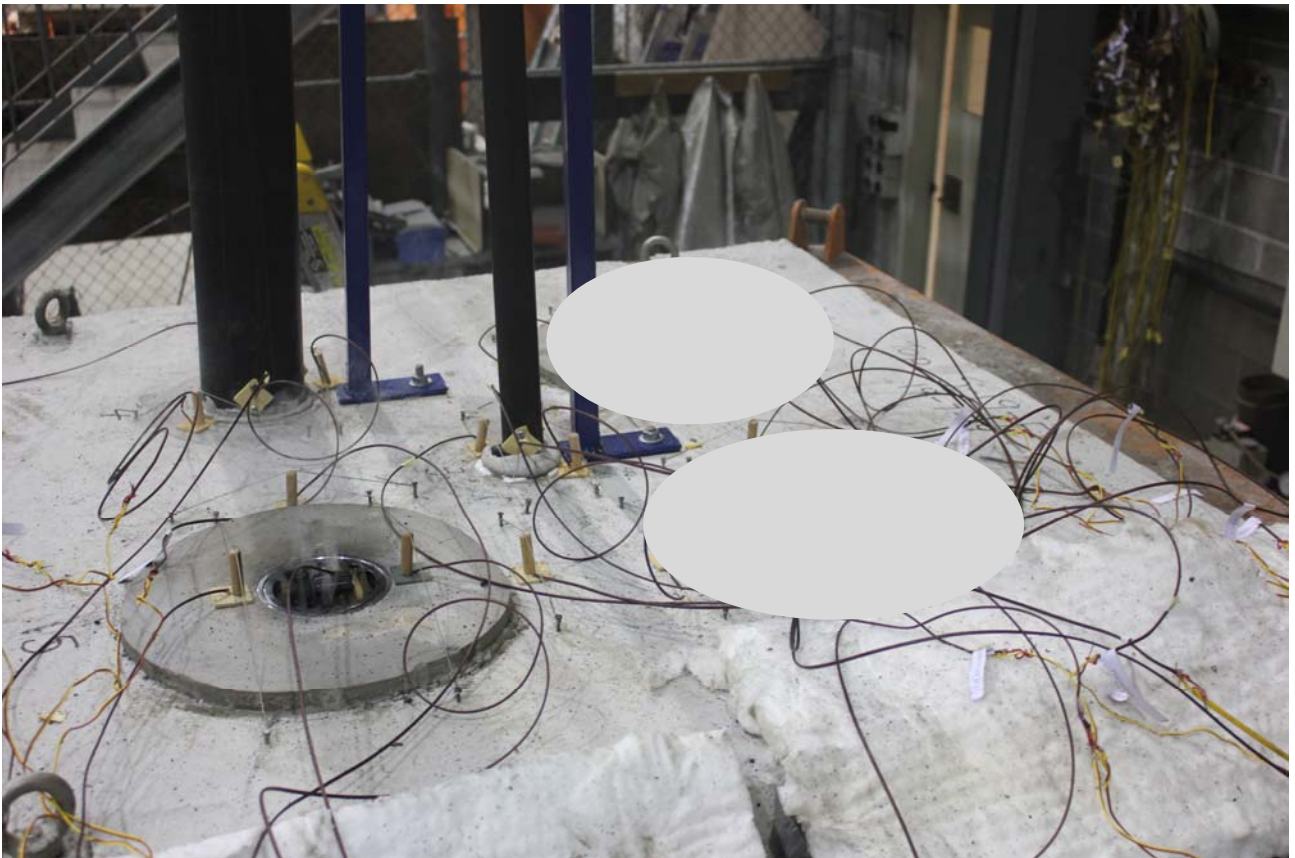
PHOTOGRAPH 8 – SPECIMENS AFTER 150 MINUTES OF TESTING

151 minutes -	<u>Insulation failure of Specimen 3</u> - maximum temperature rise of 180K is exceeded on the slab 25-mm from mastic on the unexposed face.

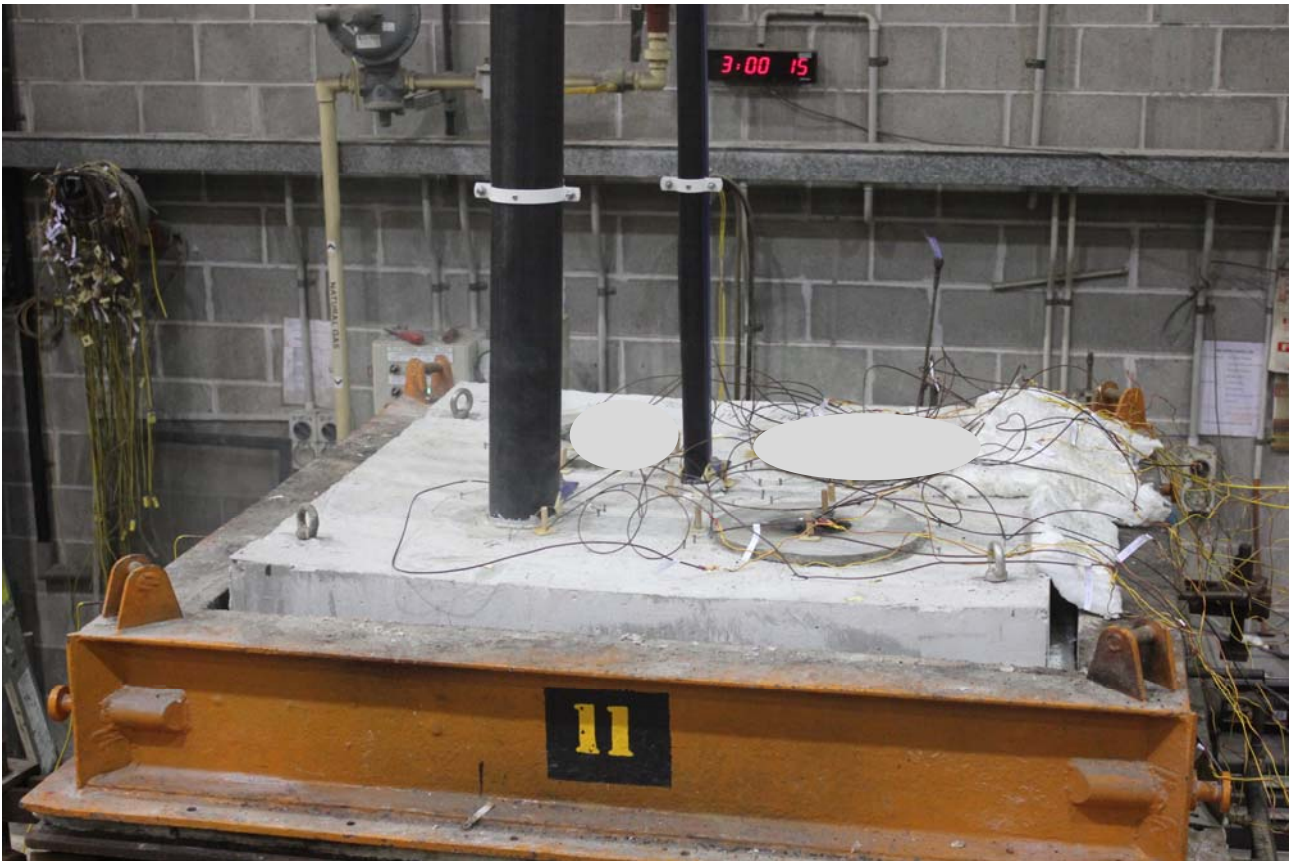
PHOTOGRAPH 9 – SPECIMENS AFTER 180 MINUTES OF TESTING

- 154 minutes - Insulation failure of Specimen 4 - maximum temperature rise of 180K is exceeded on the slab 25-mm from mastic on the unexposed face.
- 170 minutes - Insulation failure of Specimen 5 - maximum temperature rise of 180K is exceeded on the centre of the grate on the unexposed face.
- 241 minutes - Test terminated.

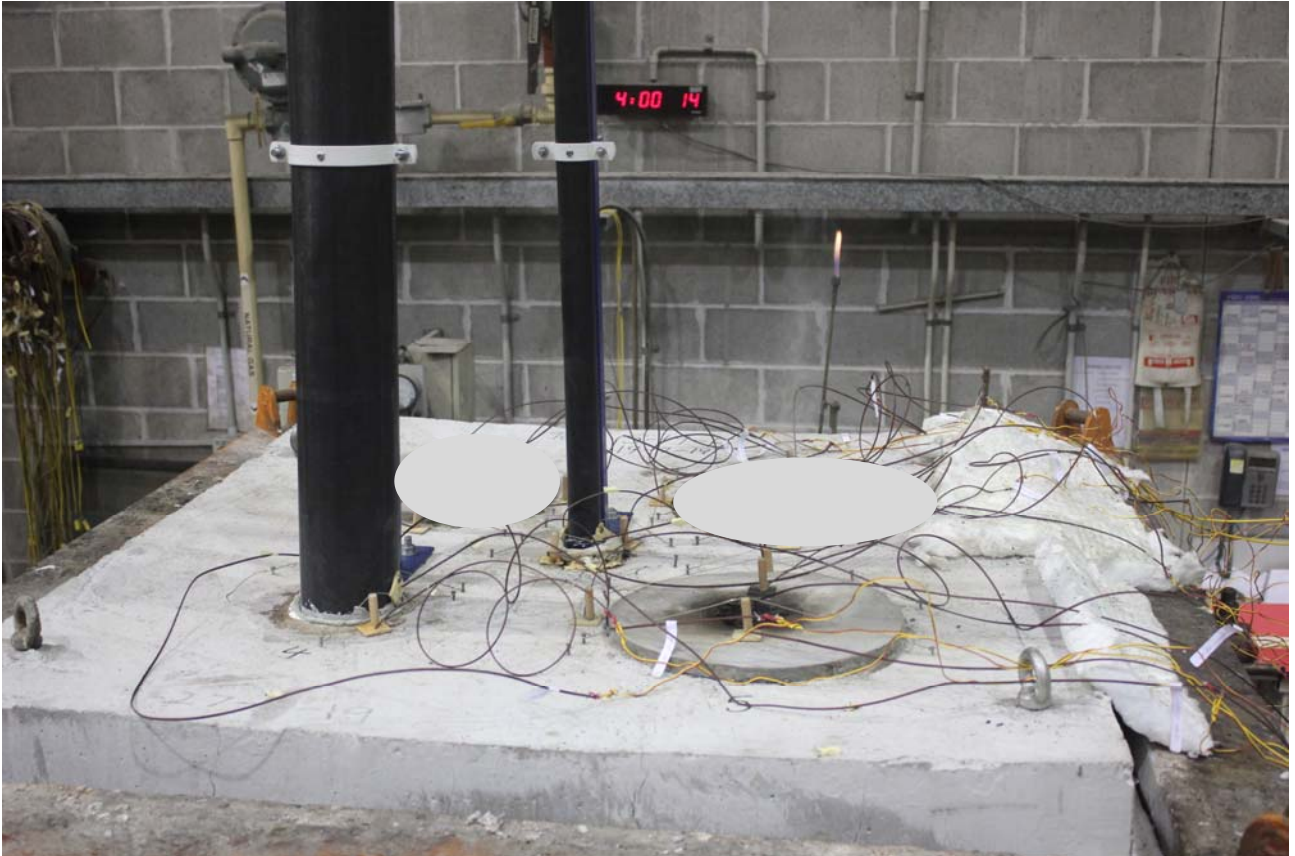
PHOTOGRAPH 10 – SPECIMENS AFTER 240 MINUTES OF TESTING

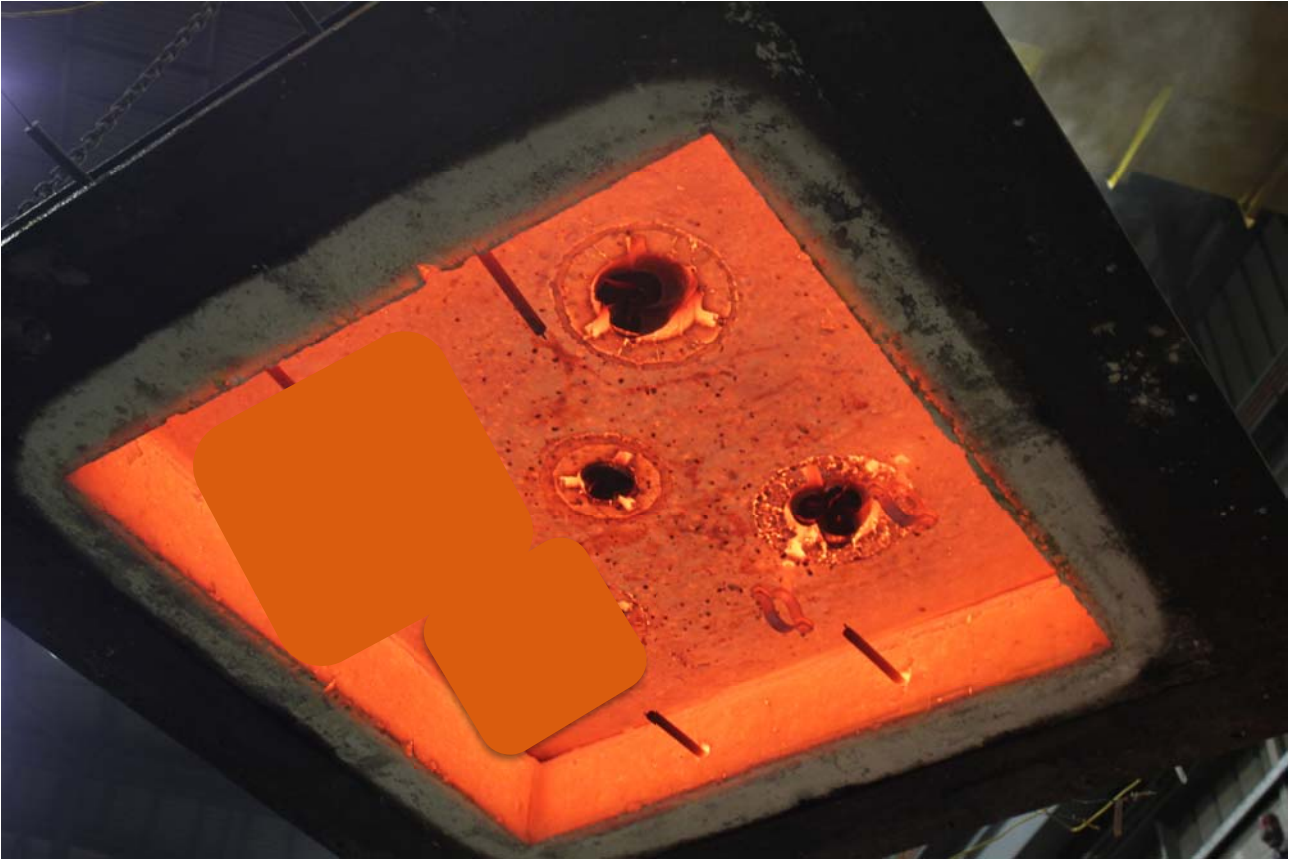
PHOTOGRAPH 10 – EXPOSED FACE OF SPECIMENS AT THE CONCLUSION OF TESTING

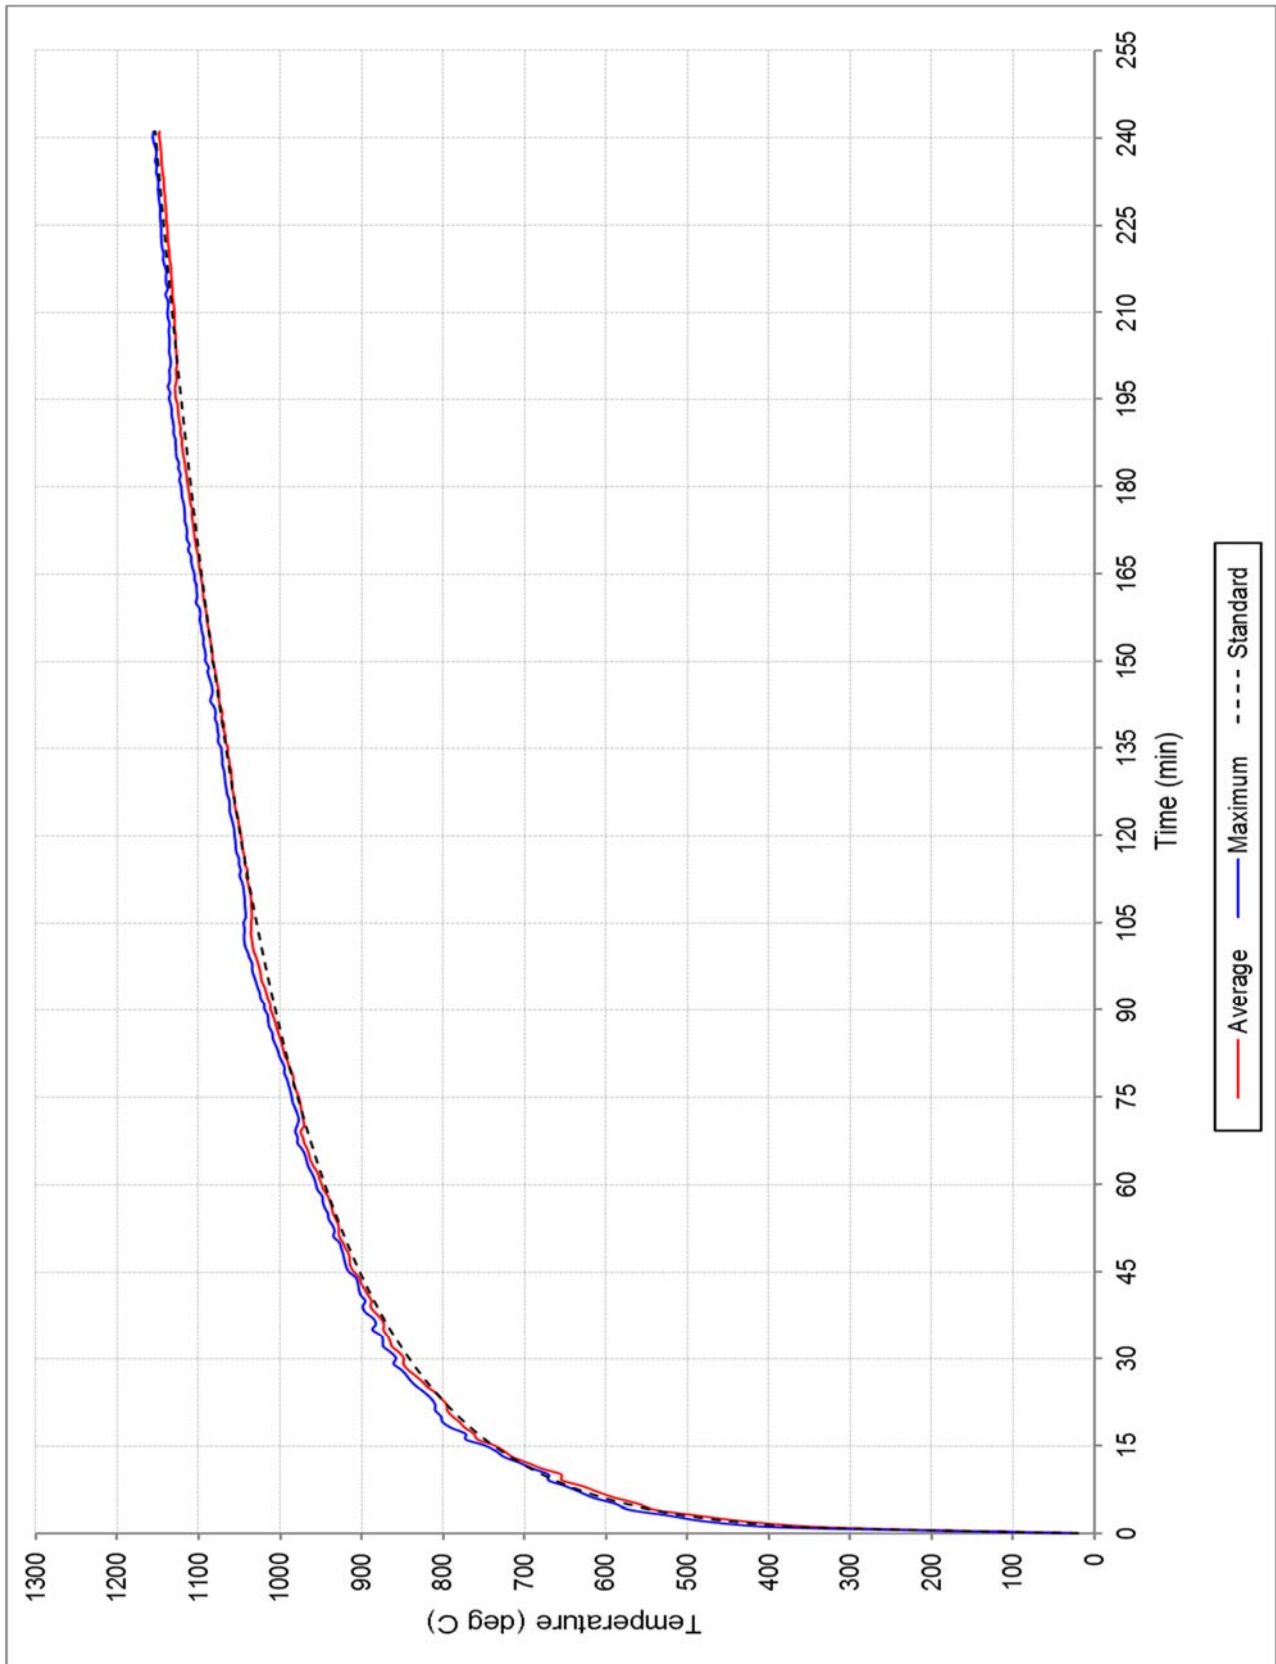
FIGURE 1 – FURNACE TEMPERATURE

Figure 1 shows the standard curves of temperature versus time for heating the furnace chamber and the actual curves of average and maximum temperature versus time recorded during the heating period.

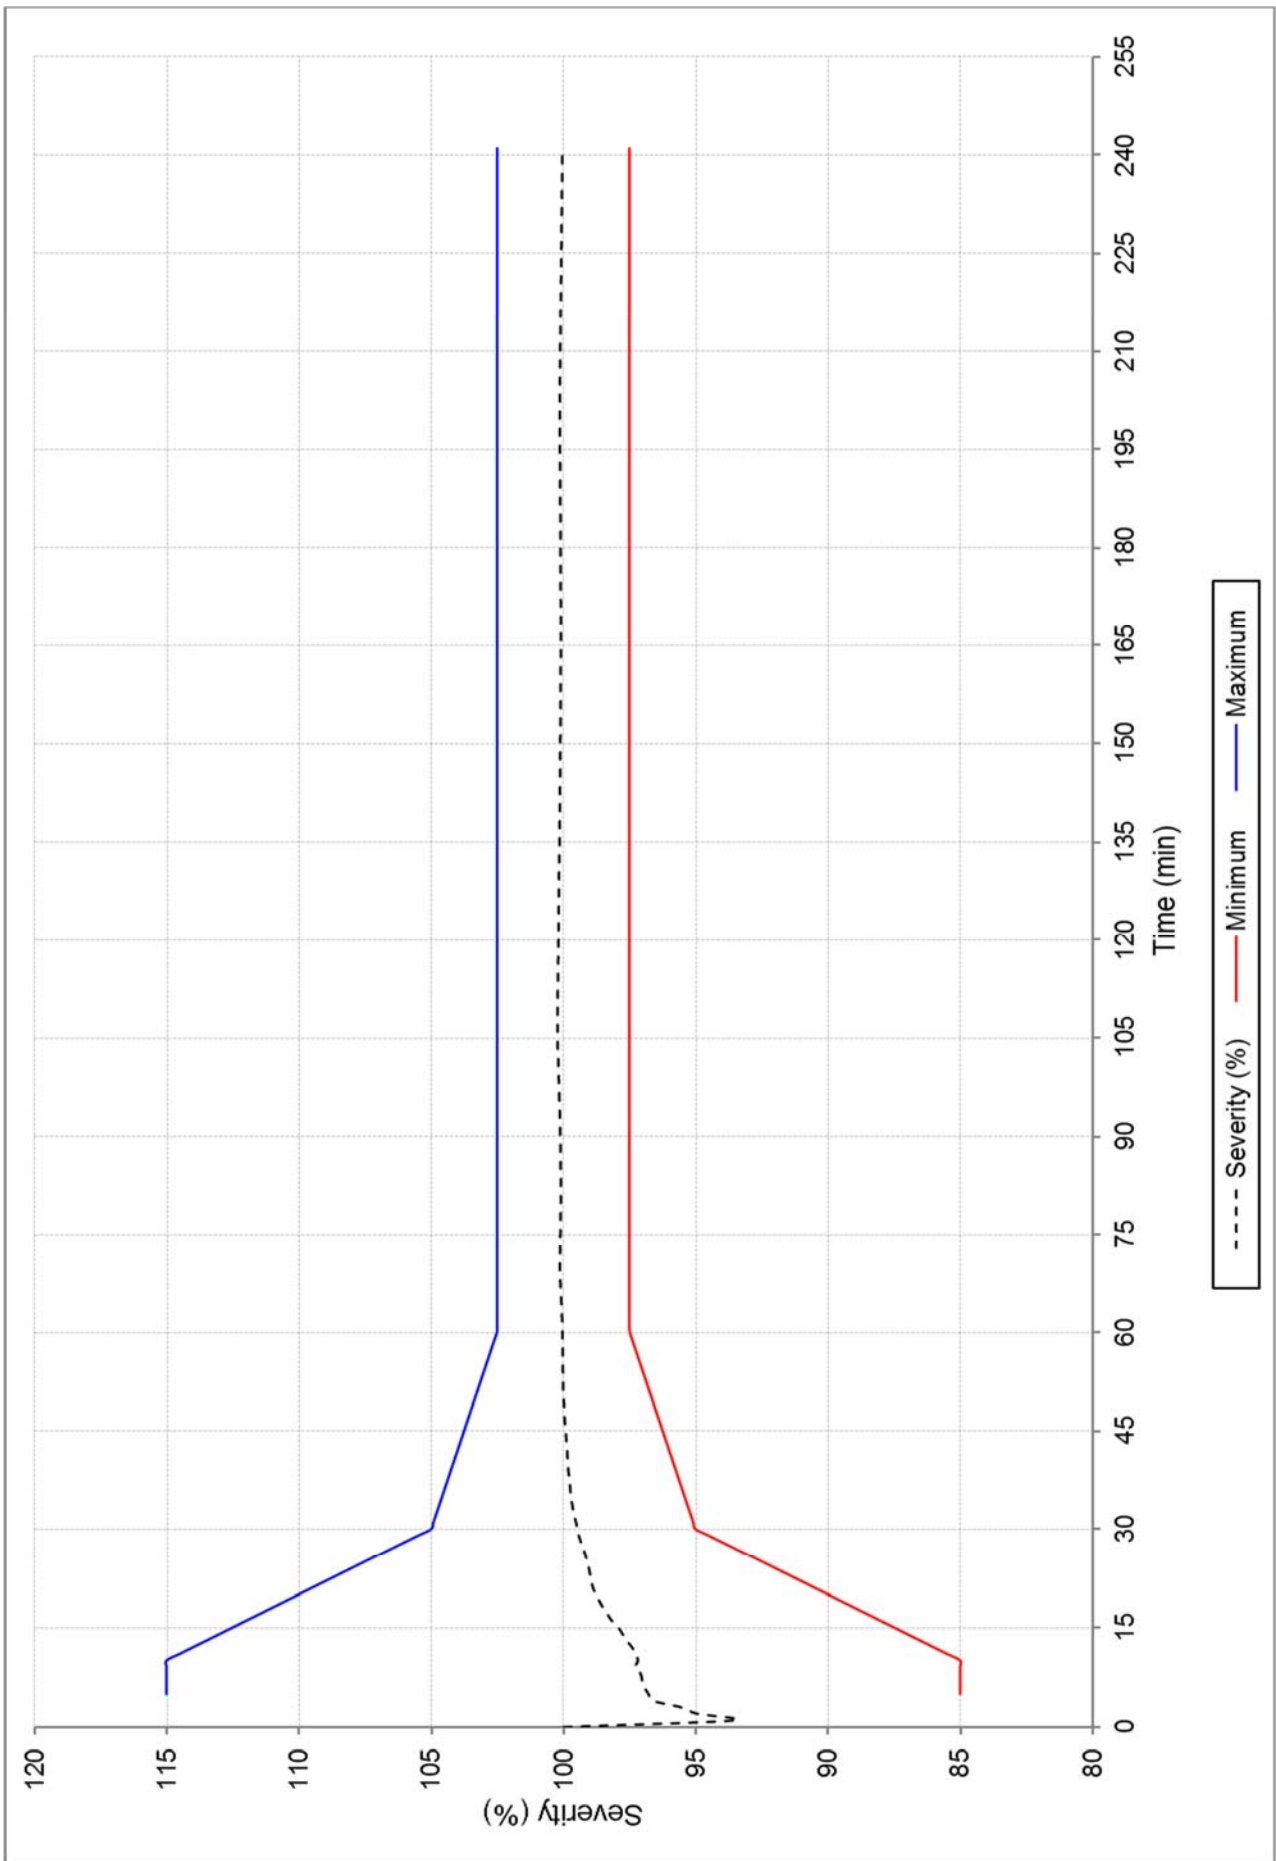
FIGURE 2 – FURNACE SEVERITY

Figure 2 shows the curve of furnace severity versus time during the heating period.

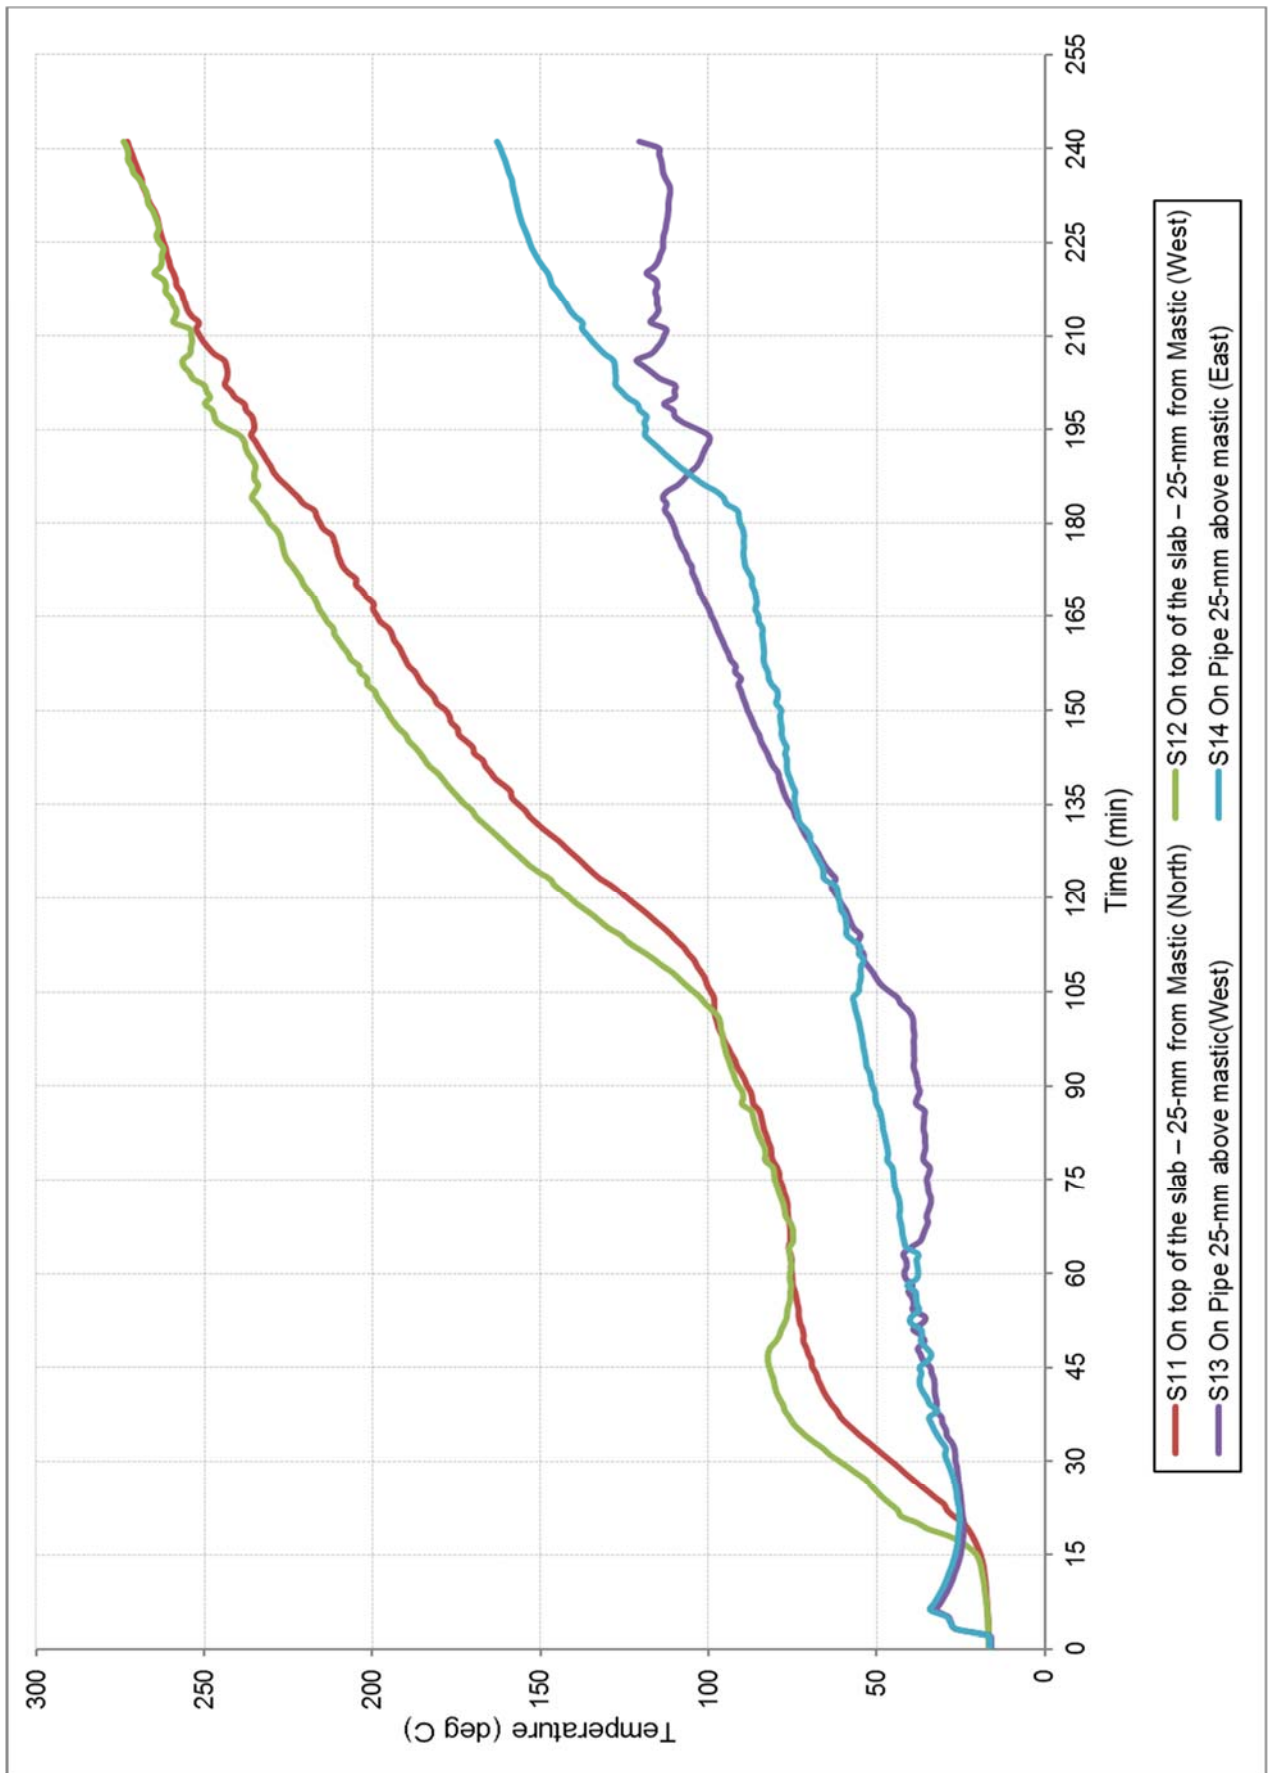
FIGURE 3 – SPECIMEN TEMPERATURE – ASSOCIATED WITH SPECIMEN 3

Figure 3 shows the curve of temperature versus time associated with Specimen 3.

Structural adequacy	-	not applicable
Integrity	-	no failure at 241 minutes
Insulation	-	151 minutes

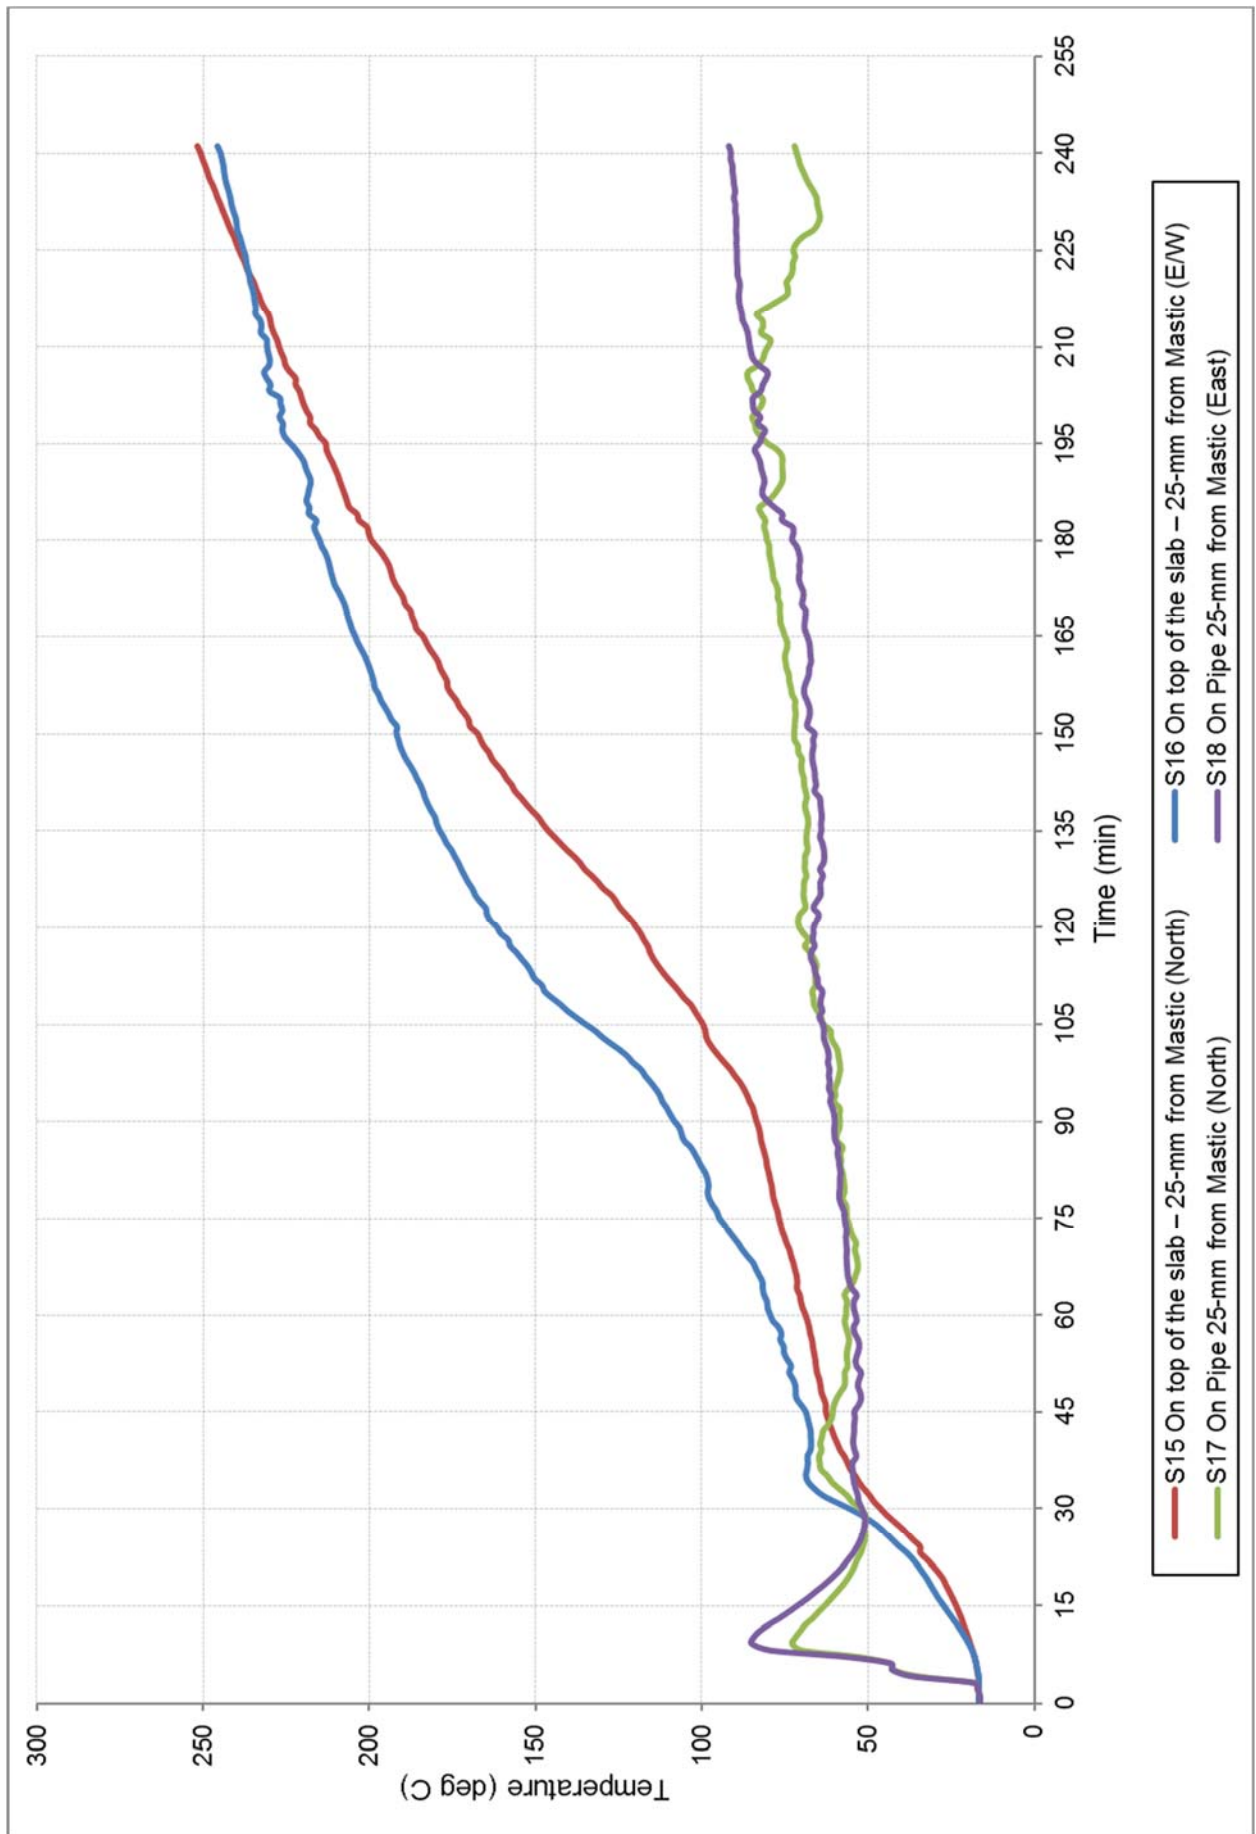
FIGURE 4 – SPECIMEN TEMPERATURE – ASSOCIATED WITH SPECIMEN 4

Figure 4 shows the curve of temperature versus time associated with Specimen 4.

Structural adequacy	-	not applicable
Integrity	-	no failure at 241 minutes
Insulation	-	155 minutes
