Fire-resistance test on fire collars protecting a concrete floor slab penetrated by services

Test Report

Author: Peter Gordon
Report number: FSP 2028
Date: 22 August 2019

Sponsored Investigation No. FSP 2028

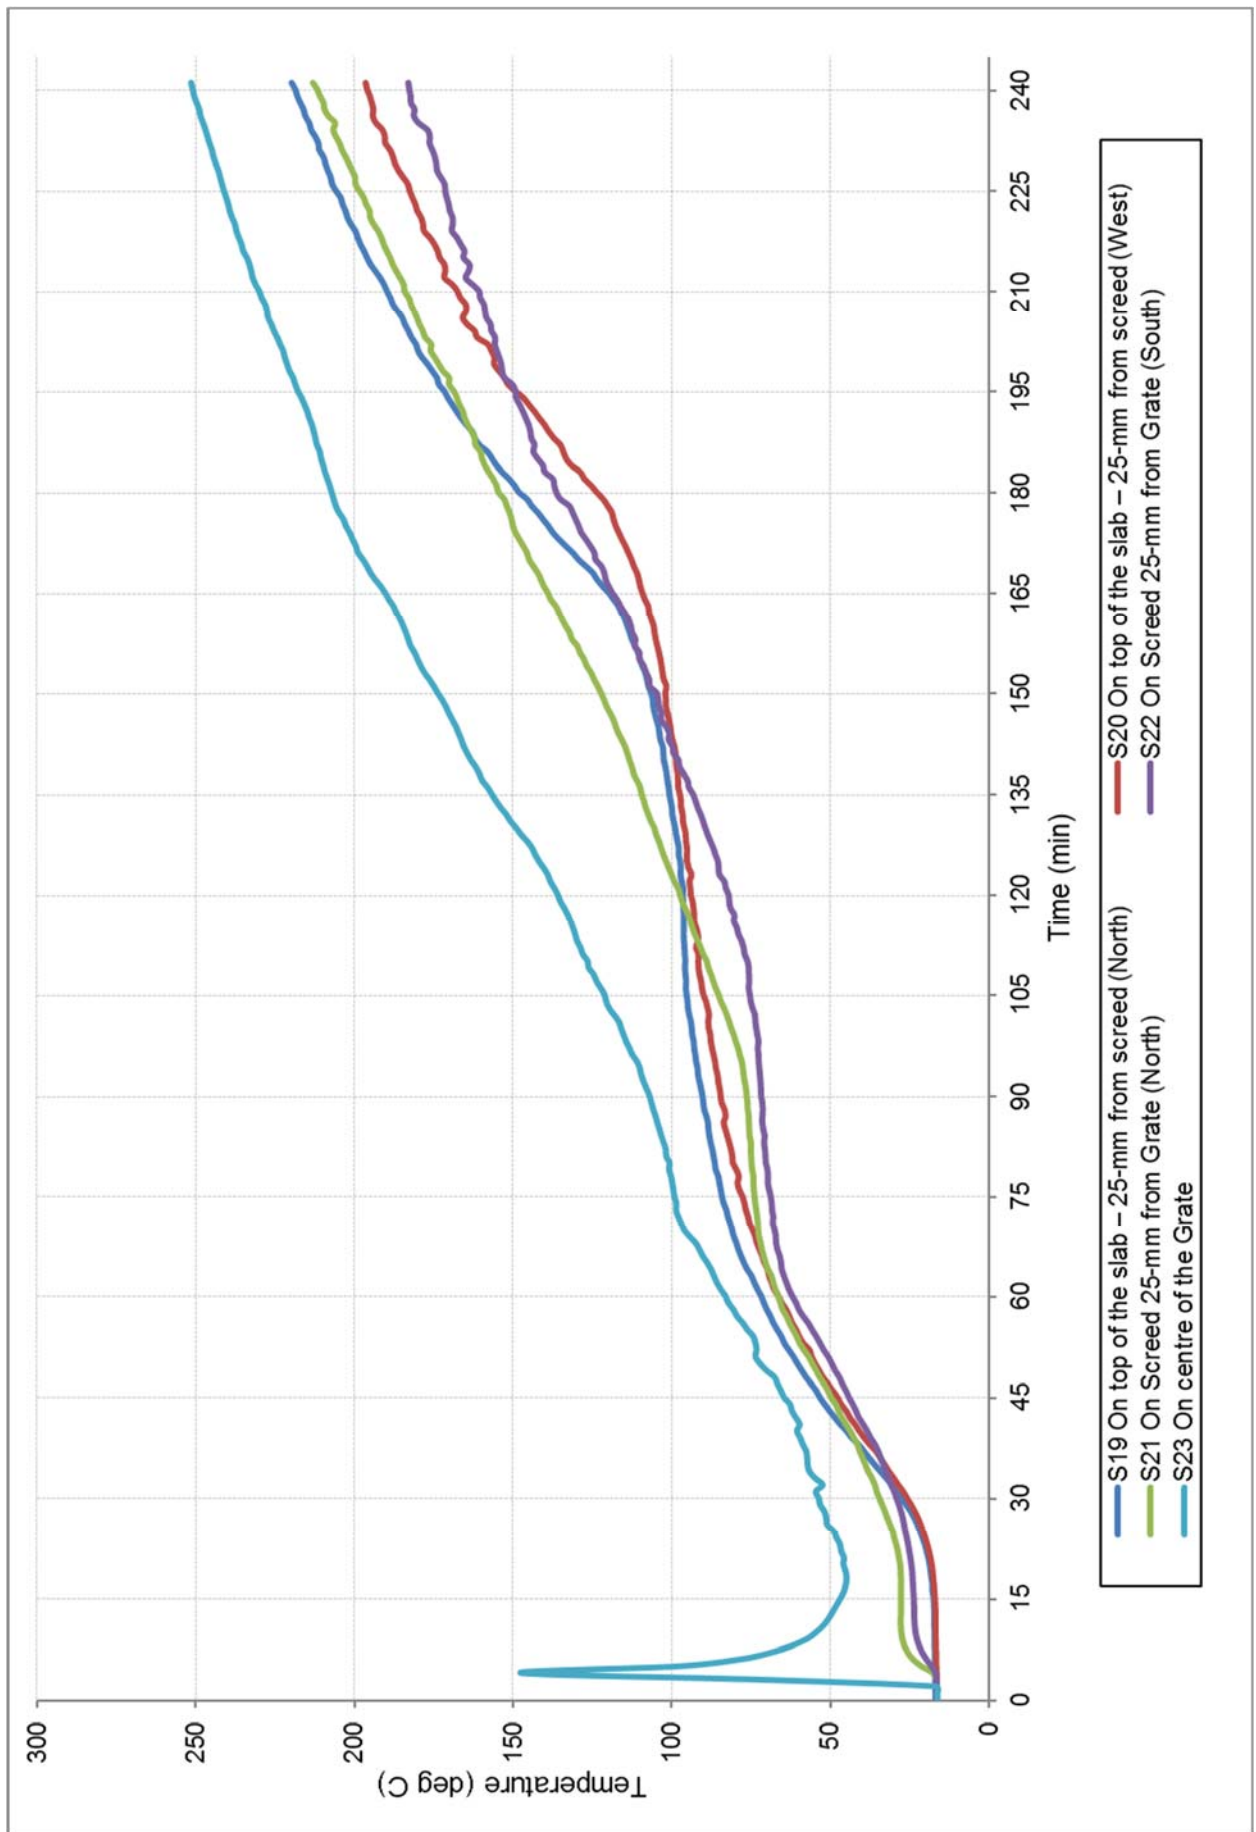
FIGURE 5 – SPECIMEN TEMPERATURE – ASSOCIATED WITH SPECIMEN 5

Figure 5 shows the curve of temperature versus time associated with Specimen 5.

Structural adequacy	-	not applicable
Integrity	-	no failure at 241 minutes
Insulation	-	170 minutes

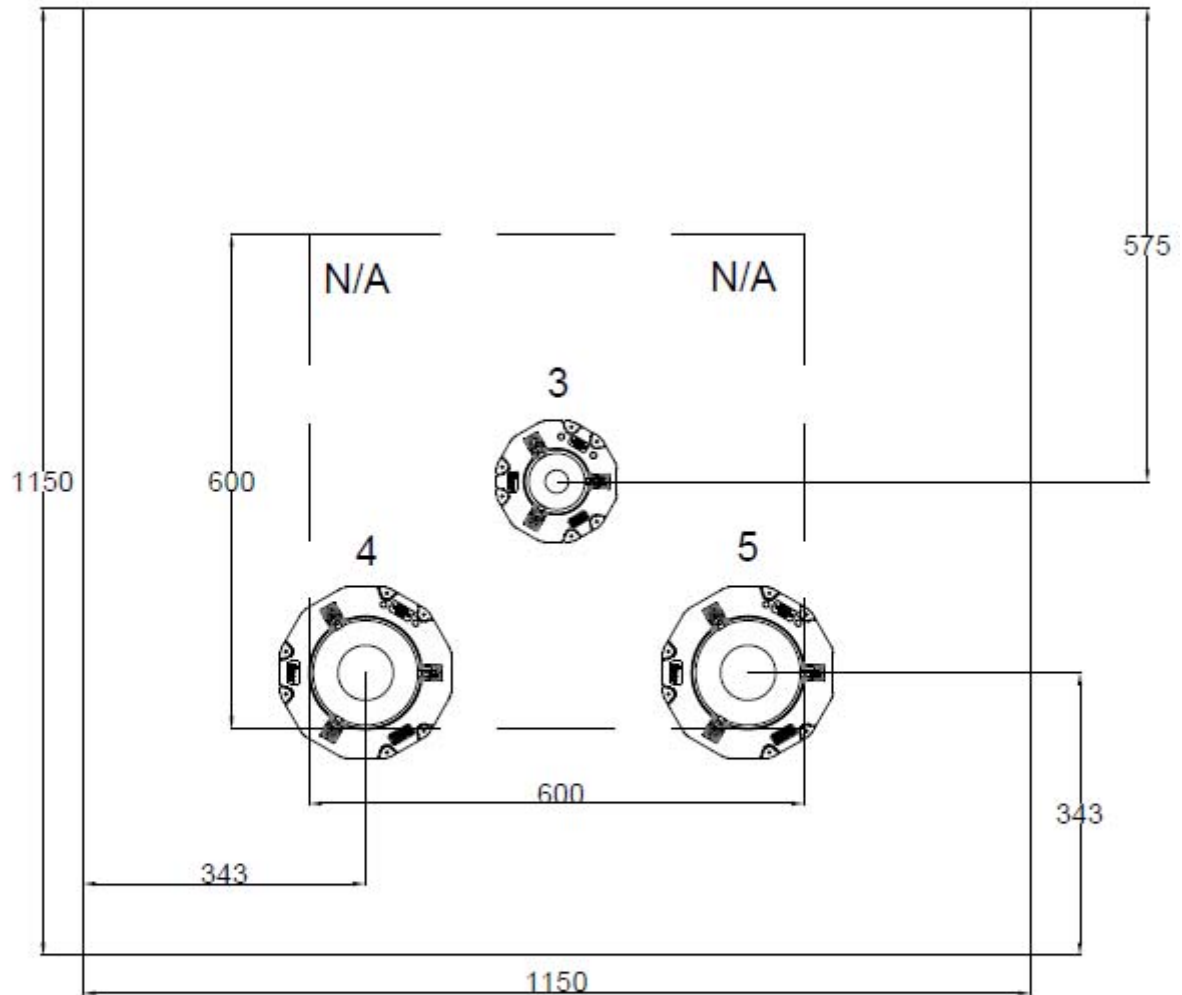
Penetration	Collar Code	Pipe Type	Pipe Diameter (mm)	Fitting
3	H50S	HDPE	40	N/A
4	H100S	HDPE	110	N/A
5	H100FWS	PVC-SC	100	N/A

DRAWING TITLED “TEST SLAB S-19-F LAYOUT”, DATED 8 MAY 2019, PROVIDED BY SNAP FIRE SYSTEMS PTY LTD

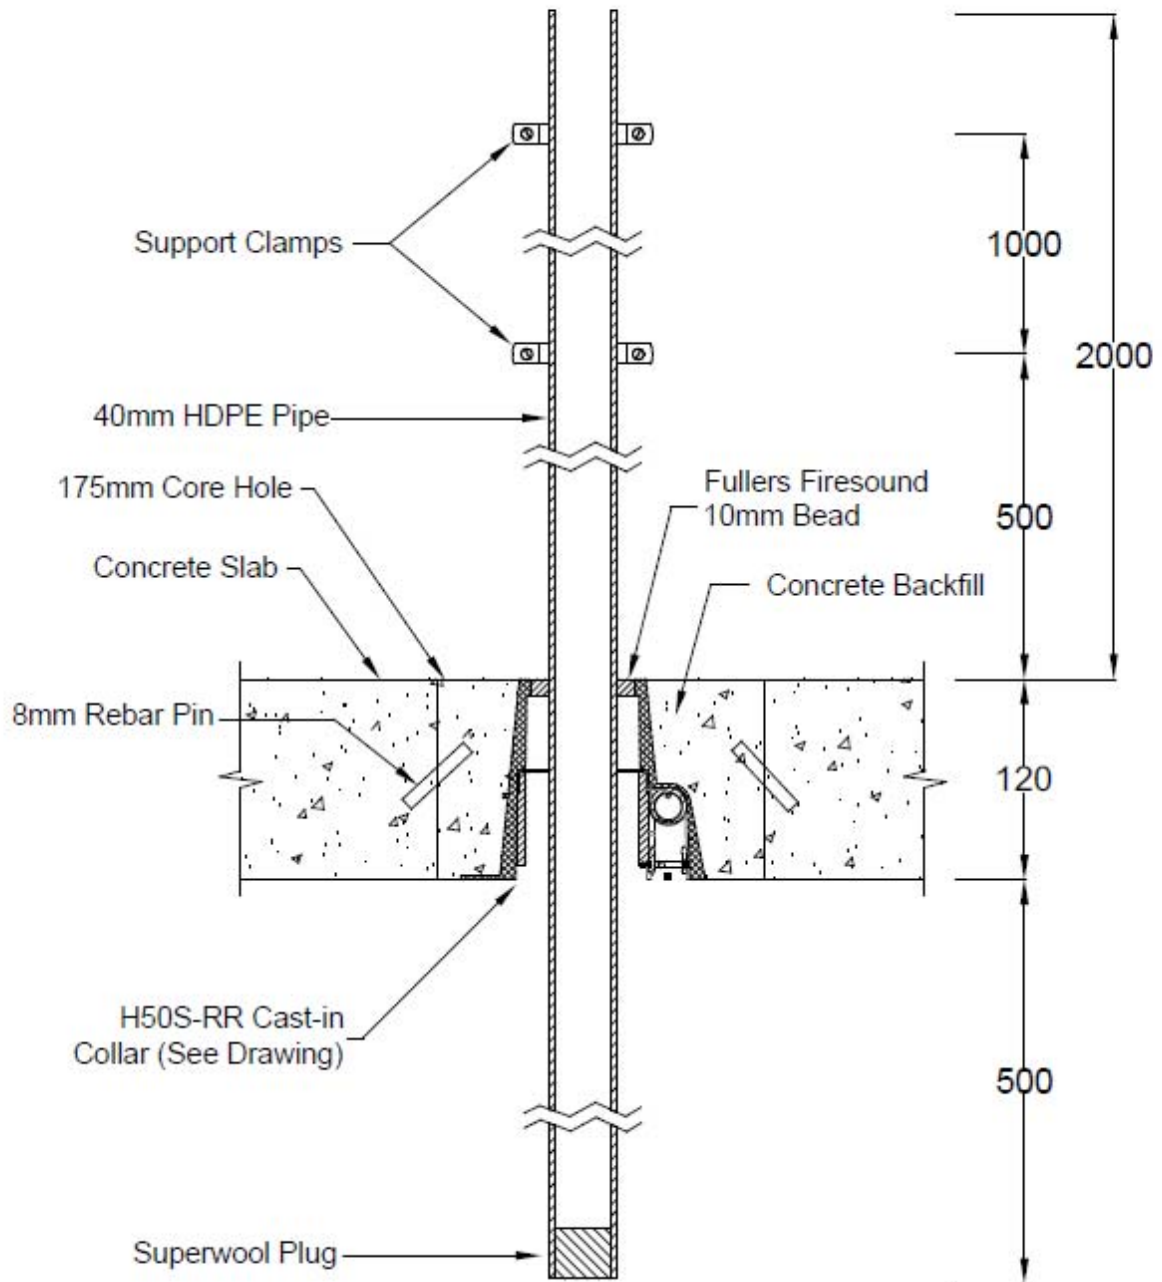
DRAWING TITLED "SPECIMEN # 3, 40 HDPE STACK & H50S-RR", DATED 15 JULY 2019, PROVIDED BY SNAP FIRE SYSTEMS PTY LTD

The penetrating service comprised a 40.5-mm outside diameter HDPE pipe with a wall thickness of 3.68-mm through the collar's sleeve. The annular gap between the pipe and the inside collar was protected with a bead of Fullers Firesound sealant as shown in titled "Specimen #3 40 HDPE Stack & H50S-RR", dated 15 July 2019, provided by Snap Fire Systems Pty Ltd. The pipe projected vertically, 2000-mm above from the unexposed face of the concrete slab and 500-mm into the furnace chamber. The pipe was supported at nominally 500-mm and 1500-mm from the unexposed face of the slab. The pipe was open at the unexposed end and capped with Superwool ceramic fibre plug on the exposed end.

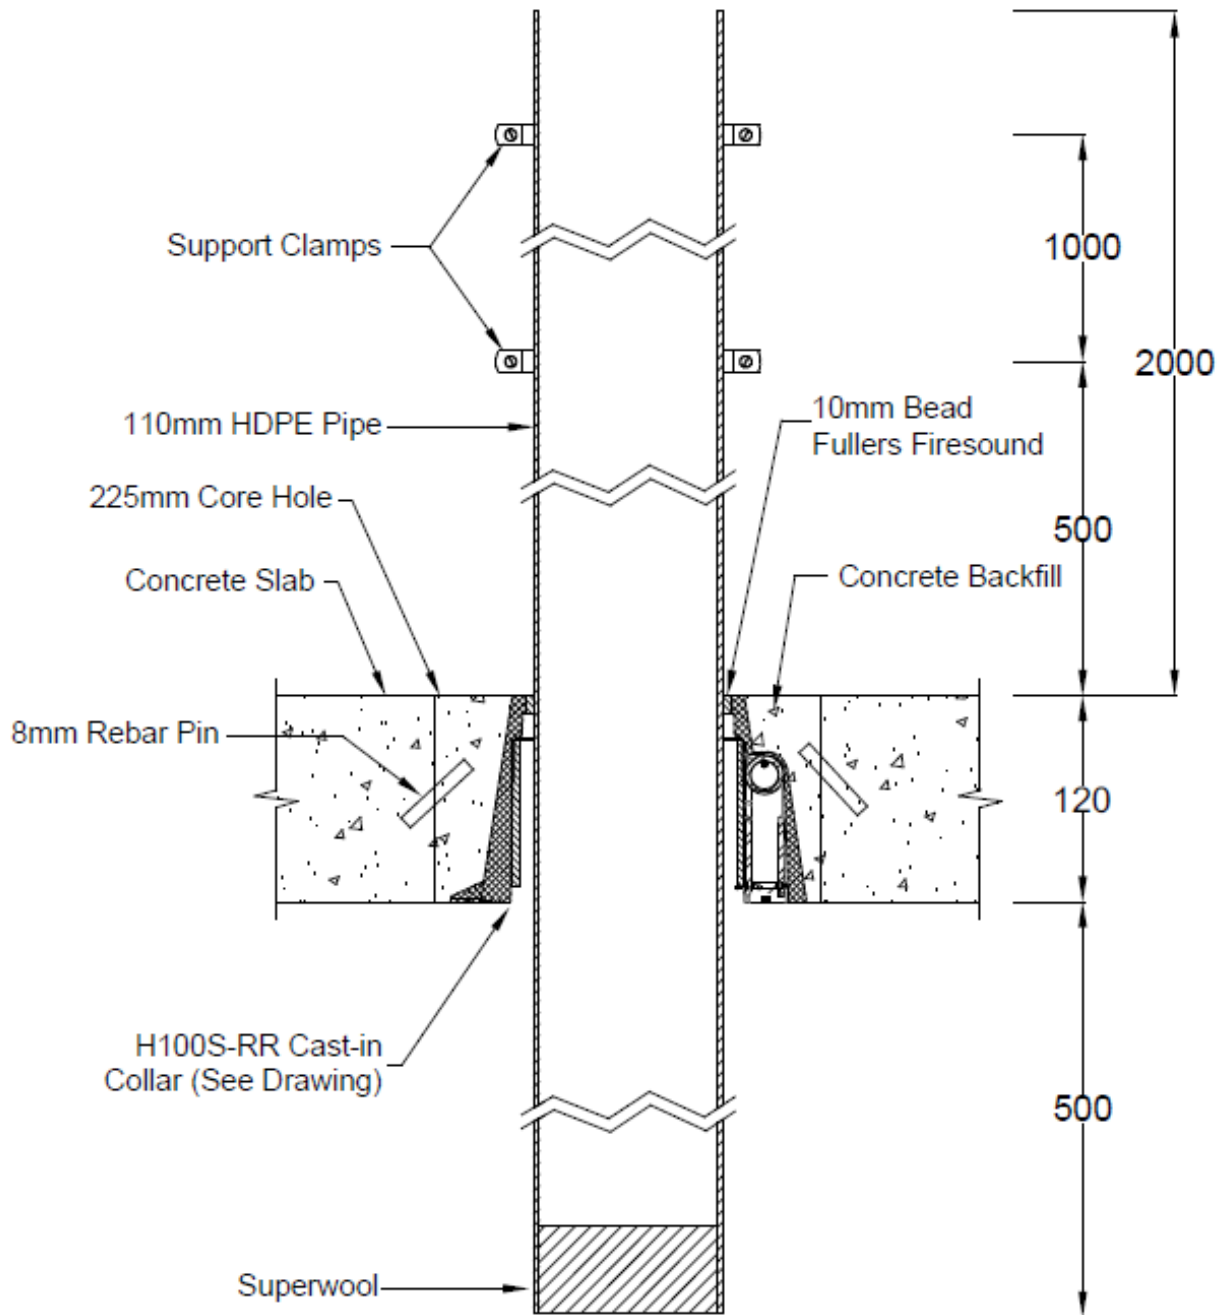
DRAWING TITLED "SPECIMEN # 4, 110 HDPE STACK & H100S-RR", DATED 15 JULY 2019, PROVIDED BY SNAP FIRE SYSTEMS PTY LTD

The penetrating service comprised a 110-mm outside diameter HDPE pipe with a wall thickness of 4.97-mm through the collar's sleeve. The annular gap between the pipe and the inside collar was protected with a bead of Fullers Firesound sealant as shown in drawing titled "Specimen #4 110 HDPE Stack & H100S-RR", dated 15 July 2019, provided by Snap Fire Systems Pty Ltd. The pipe projected vertically, 2000-mm above from the unexposed face of the concrete slab and 500-mm into the furnace chamber. The pipe was supported at nominally 500-mm and 1500-mm from the unexposed face of the slab. The pipe was open at the unexposed end and capped with Superwool ceramic fibre plug on the exposed end.

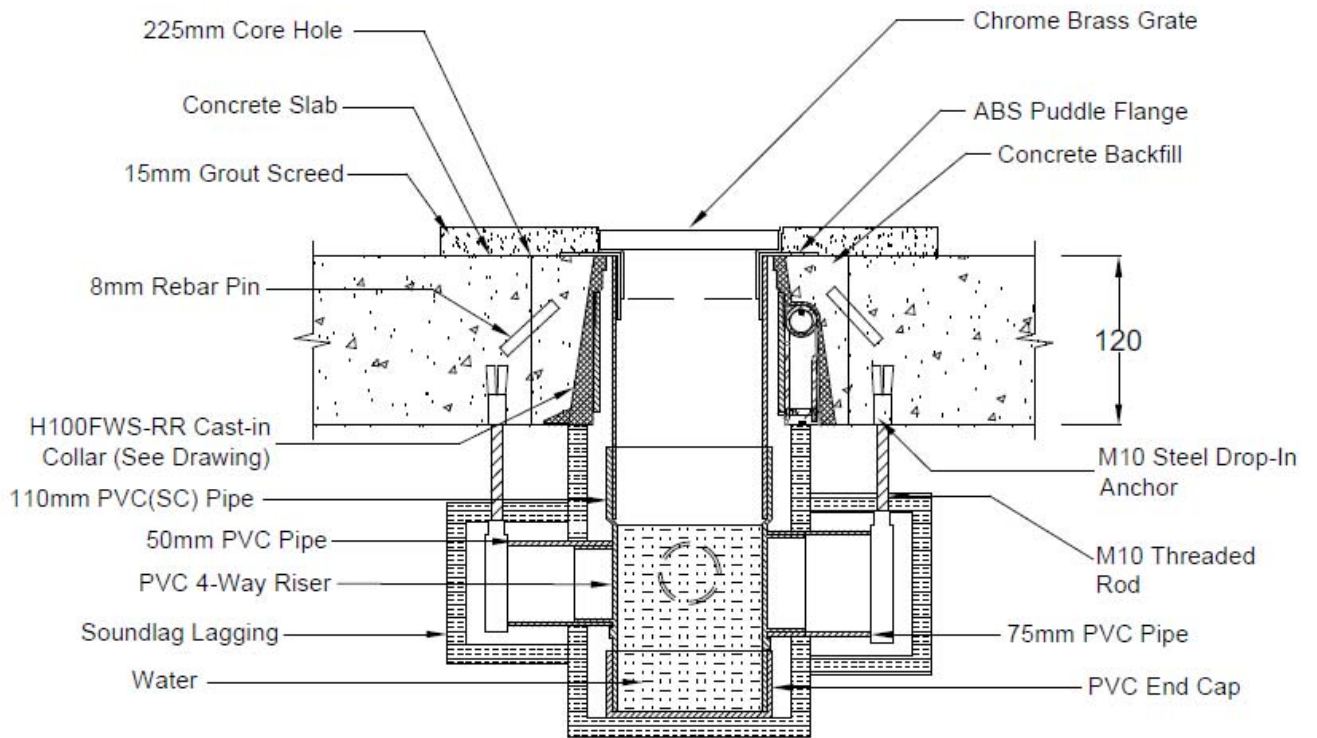
DRAWING TITLED "SPECIMEN #5, 100 PVC(SC) FWS, LAGGING & H100FWS-RR", DATED 15 MAY 2019, PROVIDED BY SNAP FIRE SYSTEMS PTY LTD

The penetrating service comprised a 110-mm outside diameter polyvinyl chloride (PVC) sandwich construction pipe with a wall thickness of 3.7-mm fitted through the collar's sleeve. The floor waste system was fitted with a chrome brass grate and ABS Puddle Flange. A 15-mm thick grout screed was laid on top of the concrete slab and finished flush with the floor grate. On the exposed side of the slab, a 4-way riser was connected to the penetrating pipe, supported by two M10 threaded rod and steel drop-in anchor to the concrete slab. On the exposed face, the 4-way riser was capped using a polyvinyl chloride sandwich construction end cap. The 4-way riser was then lagged with Pyrotec Soundlag 4525C fixed using Tesa foil tape. The floor waste gully was charged with water to the level shown in drawing titled "Specimen #5 100 PVC(SC) FWS, Lagging & H100FWS-RR", dated 15 July 2019, provided by Snap Fire Systems Pty Ltd.

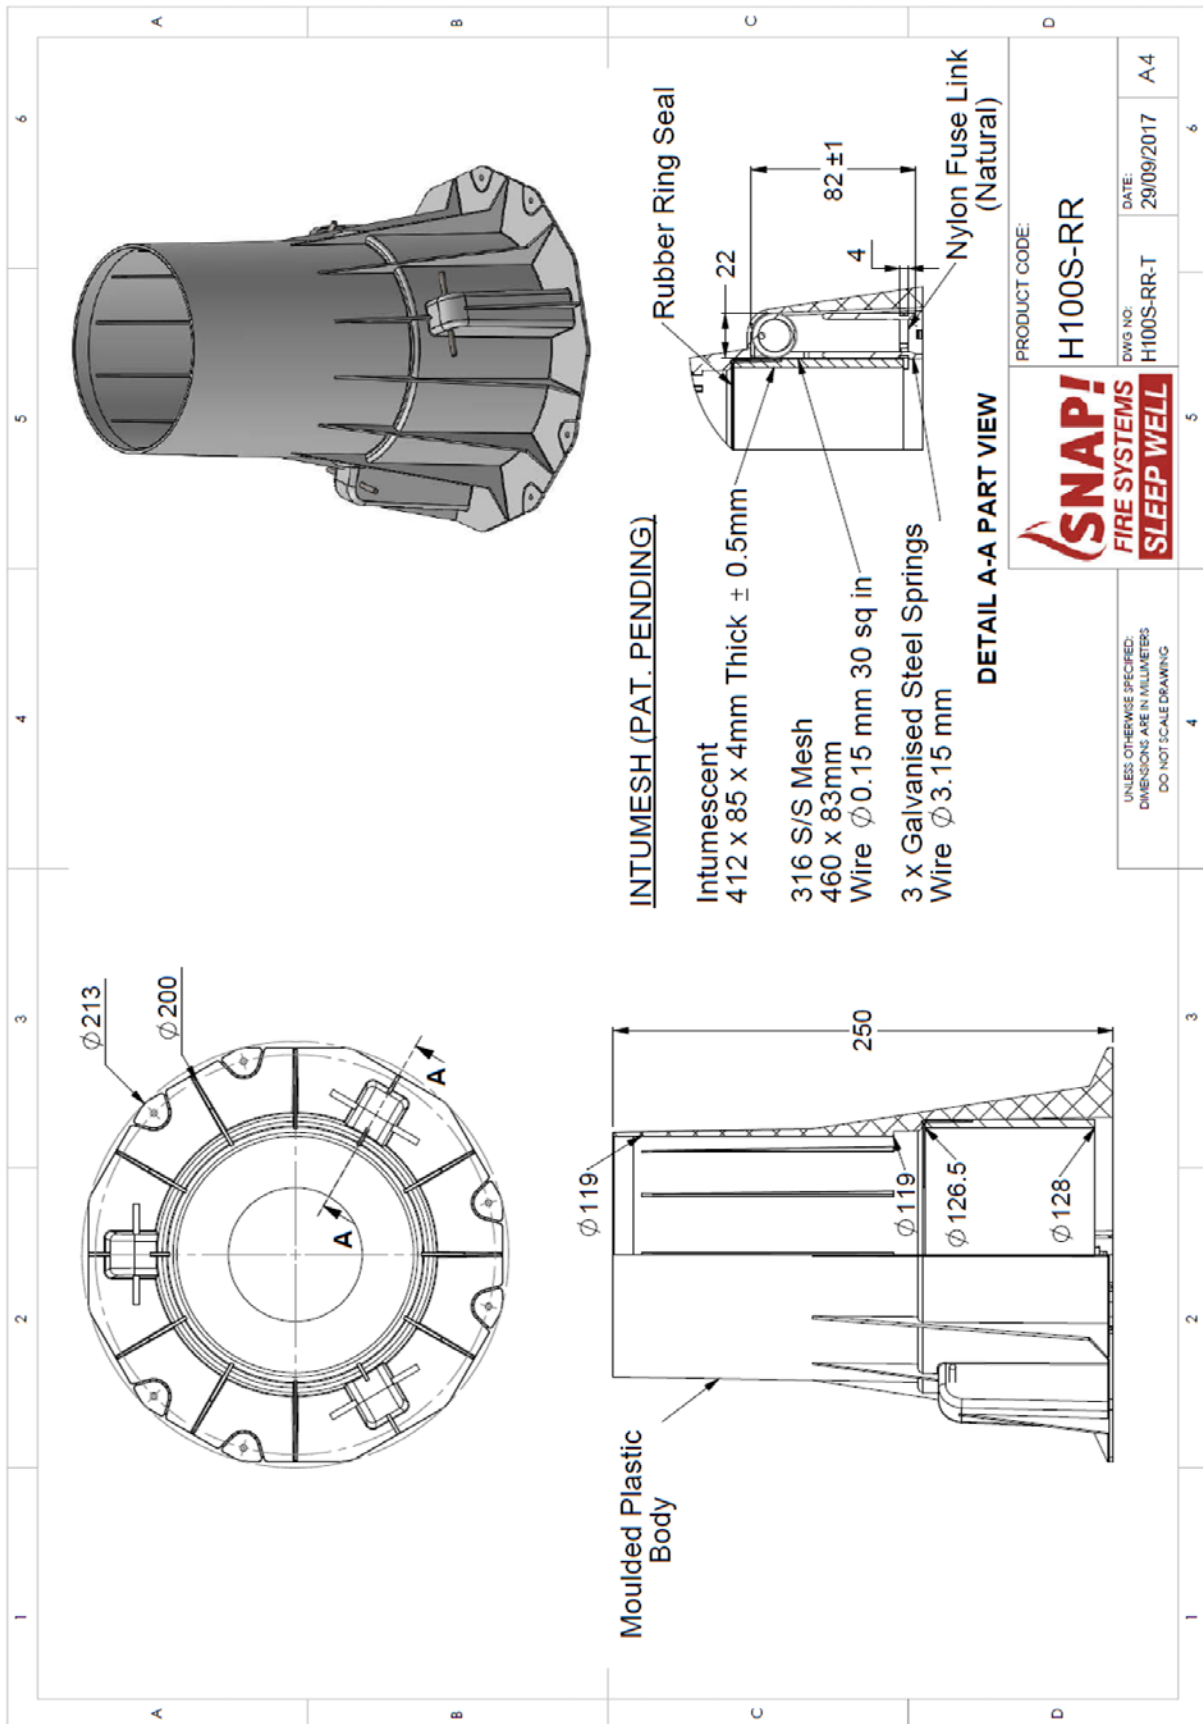
DRAWING NUMBER H100S-RR-T, DATED 29 SEPTEMBER 2017, BY SNAP FIRE SYSTEMS PTY LTD.

The SNAP Cast-in H100S-RR fire collar comprised a 1.6-mm thick polypropylene casing with a 126.5-mm inner diameter and a 213-mm diameter base flange. The 250-mm high collar casing incorporated a 412-mm x 85-mm x 4-mm thick Intumesh intumescent material and a rubber ring seal. The closing mechanism comprised three equally spaced 3.15-mm diameter galvanised steel springs bound with nylon fuse links acting against a 460-mm x 83-mm 316 stainless steel mesh as shown in drawing numbered H100S-RR-T dated 29 September 2017, by Snap Fire Systems Pty Ltd.

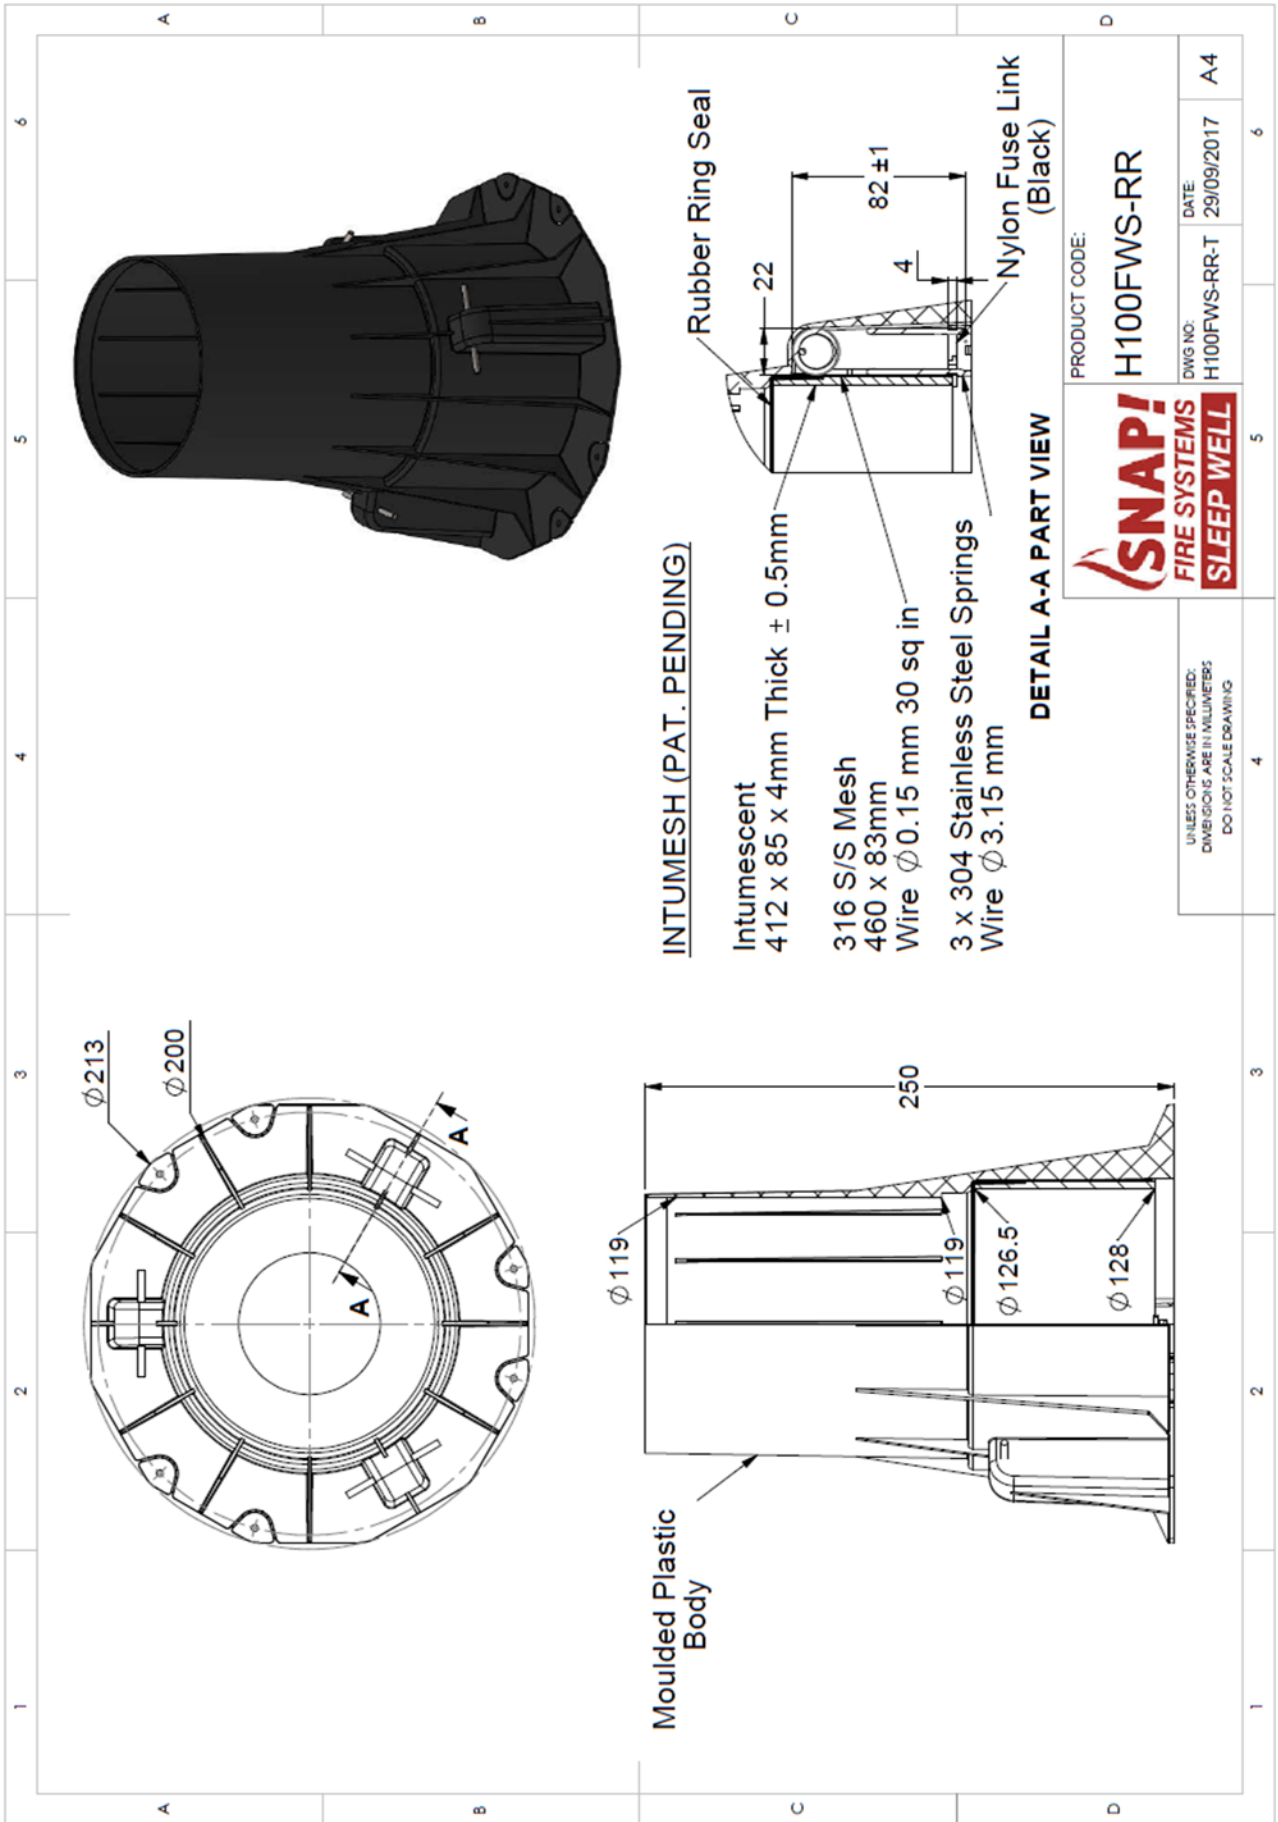
DWG NO:
H100FWS-RR-T

- Intumescent
412 x 85 x 4mm Thick ± 0.5mm
- 316 S/S Mesh
460 x 83mm
- Wire Ø0.15 mm 30 sq in
- 3 x 304 Stainless Steel Springs
Wire Ø3.15 mm

DETAIL A-A PART VIEW

PRODUCT CODE:
H100FWS-RR

The SNAP Cast-in H100FWS-RR fire collar comprised a 1.6-mm thick polypropylene casing with a 126.5-mm inner diameter and a 213-mm base flange. The 250-mm high collar casing incorporated a layer of 412-mm x 85-mm x 4-mm thick Intumescent material. The closing mechanism comprised three equally spaced 3 steel springs held with nylon fuse links. The springs were fabricated using 304 grade stainless steel wire with a diameter of 3.15-mm, with the springs acting against a layer of 316 grade stainless steel mesh measuring 460 x 83-mm as shown in drawing numbered H100FWS-RR-T dated 29 September 2017, by Snap Fire Systems Pty Ltd.

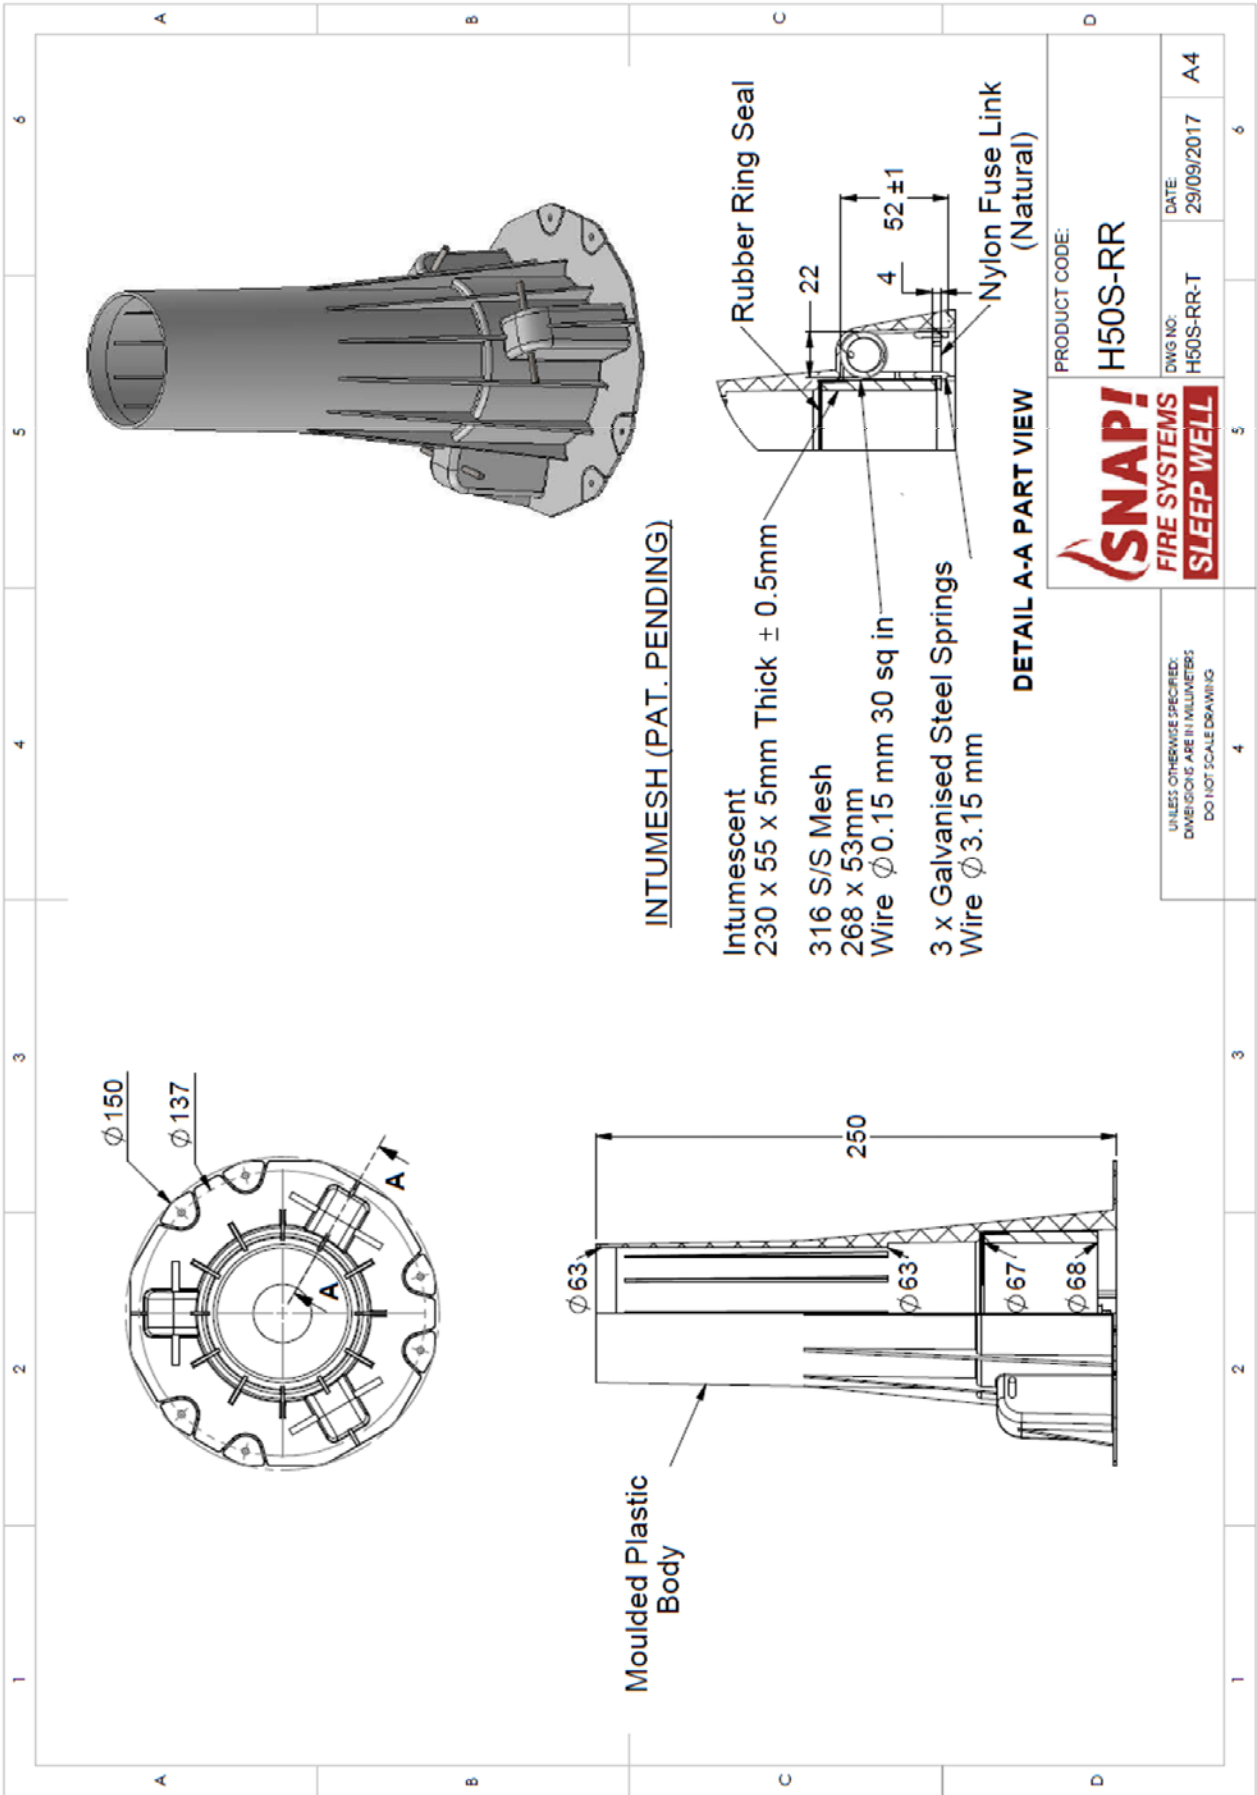
DRAWING NUMBER H50S-RR-T, DATED 29 SEPTEMBER 2017, BY SNAP FIRE SYSTEMS PTY LTD.

The SNAP Cast-in H50S-RR fire collar comprised a 1.6-mm thick polypropylene casing with a 67-mm inner diameter and a 150-mm diameter base flange. The 250-mm high collar casing incorporated a 230-mm x 55-mm x 5-mm thick Intumesh intumescent material and a rubber ring seal. The closing mechanism comprised three galvanised steel springs bound with nylon fuse links and a 268-mm x 53-mm 316 stainless steel mesh as shown in drawing numbered H50S-RR-T dated 29 September 2017, by Snap Fire Systems Pty Ltd.
